# STOP - Important Notice

## Clutch Master Cylinder Failure 1993-88 GM "C" and "K" Pickups

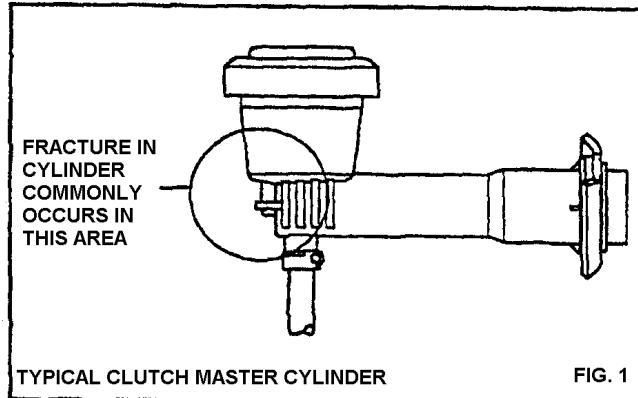
The clutch master cylinder housing can fracture, or seals can be blown out due to excessive hydraulic pressure build up (Fig. 1). Fractures in plastic units can begin as a small crack creating a leak, which can later develop into a visible crack in the clutch master cylinder housing. Also, for those units made of sheet metal, seals will blow out due to the same high pressure build up. This is often mistakenly diagnosed as a defective master cylinder, especially after repeated failures.

The various possible causes for this problem are:

- A binding clutch fork / ball stud
- A restricted line to the slave cylinder
- An incorrect clutch / pressure plate requiring a greater force to be exerted.

Finally, visually inspect the line from the clutch master cylinder to the slave cylinder for any kinks or other damage, which could cause a hydraulic restriction.

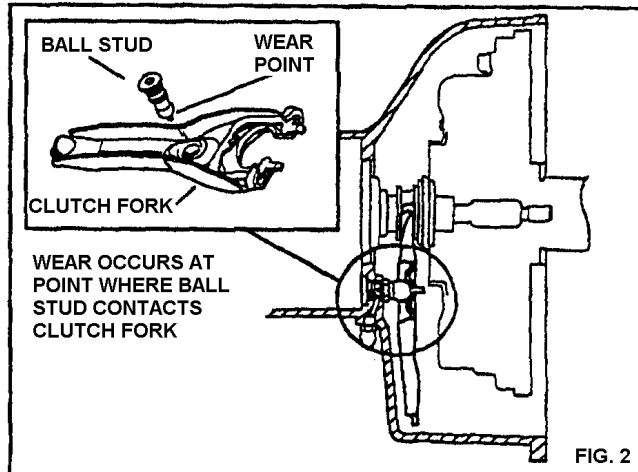
The most common cause of master cylinder fracture has been reported to be a binding clutch fork, or throw out lever (Fig. 2). If the area of contact between the ball stud and the clutch fork is binding, from lack of lubrication, hydraulic pressure in the clutch system can rise substantially. Excessively high pressure can cause the master cylinder to fracture.

If there is a squeaking in the clutch fork or increased pedal resistance the ball stud and clutch fork should be inspected and lubricated, or replaced.
