Tesla, Inc. Service Bulletin		<i>Inspect and Replace Front Tires due to NVH Issue</i>	
SB-24-34-002 August 8, 2025		R1			
Classification		Section/Group		Mobile Service	Configuration
Campaign Bulletin		34 - Wheels & Tires		Cannot Perform	All
Model	Model Year	Country/Region		Build Location	
Model 3	All	Europe		All	
Model Y	All				
The model(s) and model year(s) listed are a general approximation of the affected VIN list. Refer to the VIN/Bulletin Tracker or Customer/Vehicle profile to determine applicability of this bulletin for a particular vehicle.

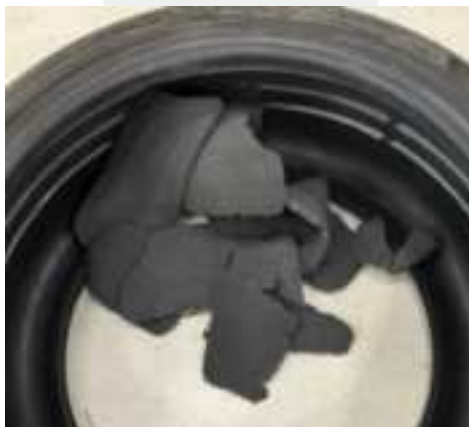
On some Model 3 and Model Y vehicles, there may be noise from the factory installed left-hand front and/or right-hand front Michelin tire(s) due to the foam insert detaching from the tire which may cause imbalance and vibration.

Figure 1 – Loose NVH foam inside tire

- If the NVH foam is properly attached, the imbalance was not caused by foam separation. Go to section [Reinstall Tire](#).
- If the NVH foam is loose, replace both tires on the front axle. Go to section [Replace Tires](#).
