Title	LIFEPAK 35 Technical Bulletin				Page	Page 1 of 30
QS Process	Field Service, Depot, Aftermarket	Owner	DAVID.HUBER		Doc #	M0000021809
Doc State	Release	Effective Date	07 Jul 2025		Doc Rev	AD
QS Parent	7000180, Servicing Process Work Instruction					
Confidential – Stryker Proprietary Information – Do Not Duplicate

Technical Bulletin

Bulletin Name: TB_LP35_Tech Bulletin

Product Family: LIFEPAK 35

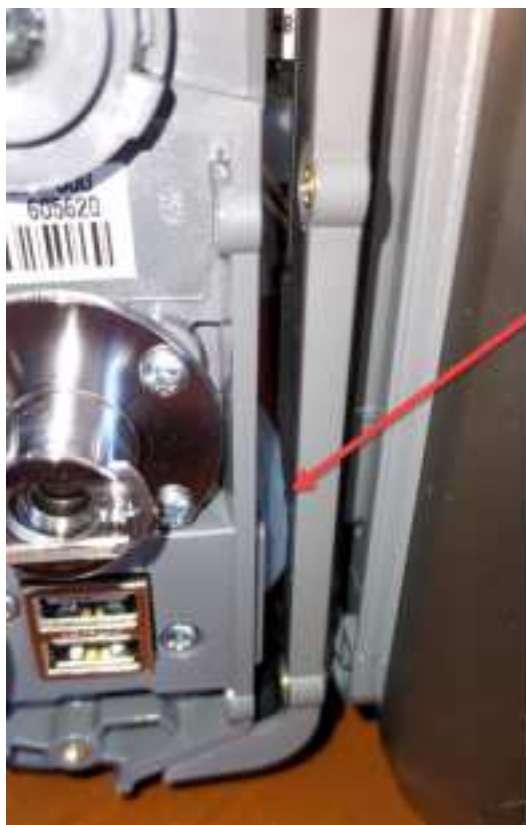
4.2.2. Neonate Alarm

The LP35 has a neonate alarm that alerts when the device senses that the cuff is inflating too quickly. This can be triggered if the cuff is put on the patient too tightly. There should be space to fit two fingers between the cuff and patient.

The Neonate Alarm can also occur if the NIBP internal hose is partially kinked because of a repair. When installing the PMOD, take care not to pinch the NIBP hose.

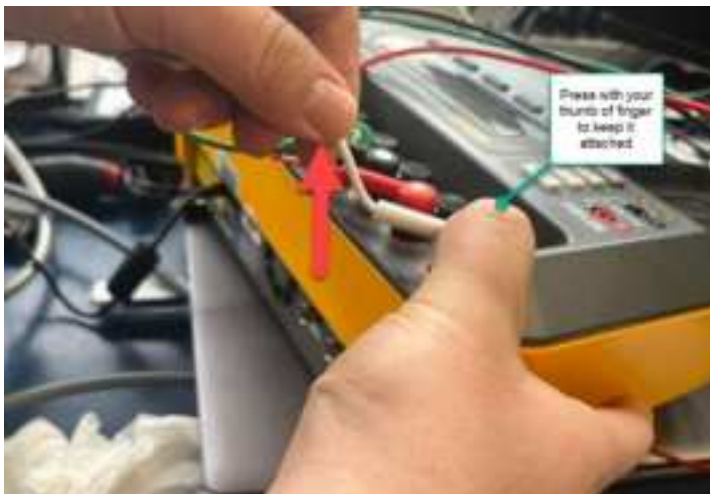
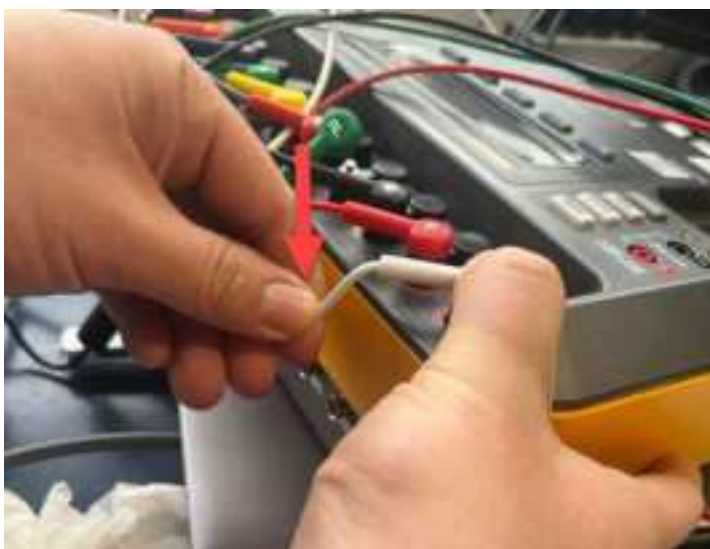
4.3.2. Intermittent ECG Signals

- Customers report
 - ECG goes blank while in use
 - Screen goes blank while in use (prod customer when they indicate screen went blank. Do they mean it went black, or they lost a signal)
- Check the ECG cable- Connect the ECG cable leads to your simulator or 7000 and gently go through each one and wiggle them to see if you lose signal (note loss of some leads will cause other leads to disappear)
- Send cables back to PAC.

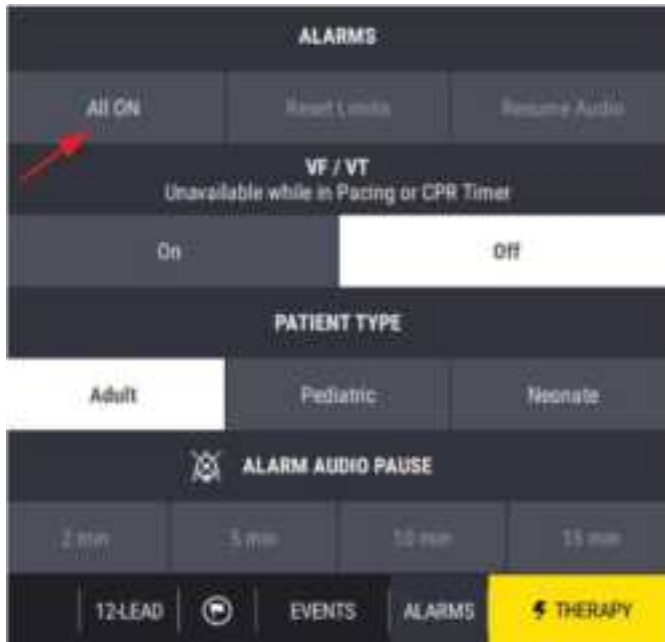
4.3.3.VF/VT Alarm Disabled but Still Alarms

- Customers have reported that the alarm is coming on although they've disabled it.
- If the customer has enabled All Alarms, although VF/VT is disabled it will alarm again.

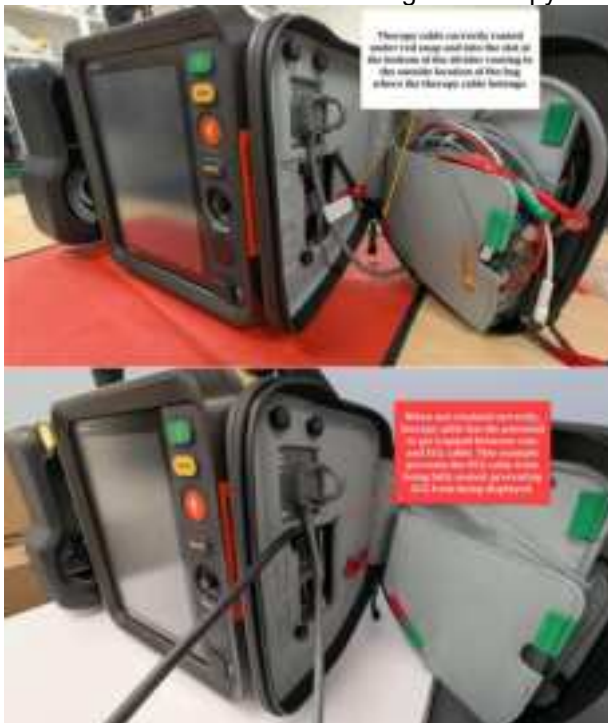
4.3.4.ECG Cable Routing

- Ensure that the customer is routing the therapy cable properly otherwise it could pull on the ECG cable.

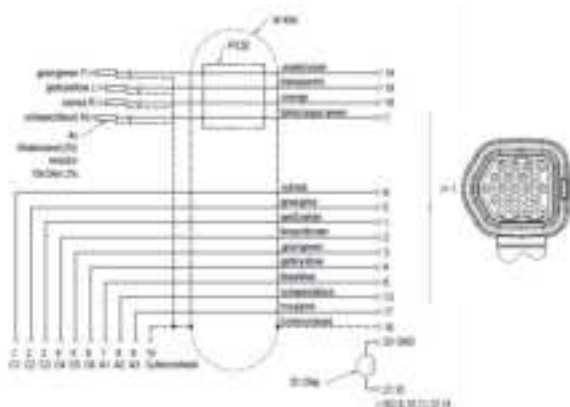
4.3.5.ECG Leads Off and Noise

- For most ECG troubleshooting, remind customers to check their cable connection, not just leads.
 - Can be hard to see with the cable tucked in the bag and behind it's shield so do a physical check.
- ECG Leads Off can be triggered by a partially disconnected cable.
- Multiple leads are on the lower half of the cable.
 - If you lose RL, you get leads off and ----.
 - If you lose more than 2, you get leads off.
- Troubleshooting in manual is incomplete and does not include a check cable connection.
 - Restarting device will clear alarms until connection is reestablished.

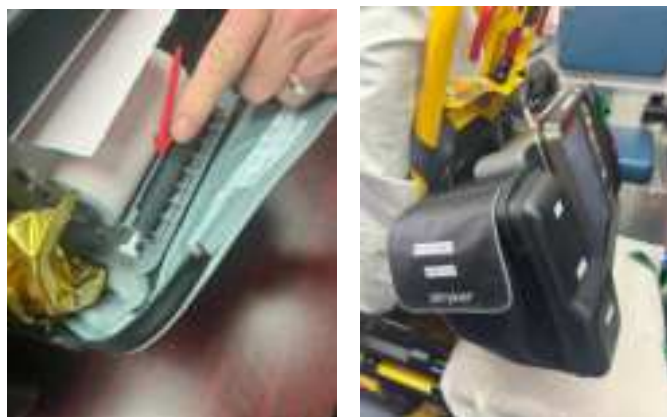
- Some customers are reporting paper feeding back into itself.
 - Ask customer specific questions about print issues. Do not assume it's a bad printer.
 - Customers can pull about 2 inches of paper out after tearing to avoid jamming.
- Some customers carry their devices on the back of the cot. This puts pressure on the printer, and it will feed back into itself.

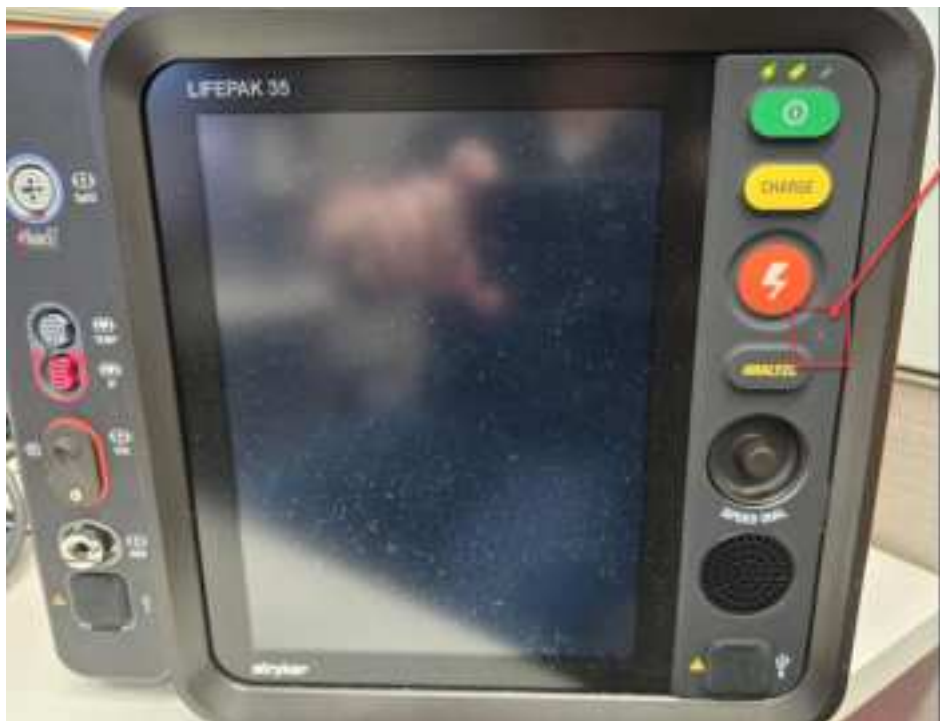
6.5. Ambient Light Sensor Test Failures

Some technicians are experiencing false failures when performing the Ambient Light Sensor test during the LP35 CAPIP. This can happen if the environment you are working in doesn't have sufficient lighting and the light sensor is not able to achieve an adequate baseline reading.

If you are working in an environment that has poor lighting it might help to shine a flashlight at the sensor at the beginning of the Ambient Light Sensor test to allow the application to register an adequate baseline reading.

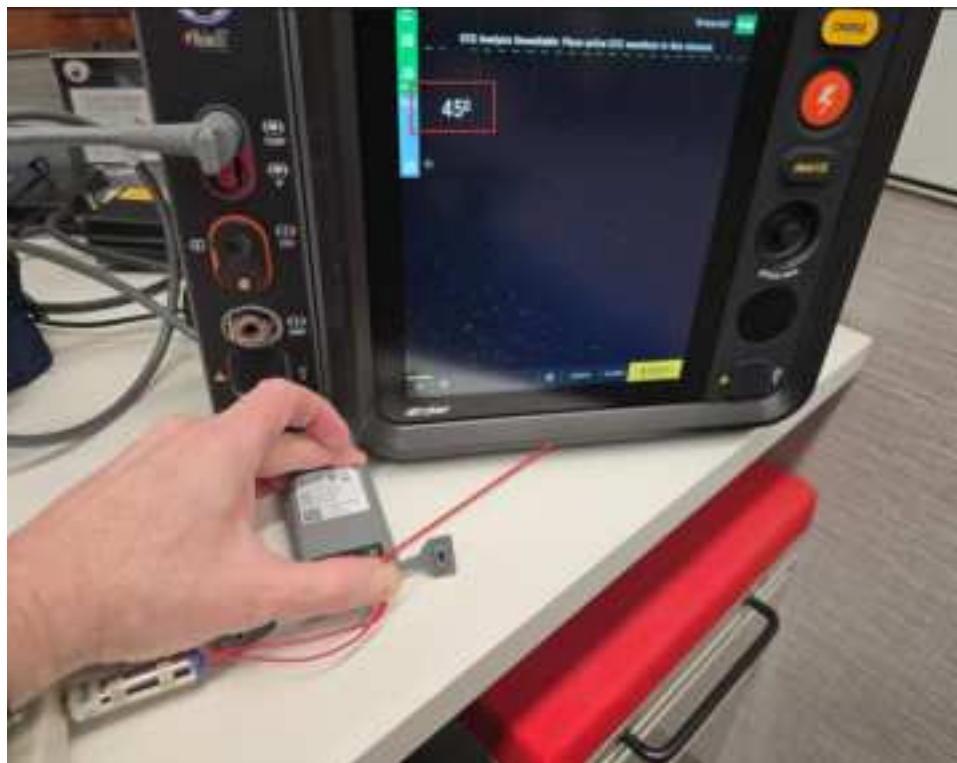
6.6. Temperature Test Failures

Some technicians are experiencing Temperature Test failures while performing the LP35 CAPIP. If you are experiencing this failure, it might be a good idea to verify your test setup in patient mode. Put the device in patient mode and connect the temperature simulator to the cable. Confirm that the simulator value matches the display within 0.2C. If your reading falls outside of this range check to make sure you have a good connection from the test adapter to the cable and see if the reading changes.

If the reading is still out of range, try testing on a different device or using a different temp cable. If it is determined that the device is the issue you can try replacing the temp connector or the system PCB.
