SIB 41 03 21

**SERVICE ACTION: CHECKING THE FRONT SIDE PANEL**

| E-Series | Model Description | Production Date |
|---|---|---|
| G20 | 3 Series Sedan | February 7, 2018 – November 17, 2020 |

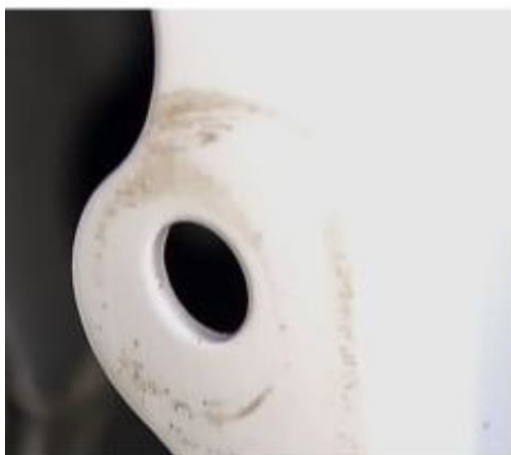
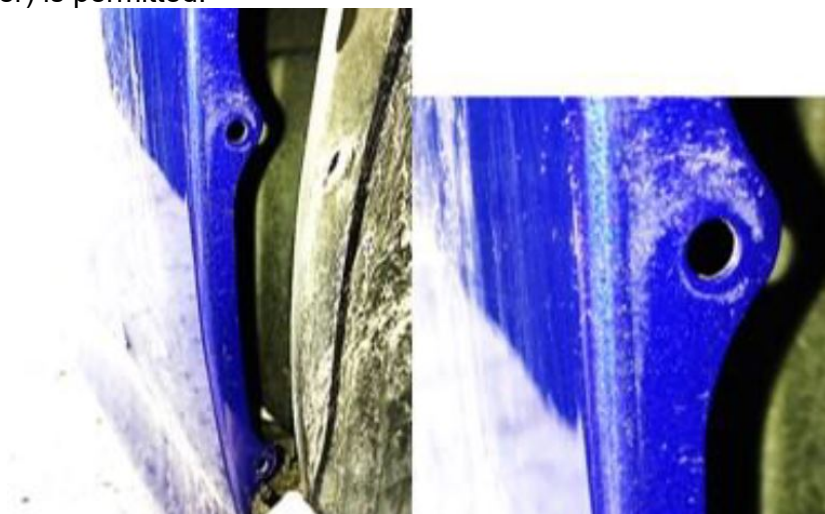
**Damage version 1:** Scratches in the clear coat, even over the entire area (matting of the clear coat in the area of the wheel arch liner) is permitted.

**Damage version 1 (No Repair):** Re-secure the fender liner using updated blind rivets. No additional repair is necessary.

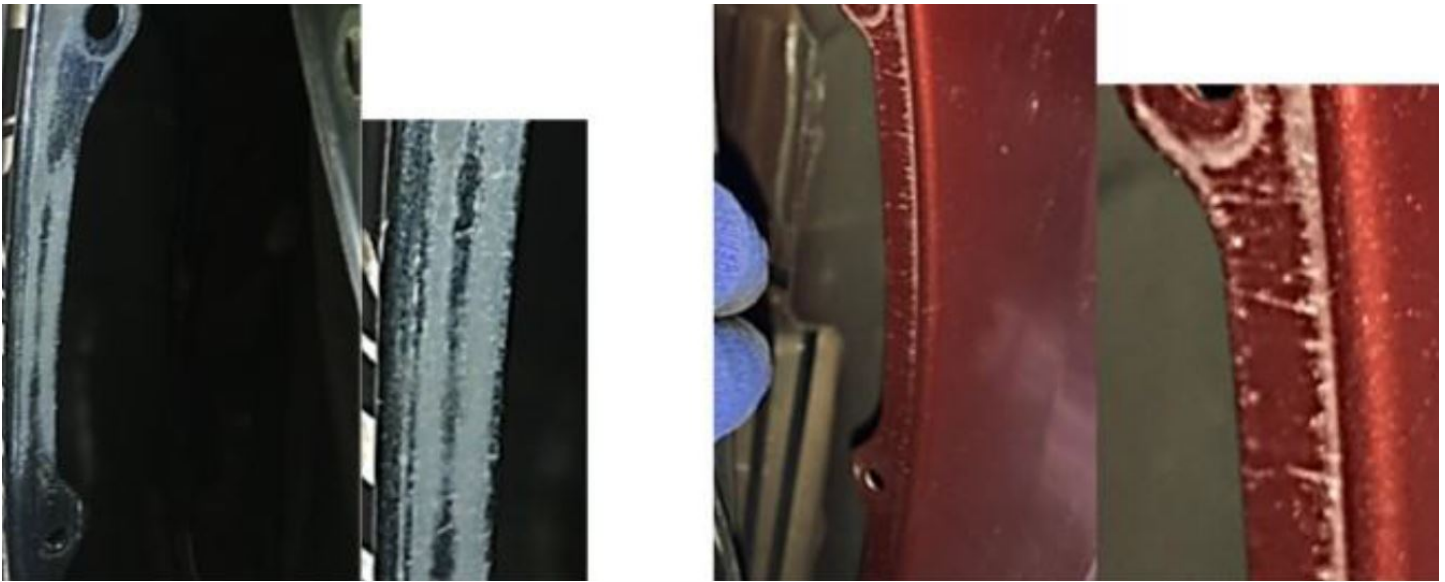
**Damage version 2:** Damage through the clear coat and paint. Damage must not extend all the way through to metal.

**Damage version 2 (Rework):** Tie back and secure the fender to keep it away from the fender. Using a clear coat touch up pen P/N 51 91 0 419 748, apply clear coat over any areas of damage. Allow the clear coat to dry completely, and re-secure the fender liner using updated blind rivets. No additional repair is necessary.

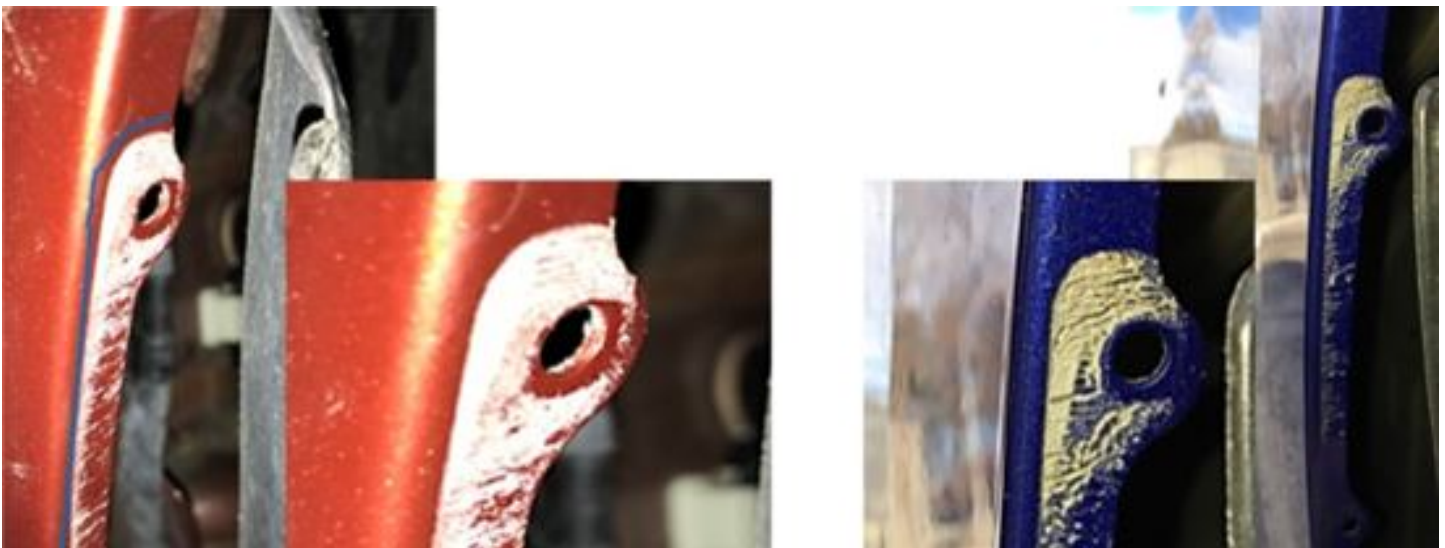
**Damage version 3:** Damage through the clear coat and paint down to the metal.

**Damage version 3 (Repair):** The small area of damage will need to be repainted by a collision repair facility. **After refinishing the damage, reinstall the fender liner and secure using updated blind rivets.** The collision repair facility can reference attachment “Attachment to B41 03 21” for additional information about how to make the repair.

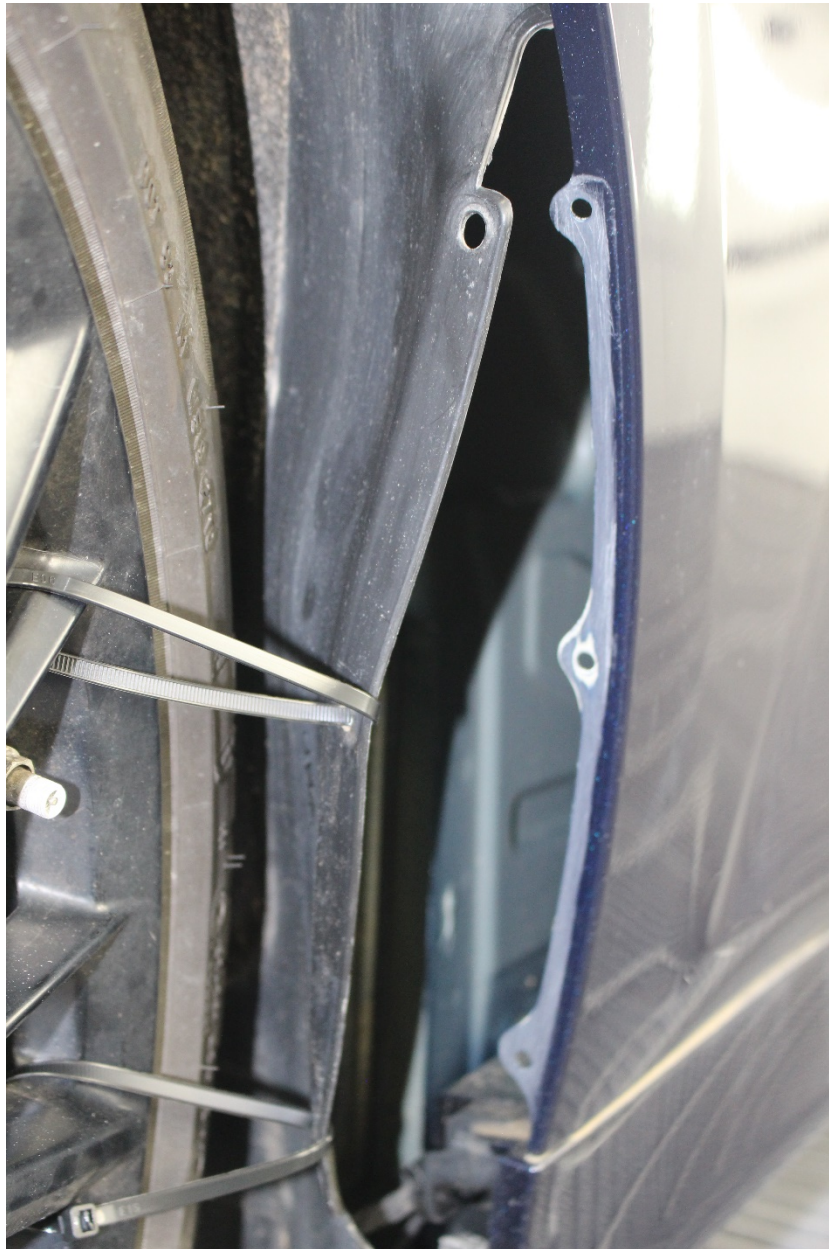
Step 4 – Once the liner is pulled back the area can be inspected for paint damage and corrosion. In this example there are a few areas with exposed metal and primer. Clean the area with Wax and Grease / Silicone Remover. (Market specific due to VOC compliance)
