TSIB 25-05 Rev A		Jun 26, 2025
TO:	All Operators	
TITLE:	Adjusting the Lower Mount of the HVAC Idler Pulley Bracket	
APPLICABILITY:	MCI coaches equipped with Isolated (rubber mounted) idler pulleys bracket

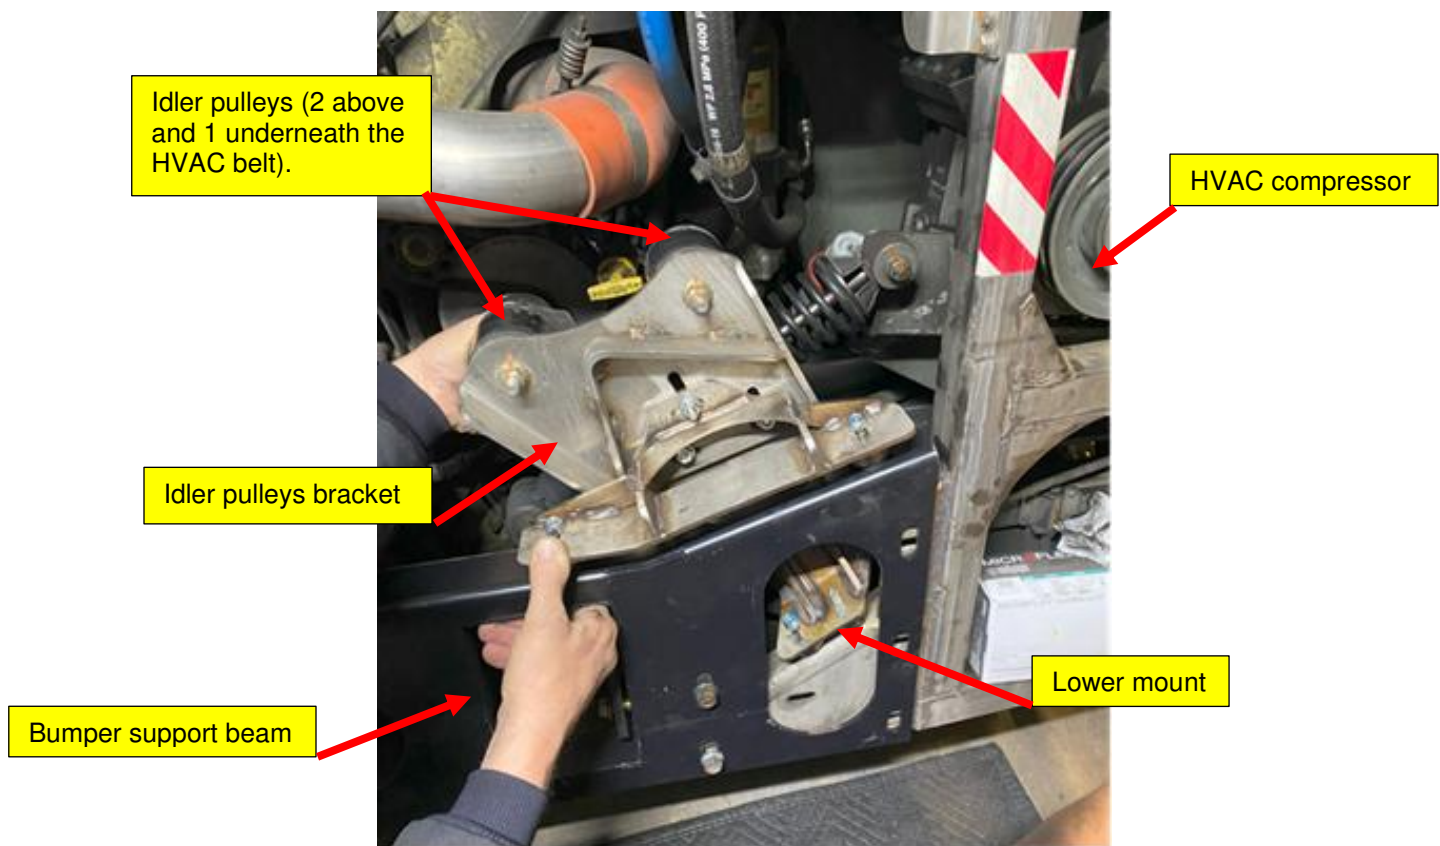
Figure 1: Idler pulley bracket and related components

This TSIB is to remind MCI coach operators that when servicing the HVAC belts, idler pulleys or the lower mount of the idler pulley bracket, ensure that the lower mount is adjusted so it is not contacting the bumper support beam nor the bumper itself. **Ensure that there is at least ¼" gap between the lower mount and the bumper support beam.** Refer to Figures 1 and 2. The idler pulley bracket is mounted with rubber isolators. If the lower mounting bracket is touching the rear bumper support beam, then the vibration from the belts will bypass the rubber isolators and may transfer belt vibration to the coach frame causing noise inside the passenger compartment.

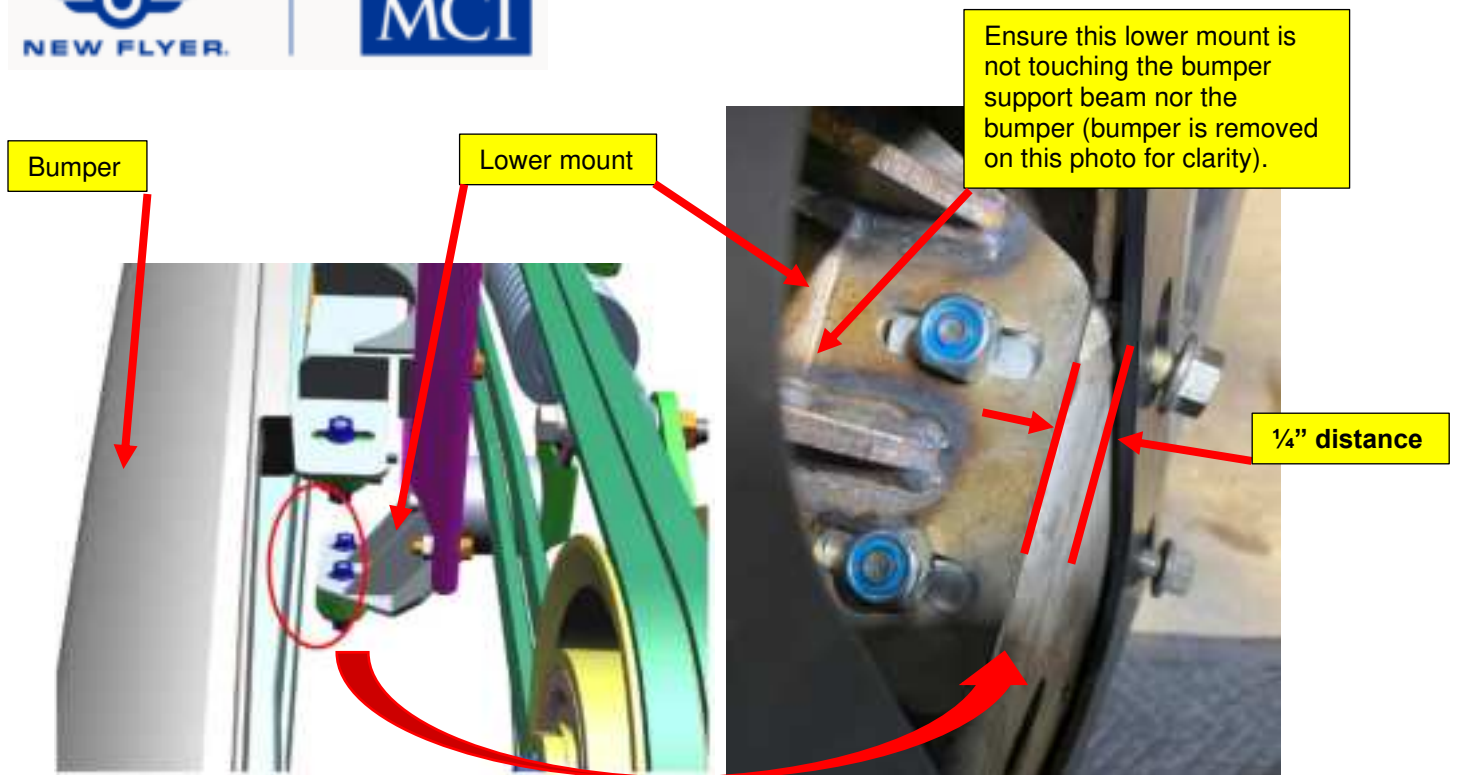
Figure 2: Idler pulley bracket lower mount
