Min/max tolerance sample catalogue for paintwork and corrosion damage

Situation: Min/max tolerance samples are available to enable improved pinpointing of paint and corrosion damage. They are a supplement to the BMW Paintwork publication announced in Service Information [41 01 08 \(452\)](#) and published in October 2008.

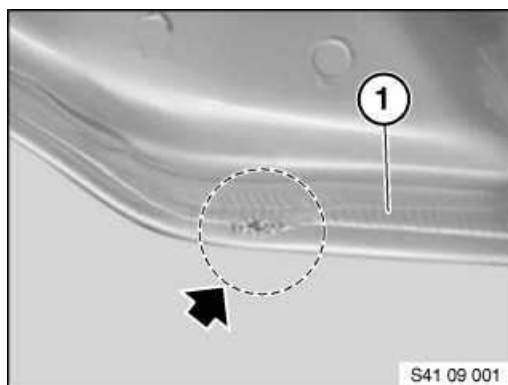
Sample A1:

General appearance: Rust is visible without scratching the surface.

Visible rusting on fold and its seal (1).

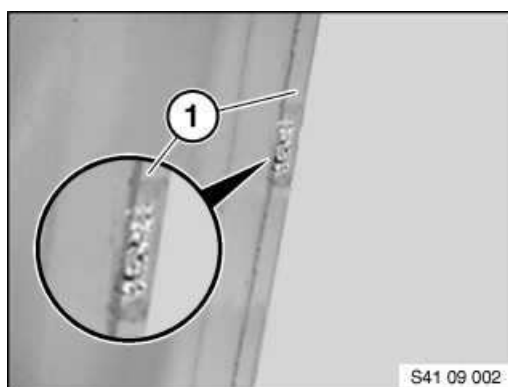
Sample A2:

Bubbling on outside (1) of fold seal.

Bubbling between fold seal and outer edge. The fold seal covers an approx. 5 mm wide strip at the edge of the component.

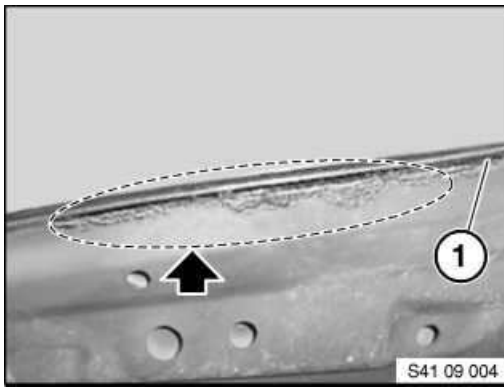
Sample A3:

Bubbling on the inside of the fold seal (1) is more extensive than the width.

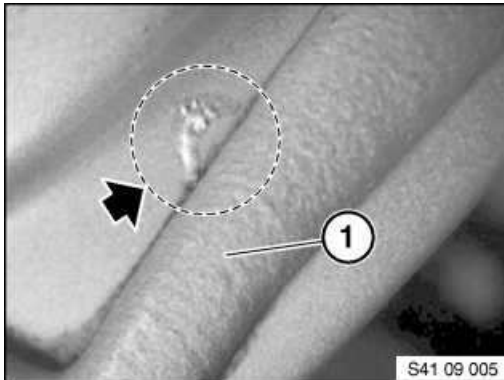
Sample B1:

General appearance: Rust is **NOT** visible without scratching the surface.

Bubbling on the inside of the fold seal (1) is less extensive than the width. Lengthwise distribution is less than the width of the fold seal (1).

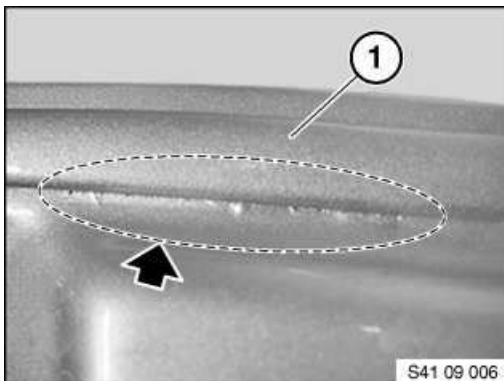
Sample B2:

Bubbling on the inside of the fold seal (1) is less extensive than the width. Lengthwise distribution is greater than the width of the fold seal (1).

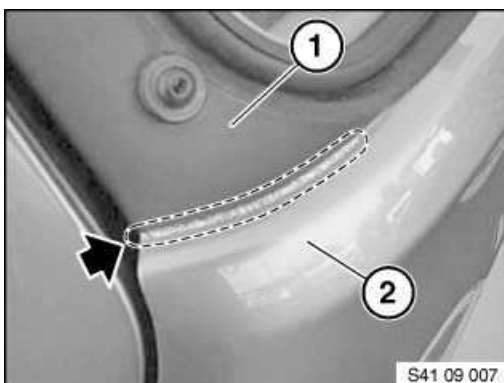
Sample C1:

Scrape marks on paint surface of the tailgate (2) by plastic trim (1) (only Touring).

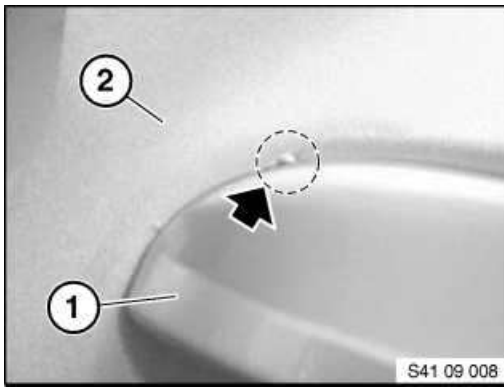
Sample C2:

Chafe marks on paint surface caused by tailgate handle strip (1) on tailgate (2).

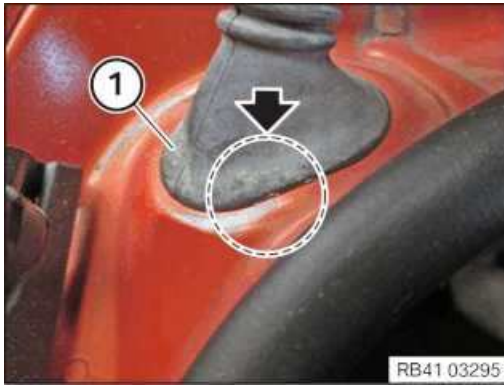
3. Tolerance sample D (rubber grommets)

Formation of blisters is not visible without lifting the rubber grommet (1).

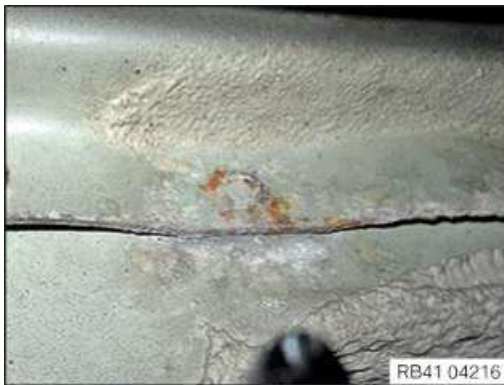
3. Min/max tolerance sample E (vehicle underbody)

Visible red rust formation originating from an edge or a spot-weld.
