| | | <b>Tesla, Inc.</b><br>Service Bulletin | | <b><i>Replace HW4 Camera Hood</i></b> | |
| <b>SB-24-15-003</b><br>August 1, 2025 | | <b>R1</b> | | | |

On certain Model Y vehicles, the camera hood may not hold the GNSS antenna firmly in place, causing a rattling sound that can be heard from the rear view mirror area.

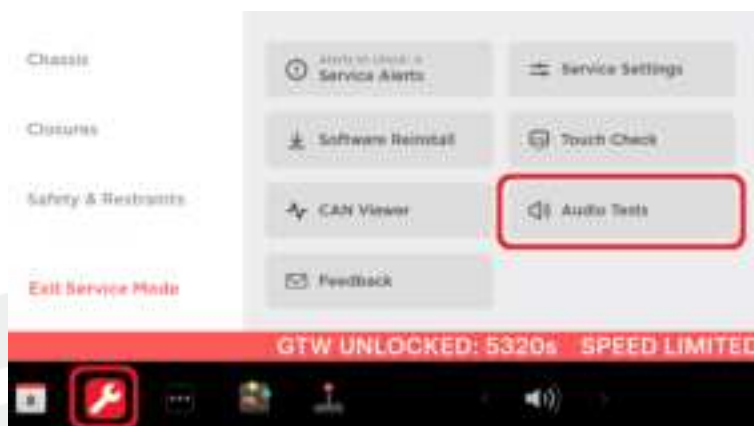
Figure 1

1. Get into the driver seat and make sure all doors and windows are closed.
2. Place the vehicle into Service Mode Plus (refer to Service Manual procedure [00050000](#)).
3. In Service Mode, touch **Controls** > **Audio Tests** (Figure 1).

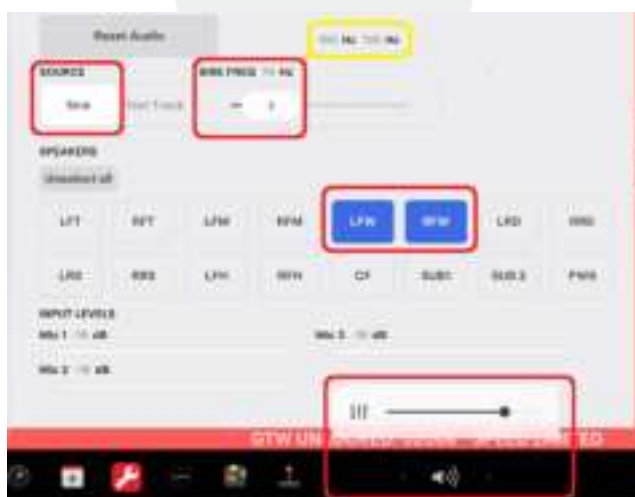
Figure 2

4. Set the 'SOURCE' to **Sine**, set the 'SINE FREQ' to **79 Hz**, set the 'SPEAKERS' to **LFW** and **RFW**, and then set the volume to 75% to play a test sound (Figure 2).
