**TECHNICAL INSTRUCTIONS**

**SPECIAL SERVICE CAMPAIGN K0B**

**MILLIMETER WAVE RADAR SENSOR**

**CERTAIN:**  
**2018 – 2019 TACOMA**  
**2018 – 2019 TUNDRA**

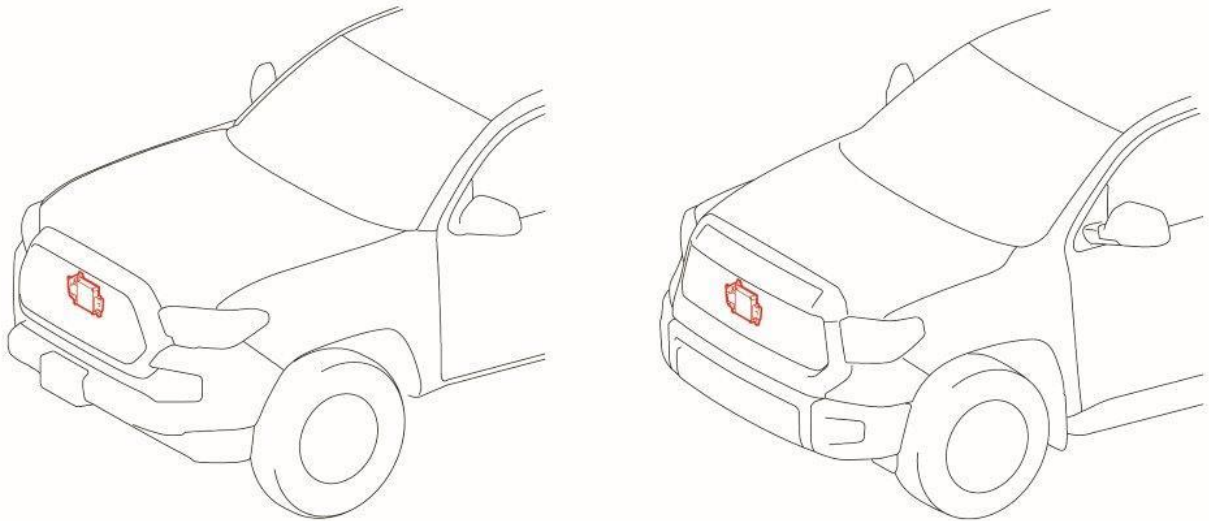
The involved vehicles are equipped with a Pre-Collision System (PCS) that may automatically apply the brakes if the system detects a potential collision. Due to the mounting of one of the system's sensors, it is possible for water to enter the sensor. This can lead to PCS deactivation or inadvertent brake activation resulting in limited deceleration for a short duration of time.
