TECHNICAL BULLETIN

LTB00916NAS2 25 APR 2016

Intake Camshaft Variable Cam Timing Actuator - Component Failure

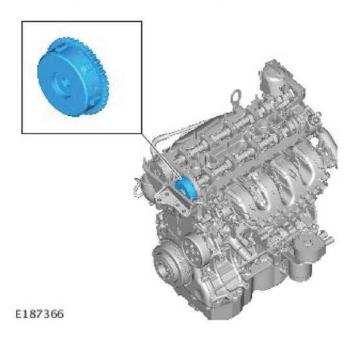
Intake camshaft Variable Camshaft Timing (VCT) actuator location

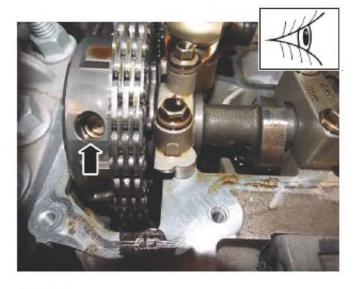
E186694

- 1. Remove the camshaft cover (see TOPIx Workshop Manual, section 303-01A / 303-01B: Engine).
- **2.** Inspect the Variable Camshaft Timing (VCT) actuator.
 - If the VCT actuator is noisy but the 'stopper' is in place, proceed to step 3.
 - if the 'stopper' is not in place in the VCT actuator, proceed to step 4.

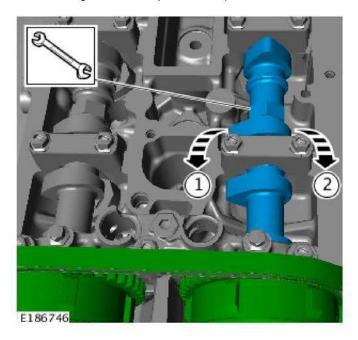
3. NOTE: clockwise movement should NOT be possible without also rotating the engine.

Fully rotate the camshaft anti-clockwise (1) and then attempt to rotate the camshaft clockwise (2).

- If no clockwise movement was possible without also rotating the engine, the VCT actuator is functioning correctly.
 - · Reverse the removal procedure.
- If the camshaft rotates freely in both directions, the VCT actuator is NOT functioning correctly; proceed to step 4.

4. Renew the intake camshaft VCT actuator (see TOPIx Workshop Manual, section 303-01A / 303-01B: Engine).
