#09-09-40-003A: SIR/Airbag Light Illuminated, DTC B0081 and Passenger Presence System (PPS) Code 23 Stored (Replace Passenger Seat Belt Retractor and Re-Route Wire Harness) - (Jul 26, 2010)

Models:	2006-2008 Chevrolet Cobalt Coupe	
	2008-2010 Chevrolet Cobalt SS Coupe	
	2006 Pontiac Pursuit Coupe (Canada Only)	
	2007-2010 Pontiac G5 Coupe

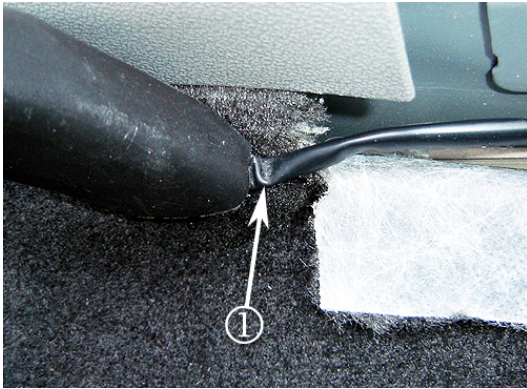
The wire on the Belt Tension Sensor (BTS), that is part of the retractor assembly, may become open or acquire a ground near the sensor. If the BTS is rotated toward the rear of the vehicle, added stress is applied to the wire bundle that may cause an open or a ground path. The two photos below illustrate the possible effects on the wiring. Each photo indicates the area to investigate at the arrow labeled (1).

Figure 1 – Stress Point on Wiring Bundle

1. Check for shorts, opens and continuity between the PPS module and belt tension sensor (BTS) mating connector that is part of the vehicle harness (Located under the passenger rear trim panel near the rear seat cushion).
2. If there are no wiring issues, replace the Passenger Seat Belt Retractor using the repair instruction “Seat Belt Installation and Seatbelt Sleeve Modification” located below. Do not replace the PPS.
3. Connect the Diagnostic Scan Tool and clear the codes.
4. Verify that the DTC does not reset.

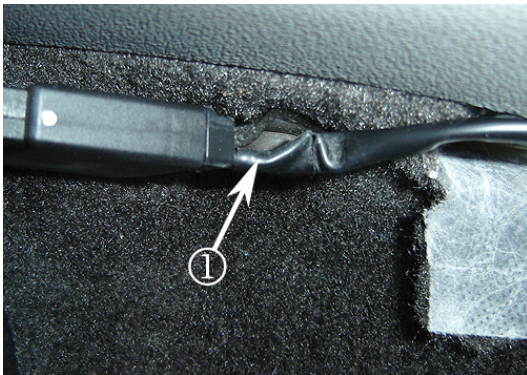
[Figure 2 – Outer Wiring Wrap Insulation Breached](#)

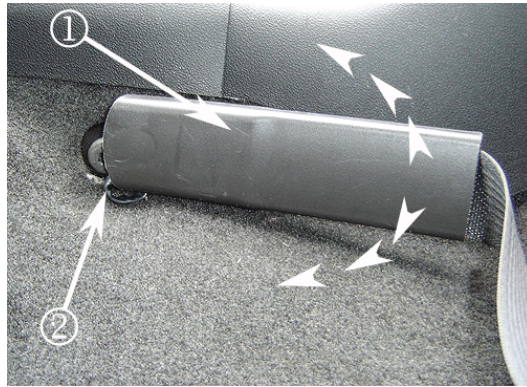
[Figure 3 – Rotating the Seat Belt Sleeve](#)

(1)	Passenger Seat Belt Sleeve
(2)	BTS Sensor Wire Sheath

1. Connect the Diagnostic Scan Tool.
2. Locate the Passenger Side Belt Tension Sensor (BTS) and rotate the seat belt sleeve fully as shown in Figure 3.

3. Slowly rotate the BTS w/sleeve forward and rearward. Did PPS and SDM faults change to current and cause the Air Bag light to illuminate? If the DTC changed to current, replace Seat Belt retractor using “Seat Belt Installation and Seatbelt Sleeve Modification” instructions located below.

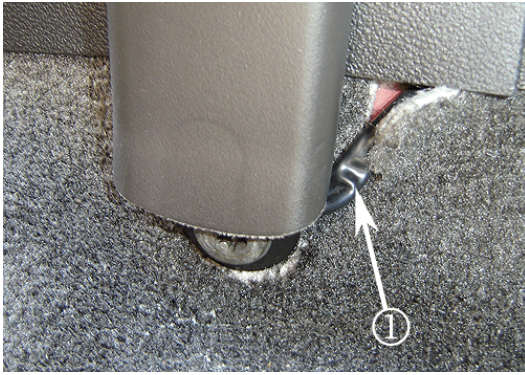
[Figure 7 – Wire Stress Area](#)

5. Route the new wire pigtail from the BTS to allow extra slack at the previous wire stress area (refer to Figure 7).
