Applies To: **2012 Civic LX and HF – ALL**

## The i-MID Does Not Display Odometer, Trip, Fuel Range, and Economy Statuses

(Supersedes 13-017, *i-MID Software Update*, dated April 4, 2013, to revise the information marked by the black bar)

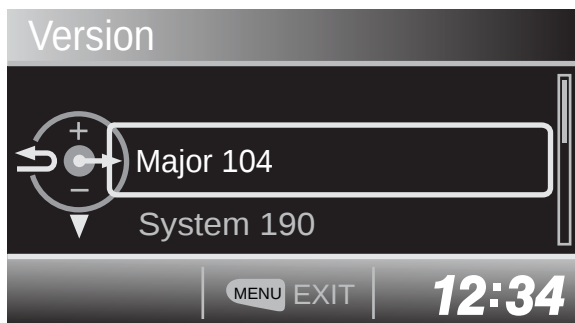
5. Check the software version.

- If the software version is **MajorV105** or later (shown on the i-MID display as **Major 105** or later), this service bulletin does not apply. Continue with normal troubleshooting.
- If the software version is **MajorV104** (shown on the i-MID display as **Major 104**), go to step 6.
