Adaptive Cruise Control Technology Sets (and Maintains) the Pace

Techline News

Customer Care and Aftersales

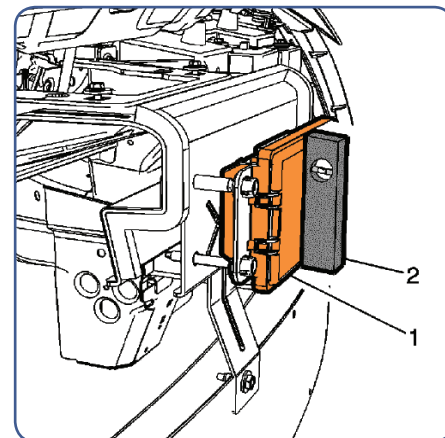
When the radar is out of alignment, DTCC1002 (Distance Sensing Cruise Control Module Performance) is set by the Adaptive Cruise Control distance sensor module. A persistent blockage warning can also be an indicator of misaligned radar. When DTCC1002 is set, the radar must be mechanically aligned using the special alignment tool. Refer to Forward Range Radar Module Alignment in the appropriate Service Information.

An out of alignment condition may result from tampering or damage to the Adaptive Cruise Control distance sensor module from a major or minor impact to the front of the vehicle. A damaged or misaligned radar module is not always obvious. Sometimes, damage can occur to the module or its alignment without any evidence of impact to the front of the vehicle.

When checking for a misaligned radar module, look for a bent mounting bracket or a module that is no longer properly attached at its attaching points on the mounting bracket. Misaligned radar can result in DTCC1002 being set, a recurring blockage warning message on the DIC, a reaction to target vehicles or objects in adjacent lanes or no reaction to target vehicles or objects in the vehicle's path.

Vehicle distance sensor module (1) and water bubble level (2)

When aligning the Adaptive Cruise Control distance sensor module, the vertical position of module should be 90 degrees relative to the ground. Use a water bubble level to align the distance sensor module vertically. The bubble level should have an accuracy of ± 0.5 degrees (9 mm/m). Turn the alignment screw until the bubble level has a value of 90 degrees.

TIP: Before performing a radar alignment, always check the three ball sockets in order to insure that the module is properly attached to the ball studs on the mounting bracket.

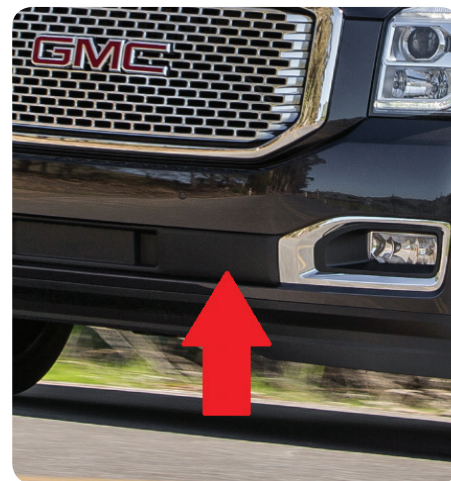
Radar blockage detection is a normal part of Adaptive Cruise Control operation. If the radar is blocked, a "Front Radar Blocked Clean Front of Vehicle" message will display on the DIC. A blockage warning message may be displayed if.

- Weather conditions such as rain or heavy snow prevent the radar from being able to properly discriminate targets. This DIC message will clear shortly after the weather conditions improve.
- Rain, snow, ice, mud or debris collect on the front or the back of the fascia in the area of the radar or on the face of the radar module itself. This DIC message will clear shortly after the affected surfaces are cleaned.
- The radar module is no longer properly aligned. If a blockage warning is observed and the radar field of view is not blocked due to weather conditions or water, snow or mud on any of the surfaces, the module should be inspected to determine if it is properly mounted and aligned.

Keep the front fascia clean for proper radar operation.

Since radar blockage is a part of normal radar operation, the radar module should not be replaced when the blockage DIC message is displayed. Be sure to check the identified possible causes.

First, turn off the ignition before cleaning the fascia or module surfaces. When cleaning the front of the vehicle to eliminate a blockage, it may be necessary to clean both the outside surface of the front fascia, the inside surface of the fascia and the cruise control vehicle distance sensor module face.

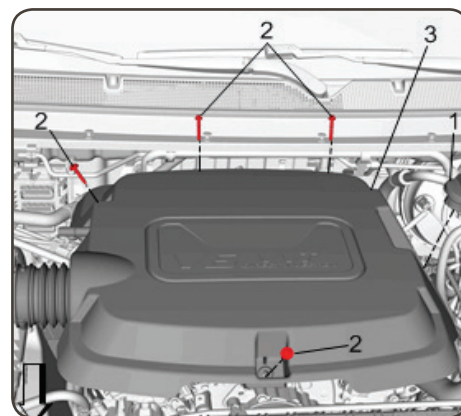
- There are four bolts that secure the cover. One bolt is located at the front of the cover and three at the rear of the cover. Make sure all bolts are completely removed before trying to remove the cover. The rear bolt closest to the air cleaner outlet duct is often overlooked. The cover cannot be removed unless all bolts have been removed first.

1. Oil fill cap 2. Air cleaner outlet duct bolts 3. Air cleaner outlet duct cover

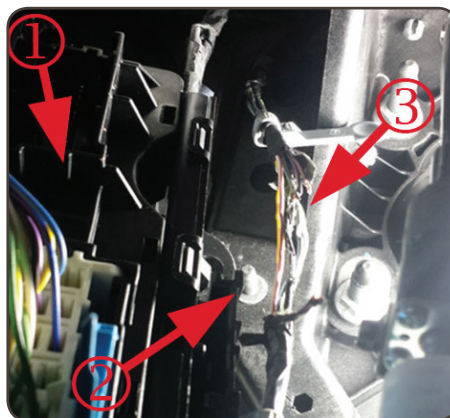
Some 2016 Escalade models, Silverado 1500, Suburban, Tahoe, Sierra 1500 and Yukon models equipped with the 4.3L engine (RPO LV3), 5.3L engine (RPO L83) or 6.2L engine (RPO L86) may have an illuminated Service Engine Soon (Check Engine) lamp or a reduced power message displayed on the Driver Information Center. Several Accelerator Pedal Position (APP) DTCs may set (including P0106, P0107, P0697, P2122, P2123, P2127, P2128 or P2138).

1. Left IP junction block
2. Mounting stud where harness may be pinched
3. Damaged harness (harness tape removed)

Follow the appropriate Service Information for the DTCs that have set. Also inspect the wiring harness near the left instrument panel junction block. The wiring harness may have been pinched at the mounting stud. Repair any damaged circuits as necessary
