Service Guide

about the Imaging unit streak defect

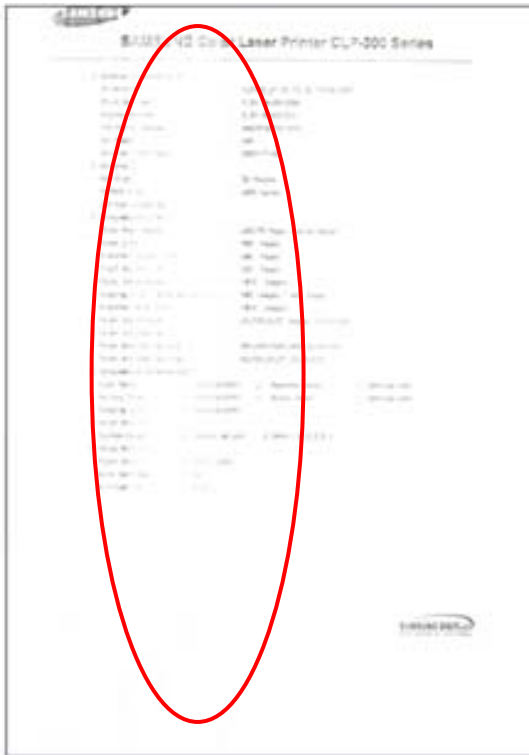
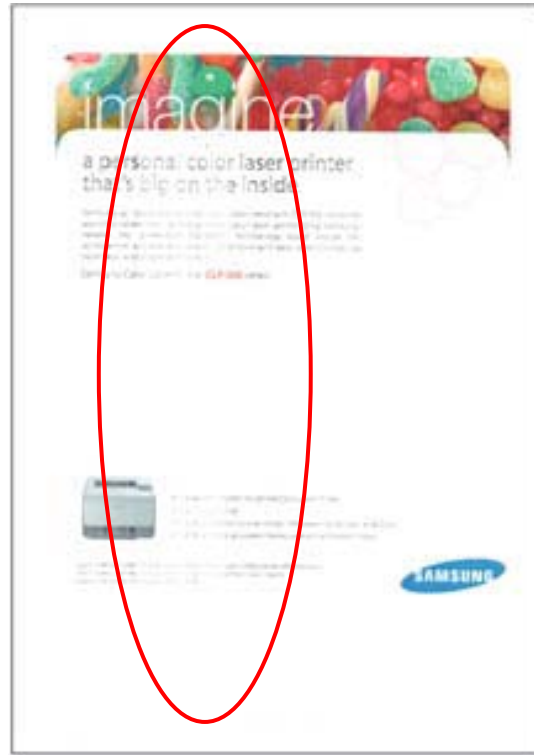
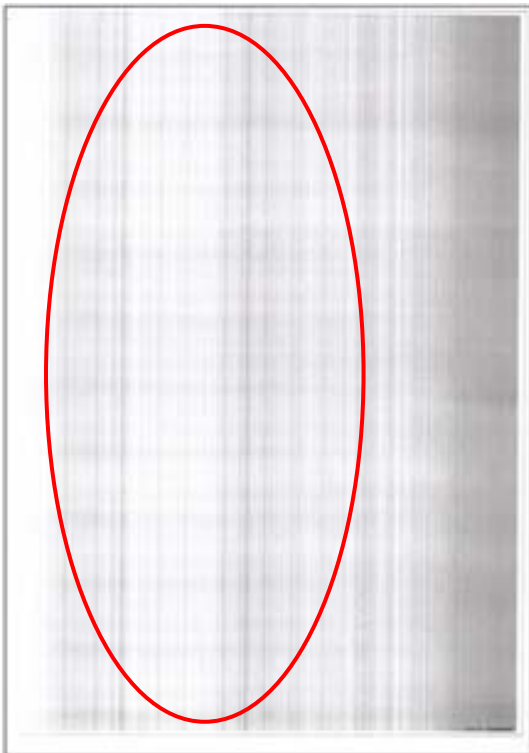
■ Example of vertical streak image

The printed page has a vertical streak defect.

Black toner was adhered to Dr-Blade, because of Toner stress
As a result, toner couldn't be transferred to Deve-Roller.

1. Clean the LSU window and do Firmware upgrade on that machine.
If this issue couldn't improve that carry out the next step.
2. Check the serial number of imaging unit. and prepare compatible with BK deve unit
 - Manufactured Imaging unit before July 2007 : BK deve unit(JC97-02616E)
 - Manufactured Imaging unit before August 2007 : BK deve unit(JC97-02616A)
3. Replace BK Deve Unit and do Firmware upgrade

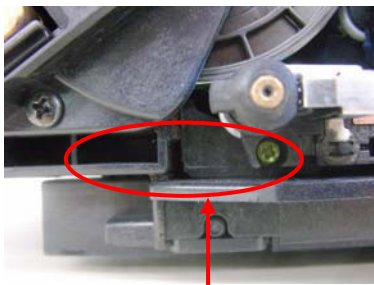
Parts Name	Parts code	Distinction of BK deve unit	Check Method.
MEA UNIT-DEV K(old)	JC97-02616E	<p>Manufactured before July. 2007</p> <p>Initial Imaging Unit : CNE3JC9603610CCD5G9P7xxxxxx ~</p> <p>After market Imaging Unit : BY74BQGP7xxxxxx ~</p>

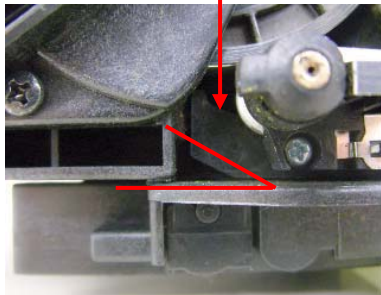
MEA UNIT-DEV K(new)	JC97-02616A	<p>Manufactured after August 2007</p> <p>Initial Imaging Unit : ~ CNE3JC9603610CCD5G9P8xxxxxx</p> <p>After market Imaging Unit : ~ BY74BQGP8xxxxxx</p>

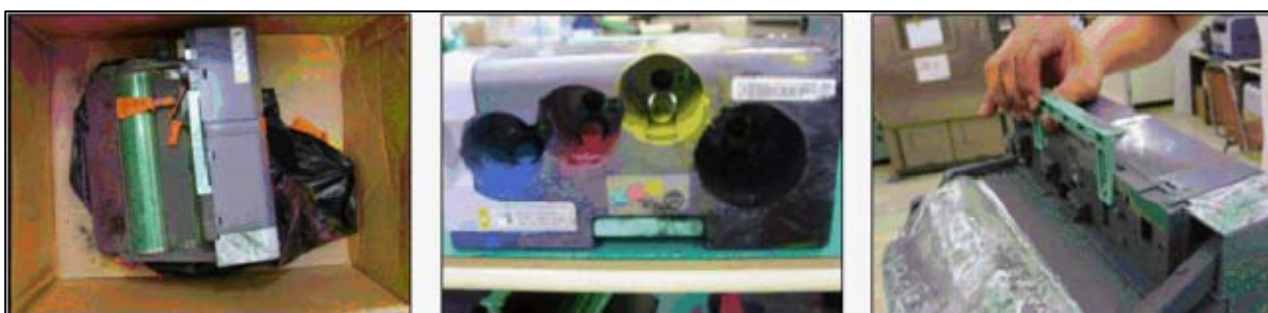
3.1 In case of not packing the hole

If you send imaging unit without packing toner bottle hole, imaging unit is a mess because of toner leakage. So, You should put the plug.(Cap deve) when move imaging unit. If you have not cap deve then you may pack the hole using toner bottle, waste paper, etc

Imaging unit is a mess like below picture.
