# SERVICE BULLETIN

Number: 13-002

## Ford 5.4L / 6.8L Mount Kit Safety Recall

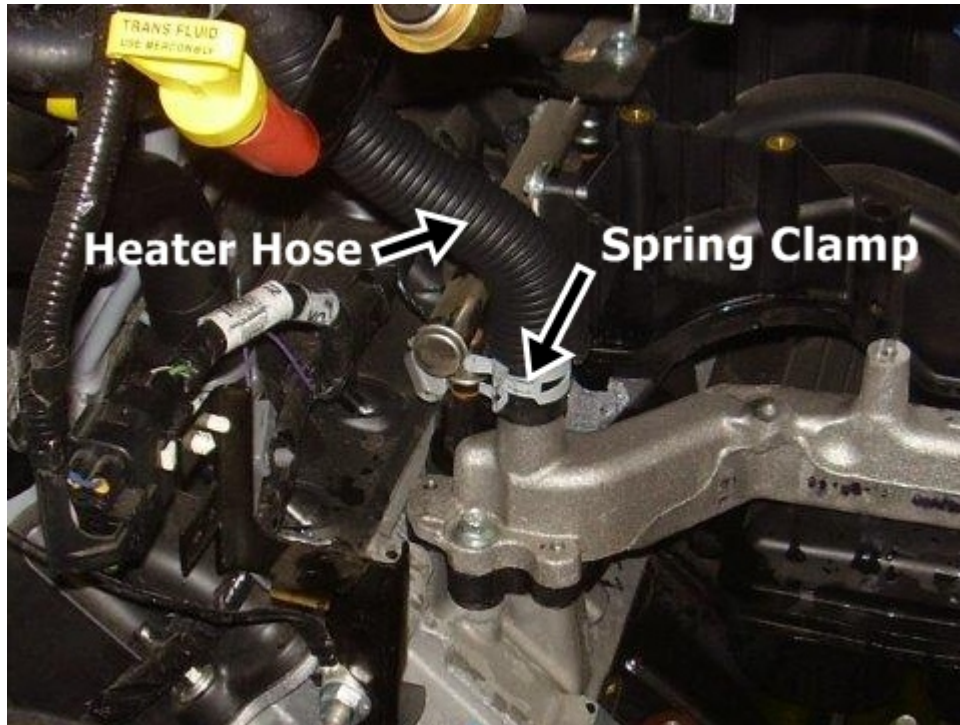
If the tab from the heater hose spring clamp is not oriented properly, (toward the rear of the engine) it could possibly pinch the alternator cable against the compressor mount plate.

**View from front of engine with the tangs improperly located to the front of the engine (without mount, compressor, or alternator)**

If the harness is pinched, move harness to a location that is clear of spring clamp and rotate the tangs of the clamp to the rear of the engine (See pictures below)

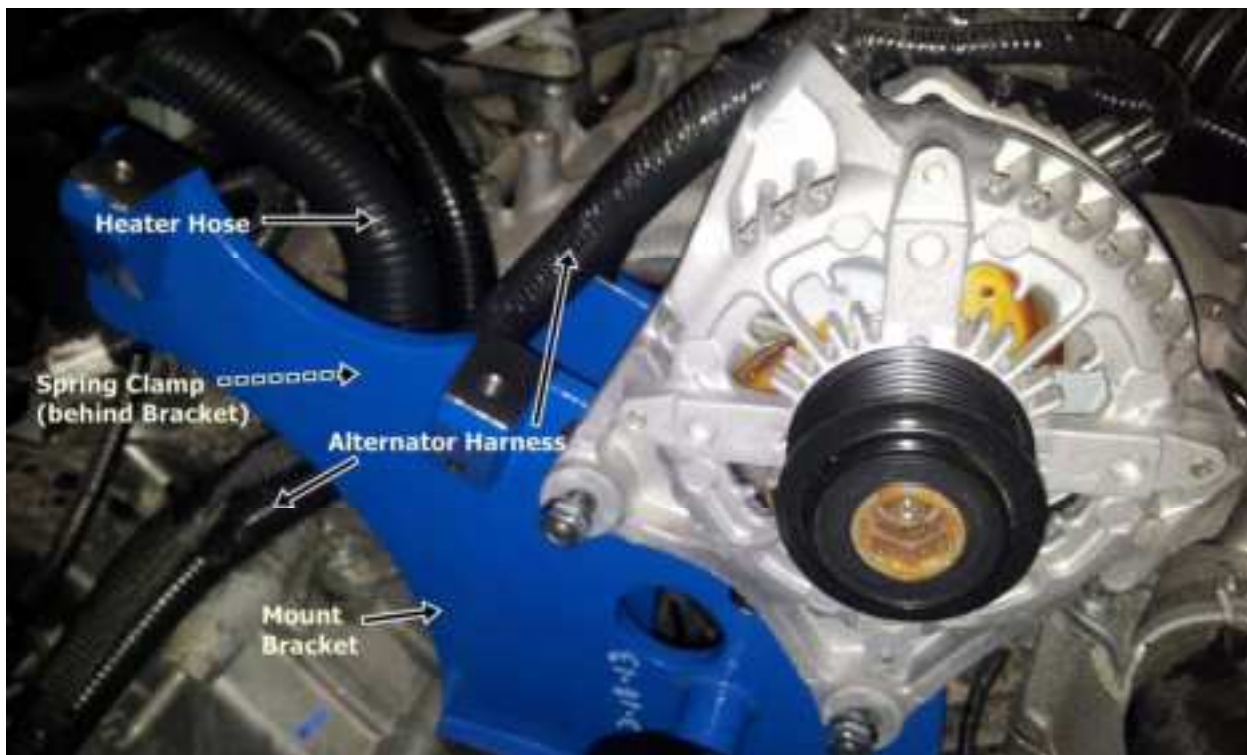
**View from front of engine (without compressor)**

1. Reach behind the compressor and move the alternator cable up and down
2. If it moves without binding and you have verified that spring clamp tangs are oriented properly, to the rear of the engine, the vehicle is OK.

3. If the harness does not move, feel to see which way the spring clamp tangs are oriented. If the tangs are oriented properly, vehicle is OK.
4. Submit warranty claim to Trans/Air Mfg. for this inspection using MK-10-A flat rate code.

5. If the harness does not move, and if the tangs are not oriented properly, follow instructions below:
  - a) Remove compressor belt
  - b) Loosen the compressor from the mount bracket

- c) Lay the compressor to the left side of the bracket
  - d) Loosen the mount bracket enough to free the harness
  - e) Rotate the spring clamp on the heater hose, until the tangs are facing the rear of the bus

- f) Inspect harness for damage and repair if necessary
  - g) Contact Trans/Air Warranty for authorization if repair is necessary
  - h) Tighten the mount bracket

- i) Re-check to make sure the harness is not binding or pinched
  - j) Mount the compressor back into the bracket
  - k) Re-install belt
  - l) Submit warranty claim to Trans/Air Mfg. for this inspection using MK-45-A flat rate code
