1199 Panigale Safety Upgrades  
Models: MY 2012 and MY 2013 Panigale (All Versions)  
**Recall Bulletin RCL-12-006**

Date: Tuesday, August 7<sup>th</sup>, 2012  
To: Dealer Principal, Service Manager, North American Dealer Network  
From: Austin Gray, Technical Director; Jonathan LaForte, Technical Manager

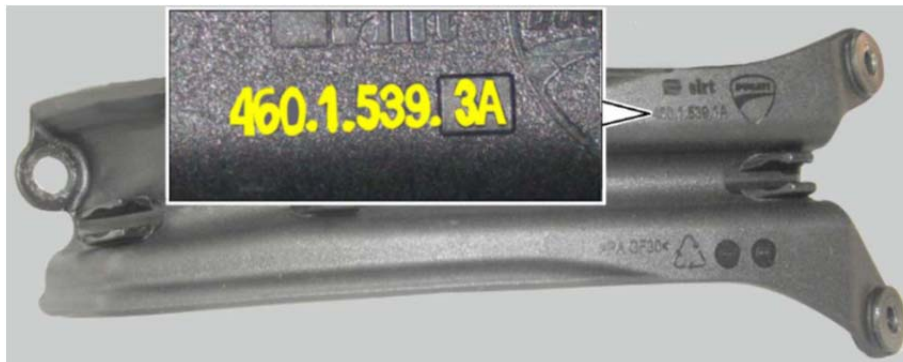
- A) **EXHAUST BUTTERFLY VALVE BOWDEN CABLE SUPPORT** (all versions): In some rare conditions of engine faulty operation (for instance when the bike is operated while running on one cylinder due to a fouled spark plug) it is possible that the excess heat built up in the catalytic converter can overheat the lower engine area. This could cause the exhaust butterfly valve Bowden cable support, installed to the oil sump, to melt or burn. This part must be replaced with the new one having a higher heat rating. During this procedure it is also required that the technician re-tighten the screws retaining the silencer central brackets. (Even if this has previously been performed during the OIL SERVICE 1000 pursuant to Tips&Tricks no. 54).

## **A) EXHAUST BUTTERFLY VALVE BOWDEN CABLE SUPPORT**

**Instructions for replacing part no. 46015393A (All versions) Ref. no. 1 Page 4.**

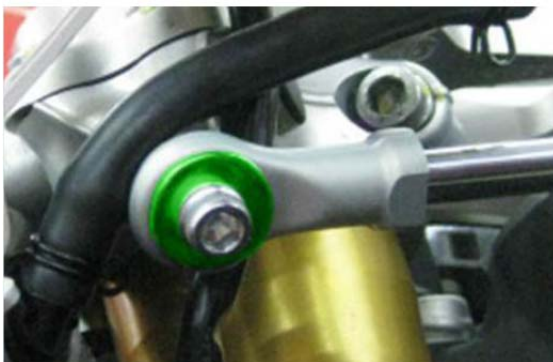
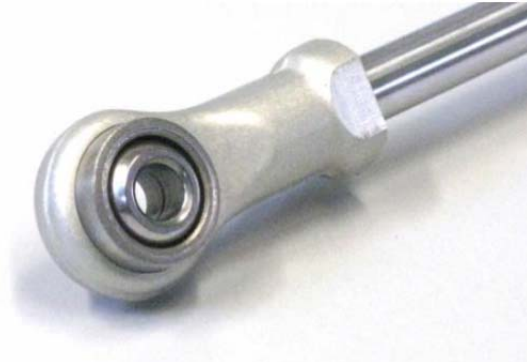
- B) **OHLINS STEERING DAMPER HEAD UNIBALL BEARING** ("S" and "S Tricolore" versions only): It is possible that due to incorrect assembly tolerance, the mentioned uniball bearing could slip out of its seat on the Ohlins steering damper. It is necessary to install a special washer on its mounting point to prevent this problem.

## B) OHLINS STEERING DAMPER UNIBALL BEARING

Instructions in Section C for installing the washer P.6.4X18X1.6 ISO7093 ("S" and "S Tricolore" versions only) Ref. no. 2 Page 4.

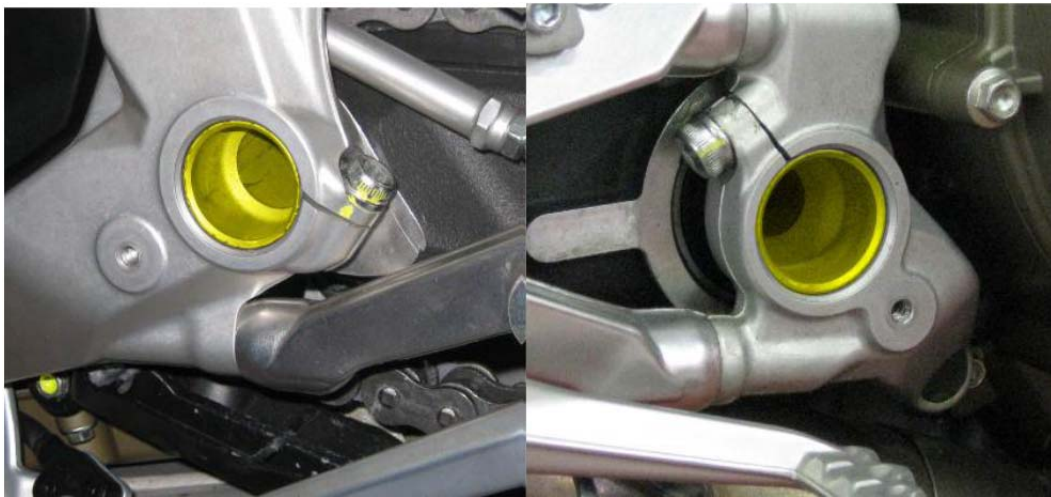
- D) **SWING-ARM SHAFTS** (all versions): It is necessary to re-tighten again the right-hand and left-hand shafts fastening the swinging arm to the engine since they might not be tightened correctly.

- 1) Loosen the **screw (21)** from clamp on RIGHT-hand swinging arm shaft.
- 2) Loosen the **RIGHT-hand swinging arm shaft (22)** by 180° without removing it.
- 3) Tighten **RIGHT-hand swinging arm shaft (22)** to **100 Nm ± 10%**.
- 4) Tighten clamp **screw (21)** to **8 Nm ± 5%**.

- 5) Slacken the **screw (23)** from clamp on LEFT-hand swinging arm shaft.
- 6) Loosen the **LEFT-hand swinging arm shaft (24)** by 180° without removing it.
- 7) Tighten **LEFT-hand swinging arm shaft (24)** to **100 Nm ± 10%**.
- 8) Tighten clamp **screw (23)** to **8 Nm ± 5%**.

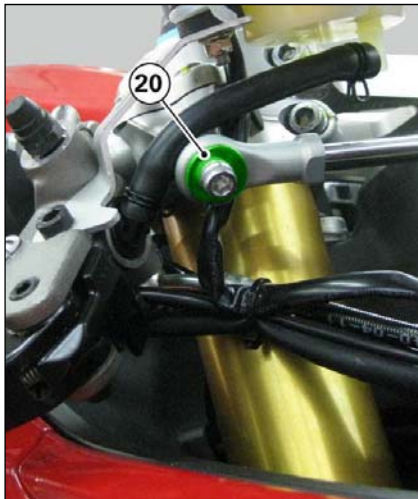
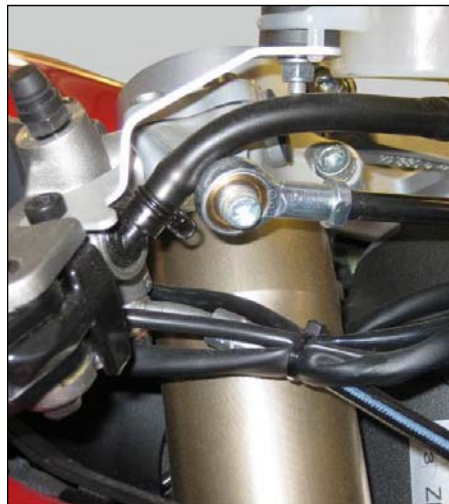
**Washer (20)** must be installed only on S versions, i.e., where an Ohlins steering damper is fitted. The washer must NOT be installed on BASE versions equipped with SACHS steering damper.
