Tesla, Inc.
Service Bulletin

Inspect and Adjust Hood Alignment

SB-25-11-003
July 16, 2025

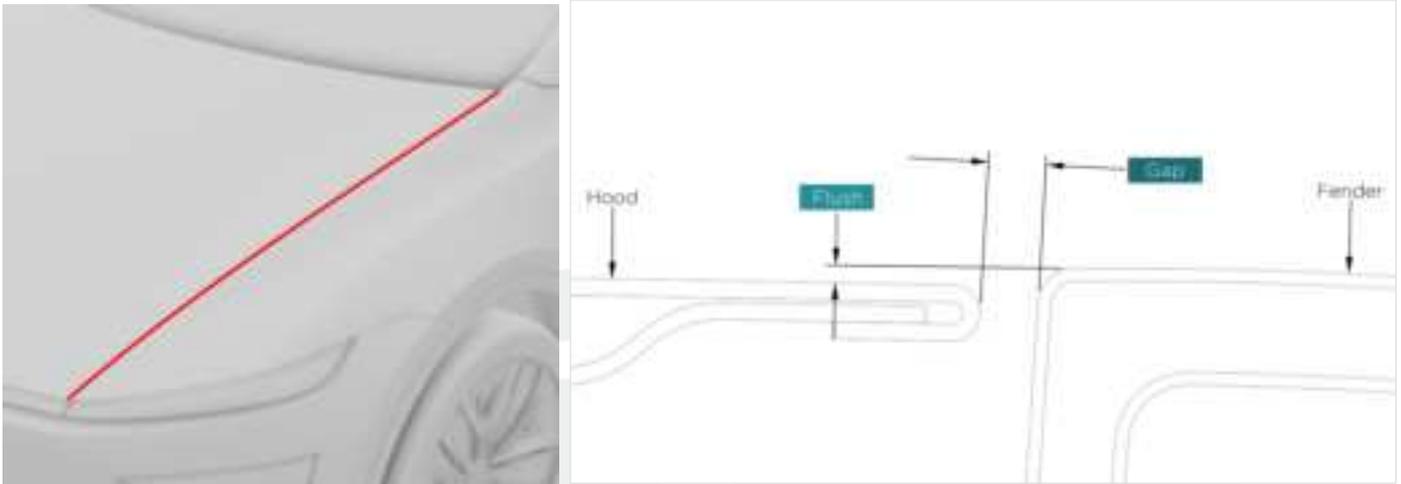
Figure 1 – LH shown, RH similar.

Verify that the hood opens and closes as expected, and measure the gap and flush between the hood and the fender on the LH and RH side of the vehicle (Figure 1).

Allowed gap: 1.75mm to 3.75mm. Nominal value: 2.75mm
Allowed flush: -1.90mm to -0.10mm. Nominal value: -1.00mm

- If the gap and flush are within specifications, discontinue this procedure and use correction code S012511003.
- If the gap and/or flush are not within specifications and/or the hood is not closing or opening as expected, proceed to the [Adjustment](#) section.

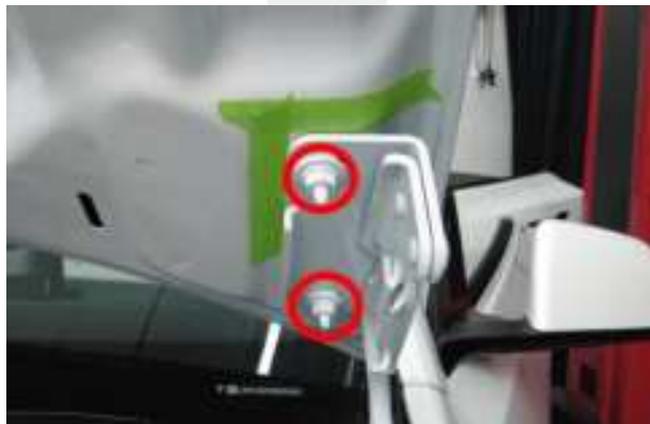
Figure 2 – LH shown, RH similar.

1. To ensure proper flush between the hood and the fender, as described in the [Inspection](#) section: adjust the bump stops and (if necessary) the hood latch (refer to Service Manual procedure [1133040200](#)).
2. If no gap adjustment is required, skip to step 11. If gap adjustment is required, continue this procedure.
3. Slightly loosen the nuts (x2, 13mm) that attach the hood to the LH hood hinge (Figure 2).

4. Repeat step 2 for the RH hood hinge.
5. Adjust the position of the hood to ensure proper and equal gap between the hood and the LH and RH fenders, as described in the [Inspection](#) section.
6. Hand tighten the nuts (x4, 13mm) that attach the hood to the LH and RH hood hinges.

7. Close the hood, and verify that the gap between the hood and the fenders is within specifications. Repeat steps 2 – 5 if necessary.
8. Fully torque the nuts (x4, 13mm, torque 27 Nm) that attach the hood to the LH and RH hood hinges.
9. Verify that the hood opens and closes as expected after gap adjustment. If necessary, adjust the hood latch (refer to Service Manual procedure [1133040200](#)).
10. Use IPA wipes to clean the nuts and washers (x4) that attach the hood to the LH and RH hood hinges, and then allow 1 minute to dry.
11. Apply touch up paint to the threaded studs of the hood (x4) and the nuts and washers (x4) that attach the hood to the LH and RH hood hinges.
