# HYUNDAI Technical Service Bulletin

Group	TRANSAXLE
		Number	05-40-006-2
Subject <b>ATA SOLENOID DIAGNOSTIC CODES P0740, P0741, P0742, P0743, P0746, P0748, P0750, P0755, P0760, P0765, P0770</b>		Date	JANUARY, 2006
		Model	1999~ SONATA, 2001~ ELANTRA, SANTA FE & XG, 2003~ TIBURON, 2005~ TUCSON, 2006 AZERA
<b>CIRCULATE TO:</b>	<input type="checkbox"/> GENERAL MANAGER	<input checked="" type="checkbox"/> PARTS MANAGER	<input checked="" type="checkbox"/> TECHNICIAN
<input checked="" type="checkbox"/> SERVICE ADVISOR	<input checked="" type="checkbox"/> SERVICE MANAGER	<input checked="" type="checkbox"/> WARRANTY MGR	<input type="checkbox"/> SALES MANAGER

***This TSB supersedes TSB# 05-40-006-1 to include 2006 Azera.***

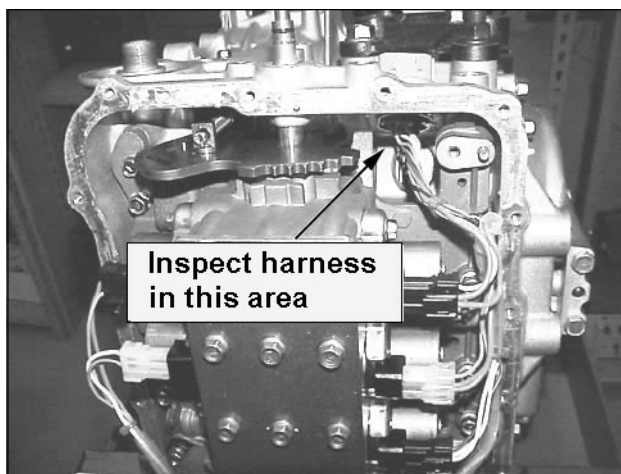
3. Visually check the wiring harness between the TCM and transaxle for a damaged wire or a short circuit to ground. Disconnect the connectors to the solenoids at the transaxle and the PCM/TCM and check for a bent pin or a pin not fully inserted into the connector. If so, repair or replace the ECM control harness, P/N 914XX-XXXXX.
4. Check the harness inside the transaxle oil pan for a short circuit to ground. Replace the harness if damage is found or if **three or more** solenoid DTCs are found in Step 1. (Refer to TSB# 04-40-015 for instructions).

MODEL	Harness P/N
2001~ Elantra, Santa Fe, 2003 Tiburon, Tucson, 1999~2005 Sonata	46307-39050
2006~ Sonata	46308-3A550
XG300/350	46308-39550

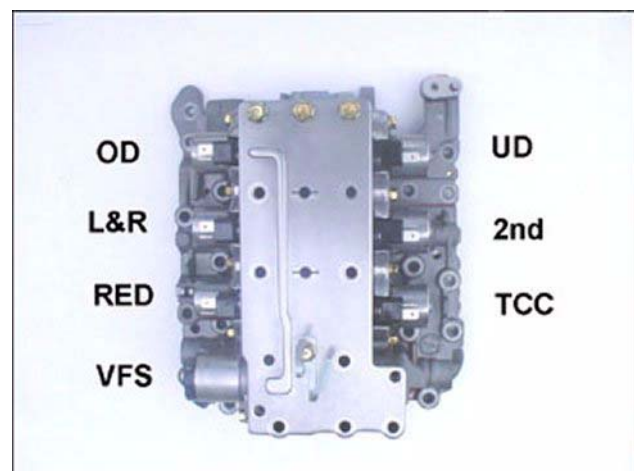
P0743 - TCC solenoid open/short  
P0746 - VFS solenoid performance  
P0748 - VFS solenoid open/short  
P0750 - LR solenoid open/short  
P0755 - UD solenoid open/short  
P0760 - 2nd solenoid open/short  
P0765 - OD solenoid open/short  
P0770 - RED solenoid open/short

6. Remove the battery.
7. Drain the radiator. Remove the lower radiator hose from the radiator.
8. Drain the ATF.
9. Remove the valve body cover from the transaxle. Do NOT remove the valve body.
10. Refer to the DTC recorded in Step 1 and replace the related solenoid according to the diagram shown. Tighten the bolts to 4-5 lb.ft (50-70 kg.cm). Go to Step 11.

11. Apply Permatex Ultra Gray Sealer or Hyundai Ultra Gray Gasket Sealer, P/N 00231-13800 to the valve body cover and reinstall the cover. Tighten the bolts to 6-7 lb.ft (80-100 kg.cm).
12. Add approximately five quarts of Hyundai SP-III ATF and check the level with the engine idling in Neutral. Recheck the ATF level when the ATF is at normal operating temperature (70-100°C, 159-212°F).
13. Clear the codes and test drive the vehicle for two driving cycles (two key-on to key-off driving cycles, including 1-2-3-4 upshifts and 4-3-2-1 downshifts). If the DTC returns, perform the following repairs:
