## SERVICE BULLETIN AMATEUR RADIO

| SUBJECT | TS-950SD TWO SECOND TX POWER DELAY WITH MONI ON | DATE | 01/22/90 |

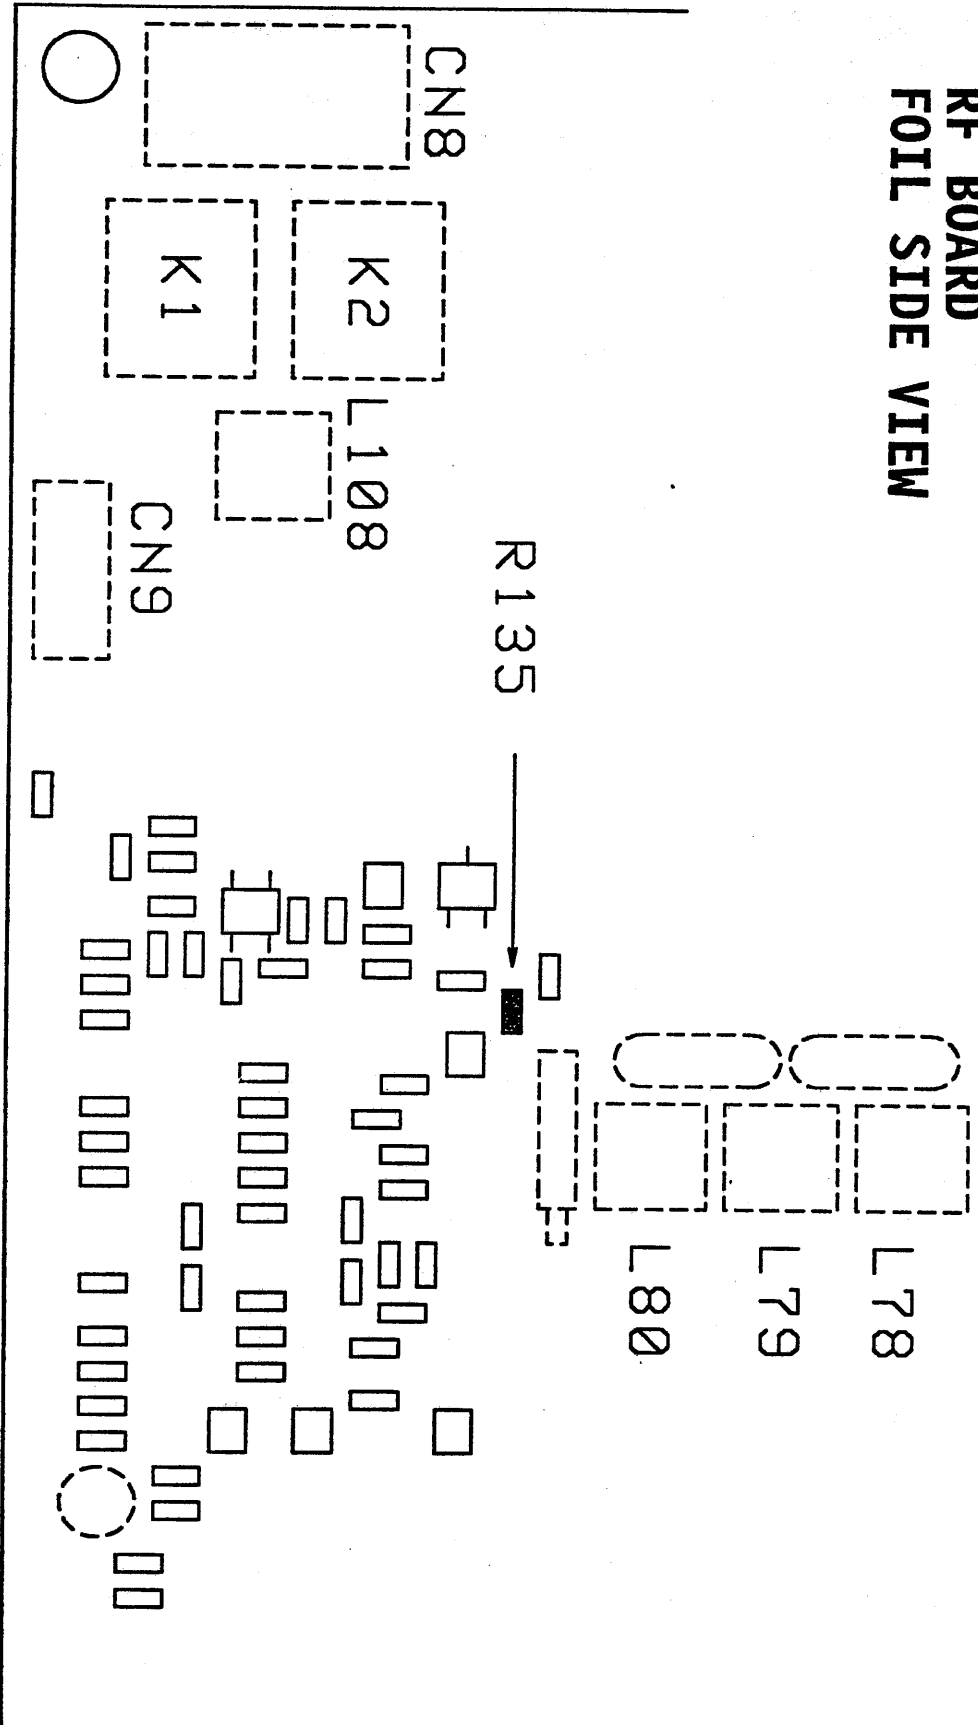
FIGURE 1

When the MONI switch is turned on, transmit power may not develop for two seconds after key down. During this time, the ALC meter will pin and the SWR meter will read high. This will more likely develop on 18MHz and 21MHz bands. The following modification will correct this condition.

1. Disconnect the power cord and antenna.
2. Remove the top and bottom covers (18 screws).
3. Locate the RF unit on the bottom of the transceiver. This is the back left board of the four boards on the bottom of the transceiver.
4. Remove the RF board shield plate (4 screws).
5. Remove the 3 remaining screws from the RF board.
6. Remove the black screw that secures the DRIVE OUT/RX ANT IN jack to the back panel.
7. Disconnect the right hand coax cables from the RF board and unplug connector #2.
8. Slide the RF board forward and then rotate it towards the front of the transceiver to expose the foil side of the board.
9. Locate chip resistor R135 as shown in figure 1.
10. Replace R135 with a 2.2K ohm chip resistor.
11. Assemble the transceiver by reversing steps 1 - 8.
