## SERVICE BULLETIN

**APPLICABILITY:** 2020-22MY Legacy and Outback Models

**NUMBER:** 15-261-20R

**SUBJECT:** Reprogramming File Availability for Optimization  
 of Gen 4 Denso CP1 Infotainment Systems

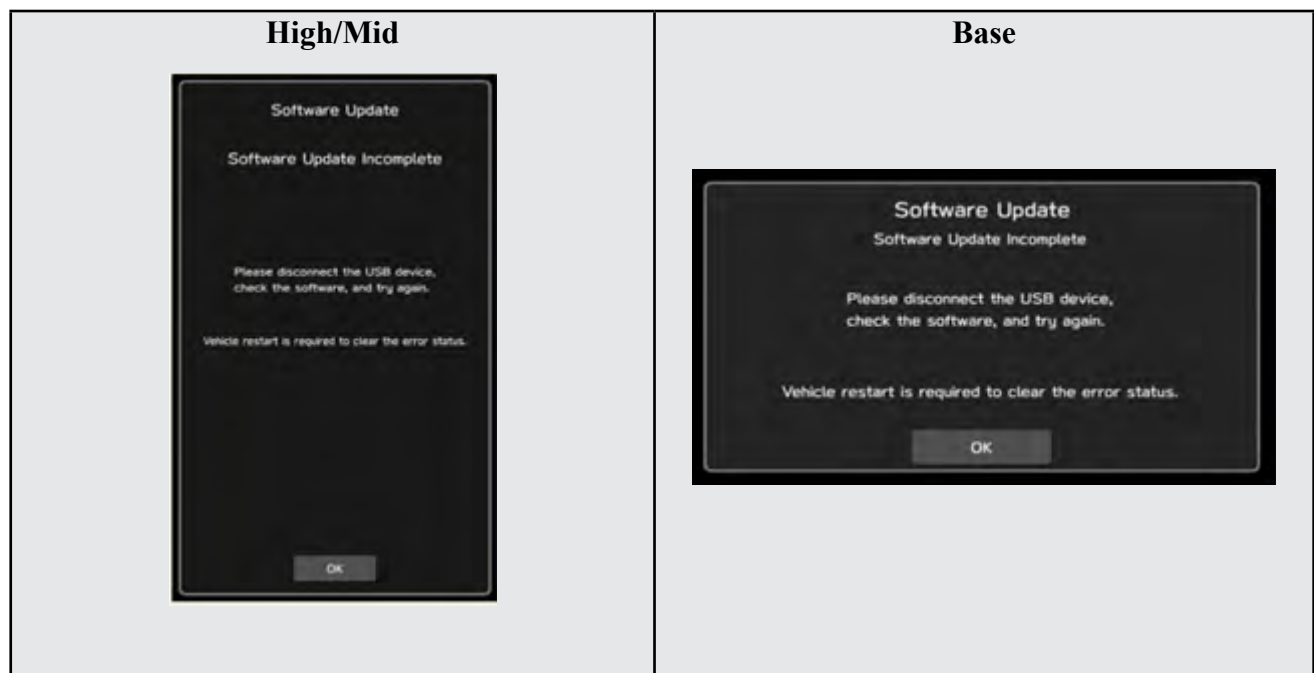
If you get the message Software Update Incomplete as shown below, please don't replace the hardware but retry updating the software according to the instructions in "Appendix B" on pg. 21.

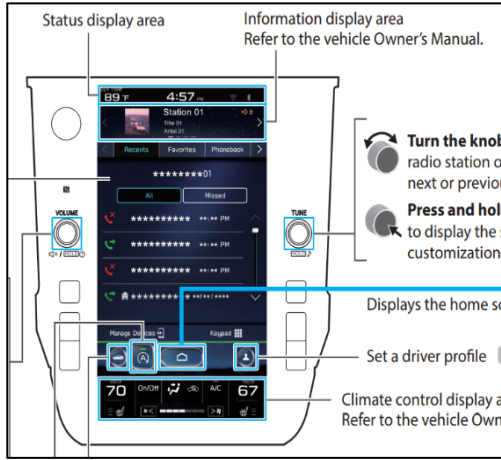
| Number | Symptoms to be Improved: |
|---|---|
| 5 | <p>The Information Display Area at the top of the CID screen displays a different information screen from the last time.</p> <p>The diagram shows the CID screen interface with the following labels and descriptions:</p> <ul style="list-style-type: none"> <li><b>Status display area</b>: Points to the top status bar showing time (4:57) and battery level (89%).</li> <li><b>Information display area</b>: Points to the main content area, with a note: "Refer to the vehicle Owner's Manual."</li> <li><b>Turn the knob</b>: Points to the volume knob, with a note: "radio station or next or previous."</li> <li><b>Press and hold</b>: Points to the touch screen, with a note: "to display the customization."</li> <li><b>Displays the home screen</b>: Points to the home screen icon at the bottom.</li> <li><b>Set a driver profile</b>: Points to the driver profile icon at the bottom.</li> <li><b>Climate control display area</b>: Points to the climate control area at the bottom, with a note: "Refer to the vehicle Owner's Manual."</li> </ul> |

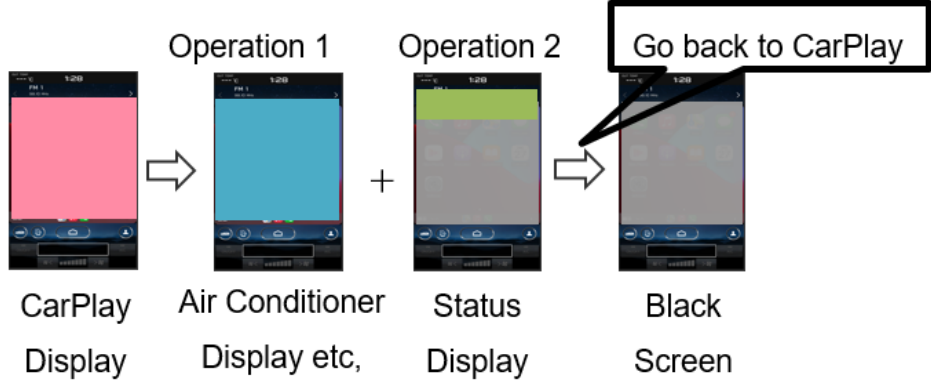
| Number | Symptoms to be Improved: |
|---|---|
| <b>15</b> | <p>After performing operations 1 and 2 below from the CarPlay screen, returning to the CarPlay screen causes the CarPlay screen to be black screen.</p> <p><b>Operation 1:</b> Switching to a pop-up screen such as the air conditioner screen</p> <p><b>Operation 2:</b> Interrupt pop-up screen display due to volume operation, etc.</p> <p style="text-align: center;"> <span>CarPlay Display</span>    <span>Air Conditioner Display etc,</span>    <span>Status Display</span>    <span>Black Screen</span> </p> |

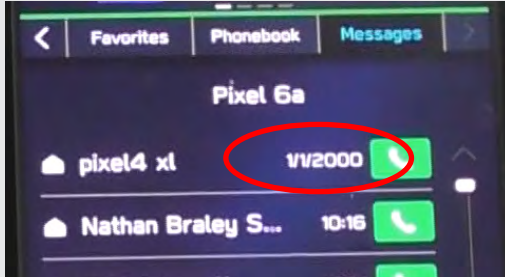
| Number | Symptoms to be Improved: |
|---|---|
| 28 | <p>The date of receipt of a received message is displayed as "2000/1/1."</p> <p>This occurs on some models of phones with Android OS 13 or later.</p> |

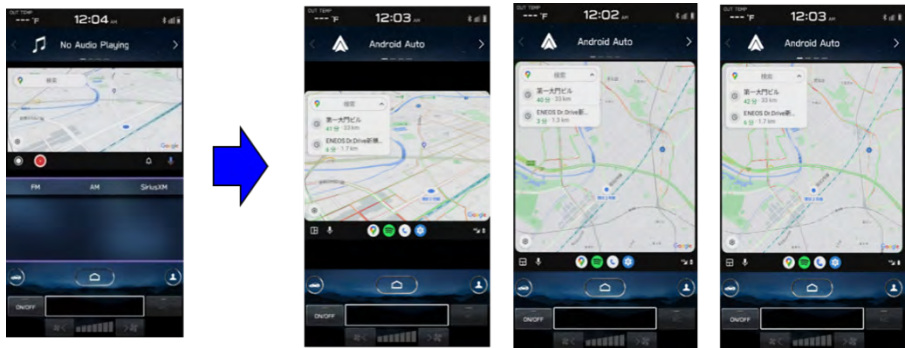
| Number | New Functions and Enhancements |
|---|---|
| 2 | CCU Support vertical screen displays for Android Auto, but the actual display screen size differs depending on the Android device's OS version.<br> |

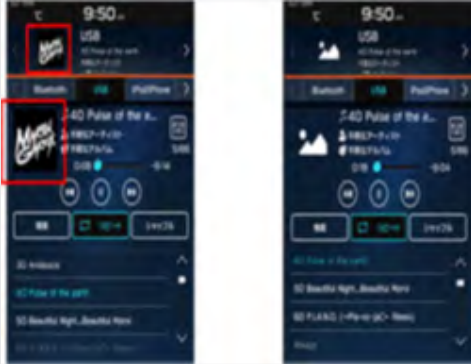
| Number | Symptoms to be Improved: |
|---|---|
| 18 | <p>Cover art of previous music is displayed when playing music without cover art in USB audio. It can occur when music with and without cover art is mixed and stored together a single USB.</p> |

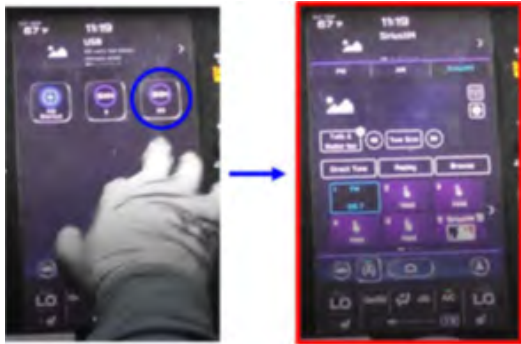
| Number | Symptoms to be Improved: |
|---|---|
| 23 | <p>When selecting shortcut for SXM channel on “Home” screen, the screen is changed to SXM but no sound is coming or no channel name is displayed.</p> |

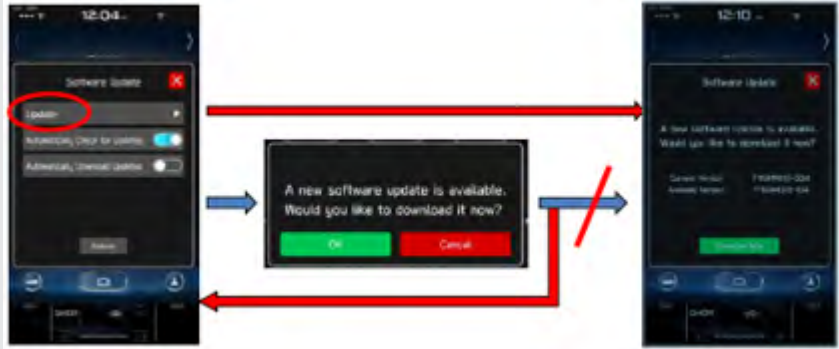
| Number | Symptoms to be Improved: |
|---|---|
| 24 | <p>When using FOTA service to update the software by selecting “Setting” &gt; “Software Update,” a message of “A new software update is available. Would you like to download it now?” is displayed but the downloading does not start after pressing “OK.” When this symptom occurs, it comes back to the “Software Update” screen. The downloading can be started by pressing the “Update” on the “Software Update” screen.<br/>(Temporary solution.)</p> |

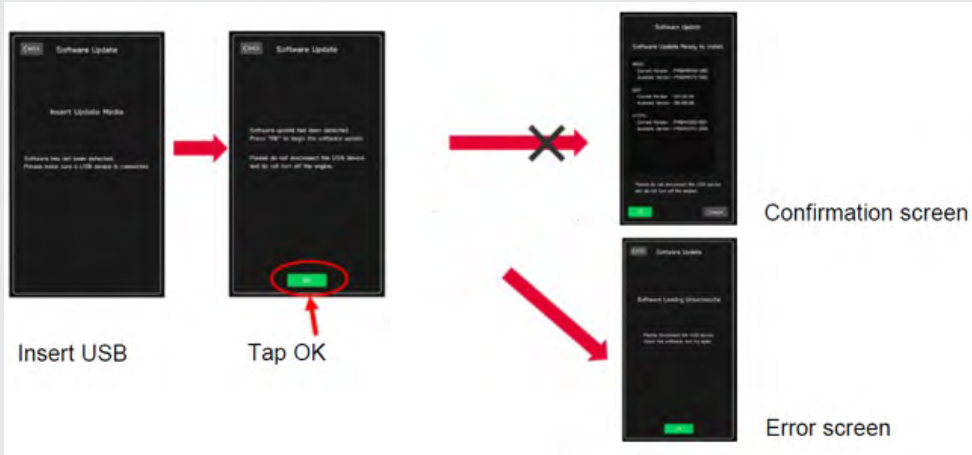
| Number | Symptoms to be Improved: |
|---|---|
| 12 | <p>When conducting USB reprogramming, the screen transition to error screen instead of confirmation screen.</p> |

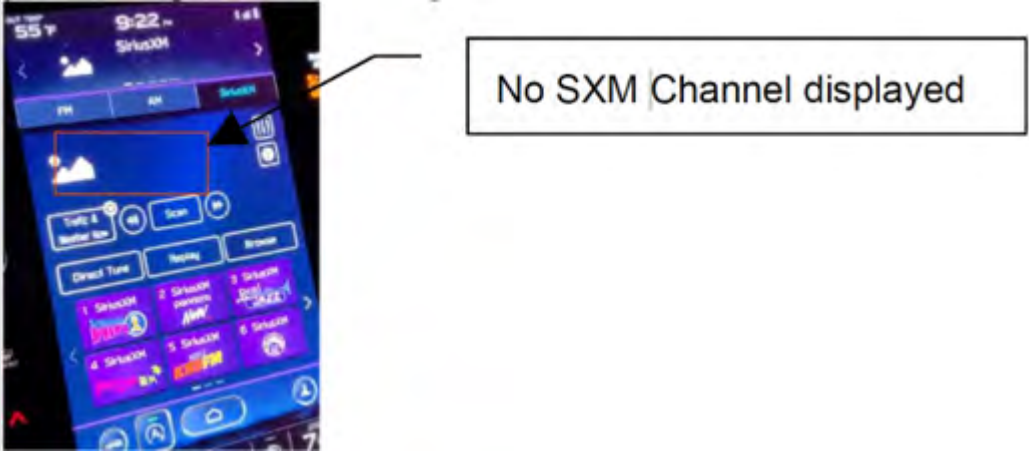
| Number | Symptoms to be Improved: |
|---|---|
| 26 | <p>SXM has blank screen and no sound when the SXM screen had been selected as audio source at the previous ignition off timing.</p> |

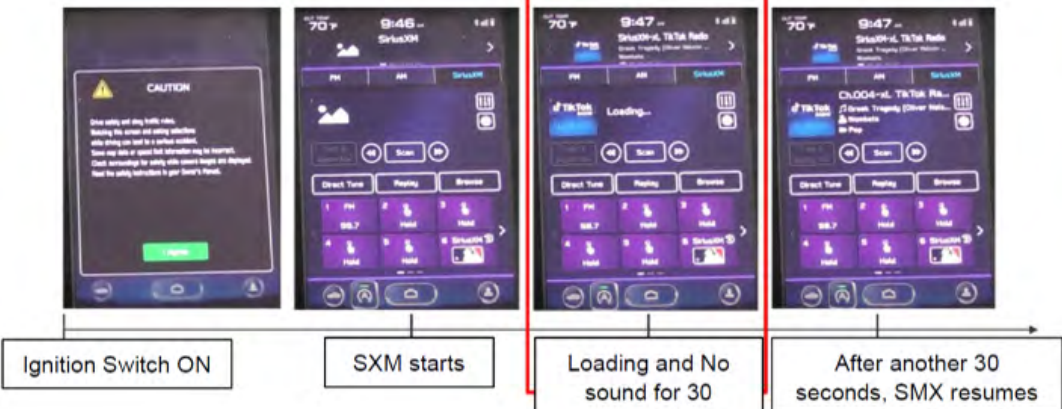
| Number | Symptoms to be Improved: |
|---|---|
| 27 | <p>About 30 seconds after starting the SXM the operation is paused with loading screen and resume after another 30 seconds. This symptom occurs when the SXM screen had been selected as audio source at the previous ignition off timing.</p> |

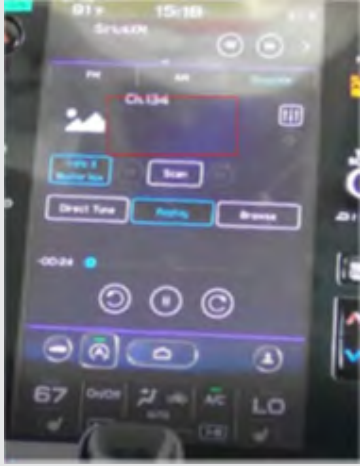
| Number | Symptoms to be Improved: |
|---|---|
| 30 | <p>The team logo is not displayed on Sports Flash screen when the SXM screen had been selected as audio source at the previous ignition off timing.</p> |

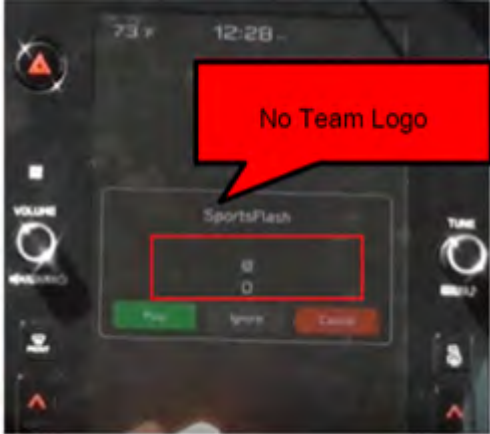
| Number | Symptoms to be Improved: |
|---|---|
| 31 | <p>The team logo is not displayed on Sports Flash screen when the SXM screen had been selected as audio source at the previous ignition off timing.</p> |

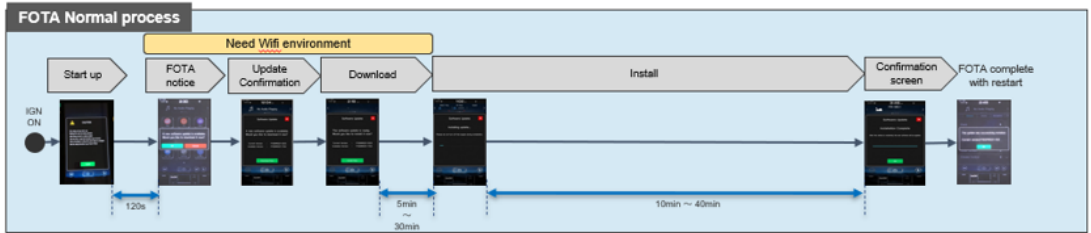
| Number | Symptoms to be Improved: |
|---|---|
| 1 | <p>System restarts itself during FOTA (Firmware Over The Air) update. FOTA operation is conducted in two processes: downloading (from the server to the Cockpit Control Unit via Wi-Fi) and installation (inside the Cockpit Control Unit). During the FOTA operation, after the new software has been downloaded to the Cockpit Control Unit (CCU) customer is to push “Install Now” on the Center Information Display (CID) to start installation of the software.</p> <p><b>FOTA Normal process</b></p> <p>The flowchart illustrates the normal FOTA process. It begins with 'IGN ON', followed by 'Start up' (120s), 'FOTA notice', 'Update Confirmation', 'Download' (5min ~ 30min), 'Install' (10min ~ 40min), 'Confirmation screen', and finally 'FOTA complete with restart'.</p> <p><b>However, in rare case, the CCU restarts itself* during installation.</b></p> <p><b>Linux reset occurs</b></p> <p>This flowchart shows the process when a Linux reset occurs during installation. It follows the same initial steps as the normal process but includes a 'Linux reset' event (CID Black screen, Max 30s) during the 'Install' phase. This is followed by a 'Restart', 'Install confirmation screen(Retry)', 'Restart Install', and 'Confirmation screen' before reaching 'FOTA complete with restart'. A note at the bottom states: 'Linux reset(CID black screen) may occur during FOTA installation' and 'If Linux reset occurred, CID will be black screen max 30s, after that CID will restart automatically'.</p> <p><b>Note*</b> Even if this symptom occurs, after approximately 2 minutes, the system resumes, and the CID comes back to the below screen. Customer can then push the “Install Now” to proceed with the installation.</p> <p>The image shows a screenshot of the 'Software Update' screen on the CID. The screen displays the message: 'The software update is ready. Would you like to install it now?'. It also shows the 'Current Version' as 'F030M02H-903' and the 'Available Version' as 'F030M02H-704'. A green 'Install Now' button is visible at the bottom.</p> |

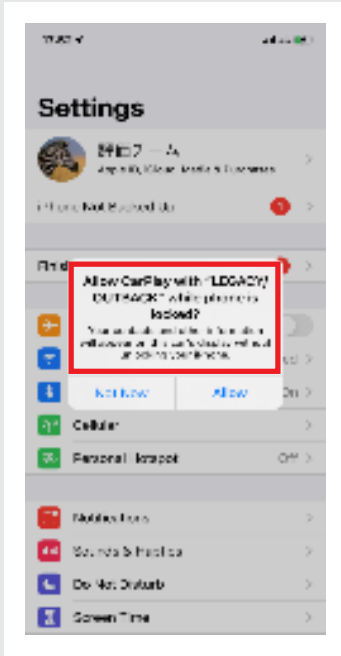
| Number | Symptoms to be Improved: |
|---|---|
| 3 | <p>While using Apple CarPlay, “SUBARU” is displayed on the iPhone Setting menu instead of vehicle name &lt;LEGACY/OUTBACK&gt;.</p> |

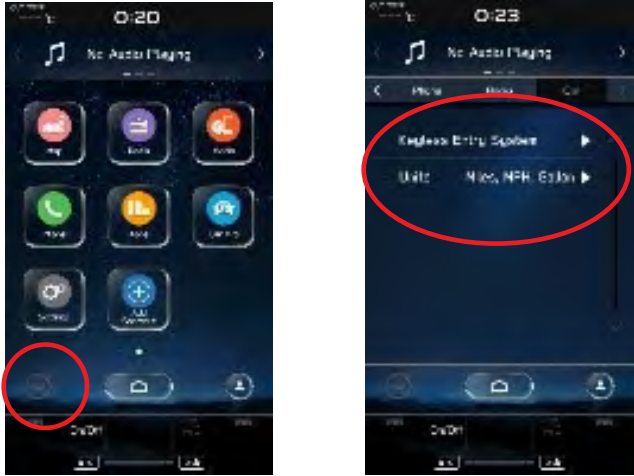
| Number | Symptoms to be Improved: |
|---|---|
| 4 | <p>Vehicle Setting Icon in &lt;Home&gt; menu is grayed out.<br/>Menu list in the “Car” tab in the Setting Menu is not displayed.</p> <div data-bbox="589 239 1218 711"> </div> |

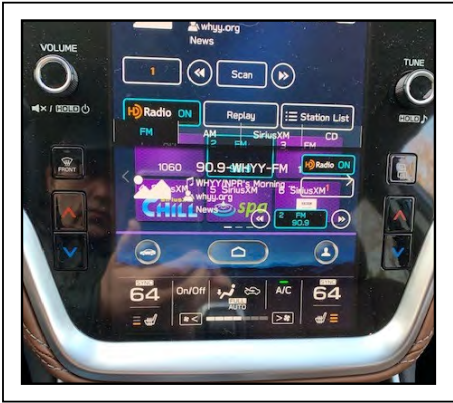
| Number | Symptoms to be Improved: |
|---|---|
| 6 | <p>CID shows multiple images simultaneously.</p> <div data-bbox="677 840 1127 1239"> </div> |

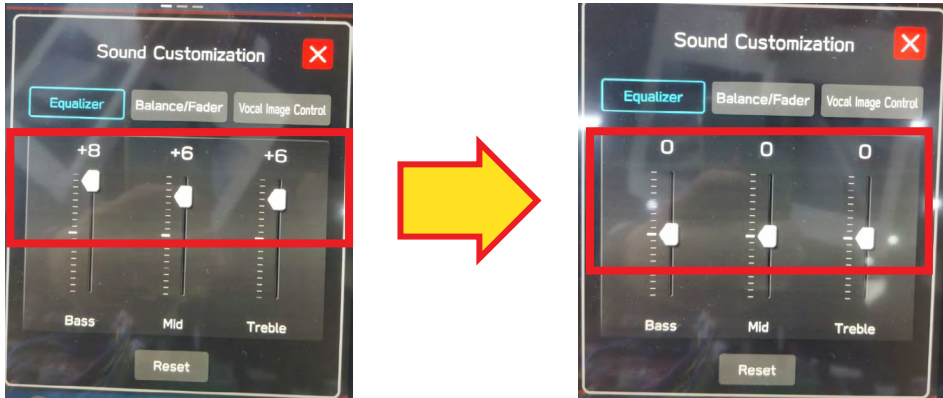
| Symptom # | Description of Symptom: |
|---|---|
| 7 | Customer-selected Equalizer settings are lost. Equalizer returns to the default settings after ignition switch is turned OFF and back ON.<br> |

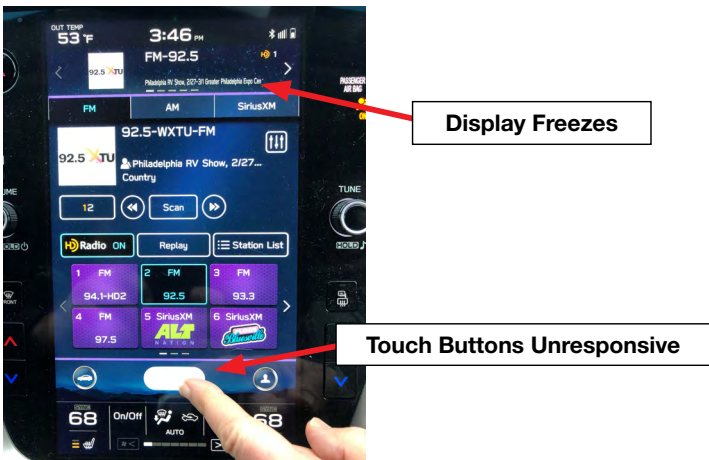
| Symptom # | Description of Symptom: |
|---|---|
| 1 | <p>The CP1 display and/or center Combination Meter display freezes. No response from touch screen or voice guidance. After switching the ignition off and opening the driver's door, the system does not recover**.</p> <p><b>**NOTE:</b> After switching the ignition off and leaving the driver's door open more than 70 seconds, the system <i>may</i> recover after switching the ignition back on.</p> |

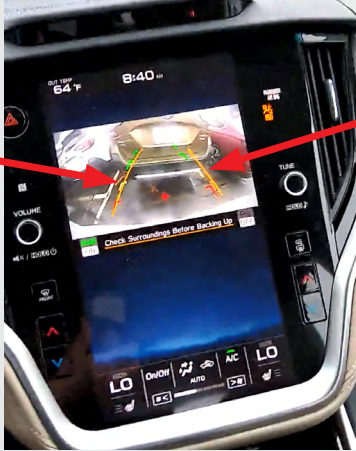
| Symptom # | Description of Symptom: |
|---|---|
| 2 | <p>Delayed response of rear view camera guide lines.<br/>When the rear view camera is activated and the steering wheel is turned, there is a delay before the steering-responsive guide lines respond to the steering wheel input.</p> <p>The image shows a rear view camera display on a vehicle's infotainment screen. The screen displays a rear view of the vehicle with yellow guide lines. Two red arrows point to the guide lines, indicating a delay in their response to steering wheel input. The screen also shows a temperature of 64°F, a time of 8:40 AM, and a warning message 'Check Surroundings Before Backing Up'.</p> |

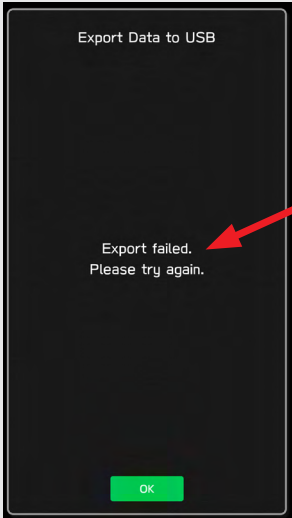
| Symptom # | Description of Symptom: |
|---|---|
| 4 | <p>Diagnostics Recorder Data cannot be exported to the USB memory device. When the diagnostic log data is being downloaded (by selecting: Dealership Menu &gt; Diagnostics Recorder &gt; Export Data to USB), it fails after the progress bar reaches almost 90% with an error message of Export failed. Please try again.</p> <p>The image shows a screen titled 'Export Data to USB'. The screen displays the message 'Export failed. Please try again.' and an 'OK' button. A red arrow points from the text 'Export Failed. Please Try Again.' to the 'Export failed. Please try again.' message on the screen.</p> |

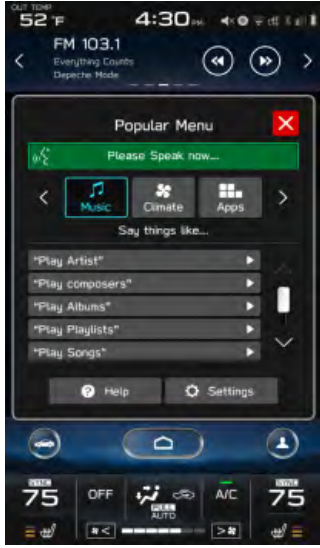
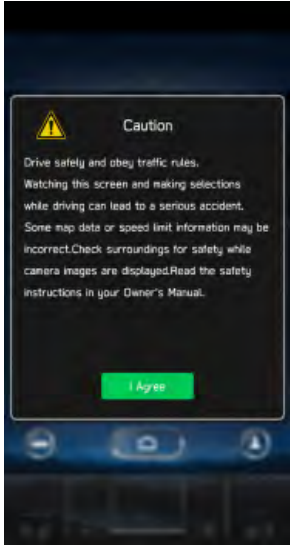
| Symptom # | Description of Symptom: |
|---|---|
| 5 | <p>When using Voice Recognition to search for a 'Nearby POI' (Point of Interest) in Canada with FRENCH language selected, the CP1 display turns black and displays a Caution / disclaimer message.</p> <div data-bbox="371 254 688 798"> </div> <div data-bbox="444 816 615 842">Voice Recognition</div> <div data-bbox="776 254 1076 798"> </div> <div data-bbox="862 816 987 842">Black Screen</div> <div data-bbox="1164 254 1451 798"> </div> <div data-bbox="1167 816 1448 842">Caution / Disclaimer Message</div> |
