| Device | SAF-C161JI-32RF, SAK-C161JI-32RF, SAF-C161JC-32RF, SAF-C161JC-32RF, SAF-C161CS-32RF, SAF-C161CS-32RF |
| Package | P-TQFP-128-2 |

This Errata Sheet describes the deviations from the current user documentation.

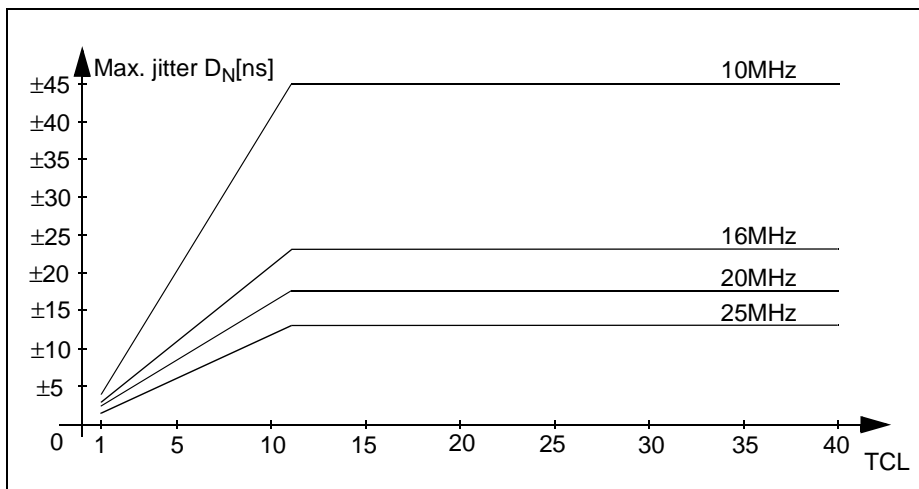
Figure 1 Additional Jitter

The value of the additional jitter is not a fixed one but it depends on the kind of activity on the external bus or output pins. The additional jitter increases with the number of output/bus pins which are switched at the same time to a new voltage level because the problem is caused by noise on the on-chip power supply.

This approximated formula is valid for $1 \leq N \leq 12$ and $10 \text{ MHz} \leq f_{\text{CPU}} \leq 25 \text{ MHz}$.

For all accumulated periods longer than 12 TCL the $N=12$ value can be used; see figure below.

In case that the additional jitter causes problems in the system which cannot be relaxed with software adapted timing parameters, then direct drive or prescaler mode can be used. If the maximum frequency of the on-chip oscillator (16 MHz) is not sufficient then an external clock generator can be used.

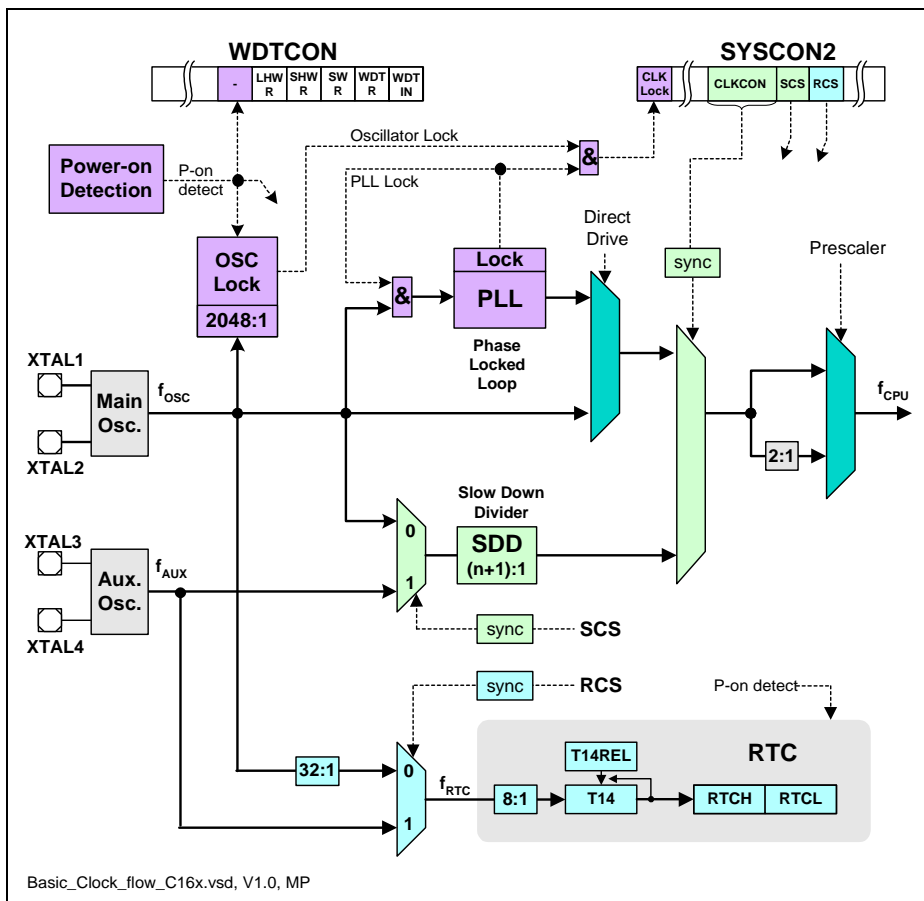
Figure 2 C161CS/JC/JI-32RF Clock Configuration

During power-on or during a power off/on sequence it is possible that the internal clock configuration of the power management is not set to a defined state. An undefined state of the power management clock configuration can cause different kinds of malfunctions in the system. The below described malfunction does not always occur but can appear sporadically.

If power-on was not detected by the on-chip power-on detection unit then this can cause a malfunction of the internal oscillator lock detect unit. In that case the internal oscillator lock signal is not set after 2048 XTAL1 clock periods.

When the power-on detection fails during power-on because of not considering the necessary conditions, the register bits SCS, RCS and the RTC registers are undefined. Further the oscillator lock signal is not set.

Consider the conditions to get a defined clock configuration at power-on.

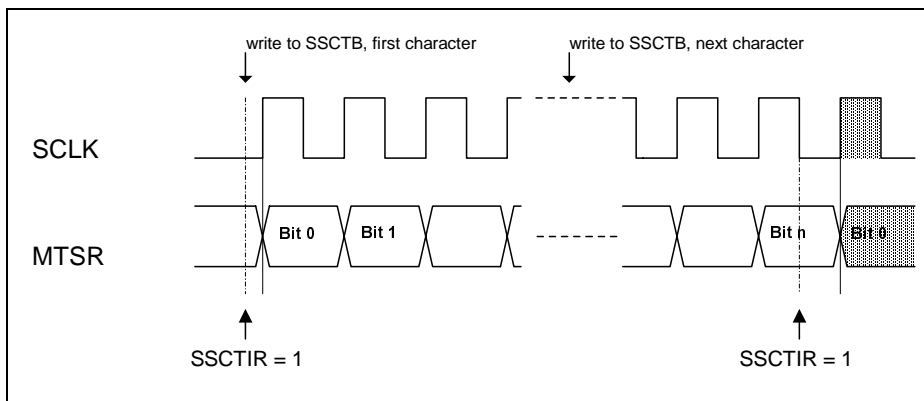
Figure 3 SSCTB Timing

- When SSCTB has been written while the transmit shift register was empty (and the SSC is enabled), flag SSCTIR is set to '1' directly after completion of the write operation, independent of the selected baud rate. When the transmit shift register is not empty when SSCTB was written, SSCTIR is set to '1' after the last latching edge of SCLK (= 1/2 bit time before the first shifting edge of the next character). See also e.g. C167CR User's Manual V3.1, p. 12-5.

The following diagram shows these relations in an example for a data transfer in master mode with SSCPO = 0 and SSCPH = 0. It is assumed that the transmit shift register is empty at the time the first character is written to SSCTB:

Typically, in interrupt driven systems, no problems are expected from the modified timing of flag SSCTIR. However, when flag SSCTIR is polled by software in combination with other flags which are set/cleared at the end or at the beginning of a transfer (e.g. SSCBSY), the modified timing may have an effect.

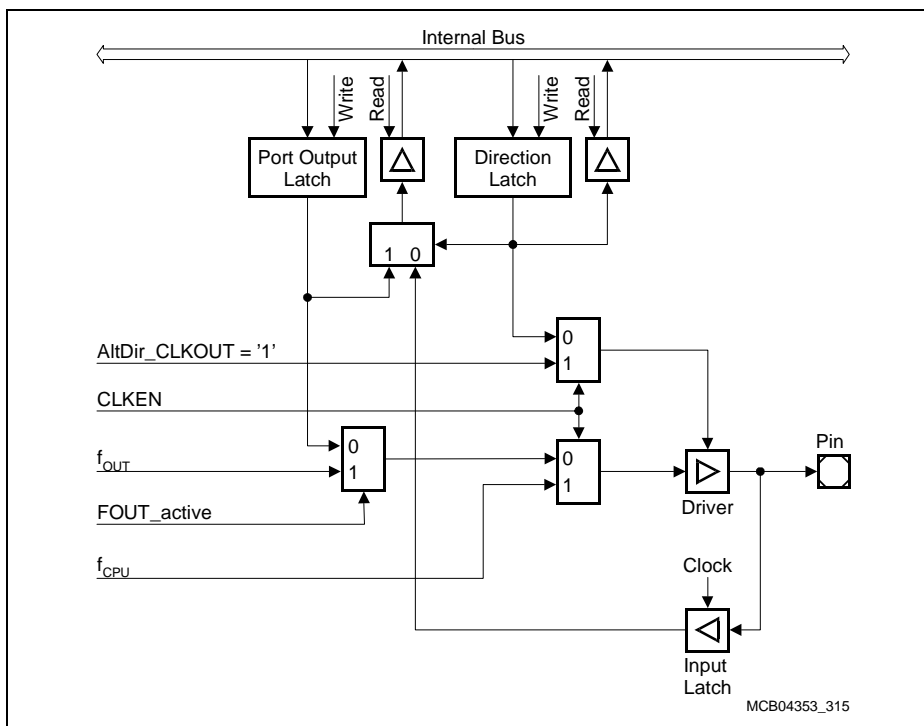
PORT.D3 P3.15 and Frequency Output Signal Path

To enable the frequency output signal f_{OUT} bit CLKEN in register SYSCON must be cleared (before EINIT) and f_{OUT} must be enabled in register FOCON. In contrast to signal CLKOUT the direction latch has to be set by software to enable f_{OUT} .
