# Service Bulletin

Bulletin No.: 08-05-22-009

**Subject:** Intermittently Brake Lights (Stop Lamp) Do Not Function Correctly, Extended Travel to Shift Out of Park, Cruise Control Inoperative, DTCs C0161/C0277 Set (Perform Repair as Outlined)

**Models:** 2004-2007 Chevrolet Malibu, Malibu Maxx  
2008 Chevrolet Malibu Classic  
2005-2009 Pontiac G6  
2007-2009 Saturn AURA

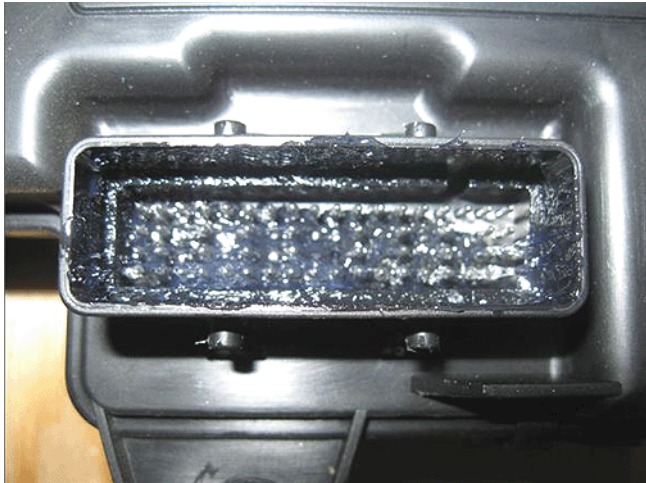
2214281

**Note:** Fretting corrosion looks like little dark smudges on electrical terminals and appear where the actual electrical contact is being made. In less severe cases it may be unable to be seen or identified without the use of a magnifying glass.

3. With a one-inch nylon bristle brush, apply dielectric lubricant to both the module/component side and the harness side of the affected connector(s).
  4. Reconnect the affected connector(s) and wipe away any excess lubricant that may be present.
  5. Attempt to duplicate the condition by using the following information:
    - DTC Diagnostic Procedure
    - Circuit/System Description
    - Conditions for Running the DTC
    - Conditions for Setting the DTC
    - Diagnostic Aids
    - Circuit/System Verification
- If the condition cannot be duplicated, the repair is complete.
- If the condition can be duplicated, then follow the appropriate DTC, Symptom or Circuit/System Testing procedure (refer to SI).

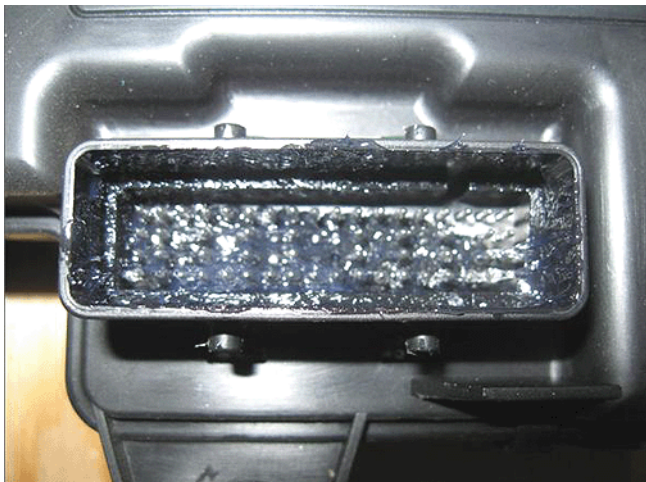
2214281

**Note:** Fretting corrosion looks like little dark smudges on electrical terminals and appear where the actual electrical contact is being made. In less severe cases it may be unable to be seen or identified without the use of a magnifying glass.

3. With a one-inch nylon bristle brush, apply dielectric lubricant to both the module/component side and the harness side of the affected connector(s).
  4. Reconnect the affected connector(s) and wipe away any excess lubricant that may be present.
  5. Attempt to duplicate the condition by using the following information:
    - DTC Diagnostic Procedure
    - Circuit/System Description
    - Conditions for Running the DTC
    - Conditions for Setting the DTC
    - Diagnostic Aids
    - Circuit/System Verification
- If the condition cannot be duplicated, the repair is complete.
- If the condition can be duplicated, then follow the appropriate DTC, Symptom or Circuit/System Testing procedure (refer to SI).

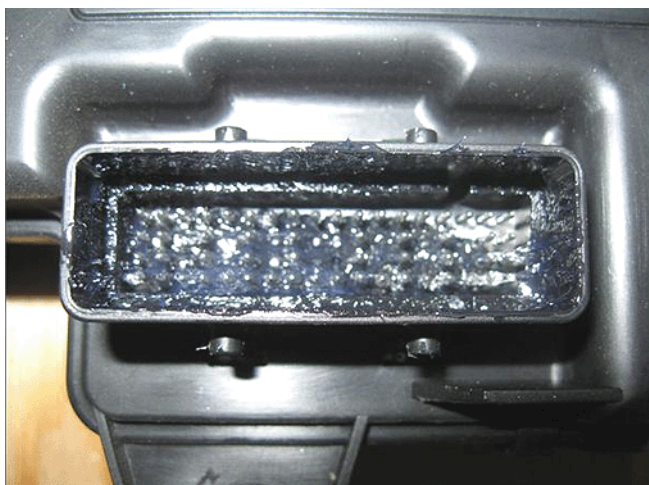
2214281

**Note:** Fretting corrosion looks like little dark smudges on electrical terminals and appear where the actual electrical contact is being made. In less severe cases it may be unable to be seen or identified without the use of a magnifying glass.

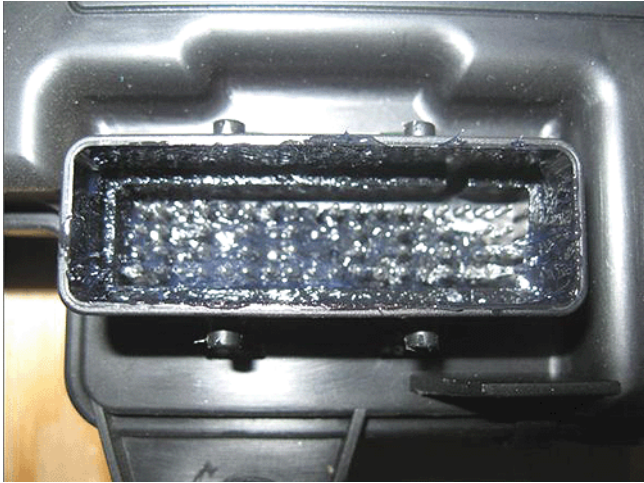
2214281

**Note:** Fretting corrosion looks like little dark smudges on electrical terminals and appear where the actual electrical contact is being made. In less severe cases it may be unable to be seen or identified without the use of a magnifying glass.
