Published by:  
Service Department Audio

# SERVICE NEWSLETTER

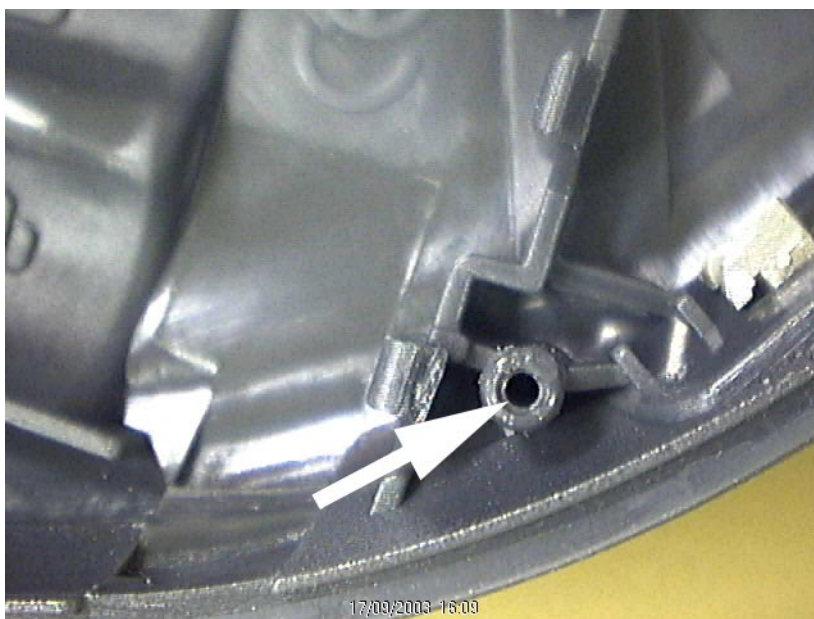
## 06.01 TYPENUMBER(S): ACT300

INFORMATION : In course of production a pole has been added to the Bottom Cabinet to strengthen the pcb supporting. If an old Bottom Cabinet needs to be replaced by a new one, we suggest to cut the pole as indicated in the drawing below:

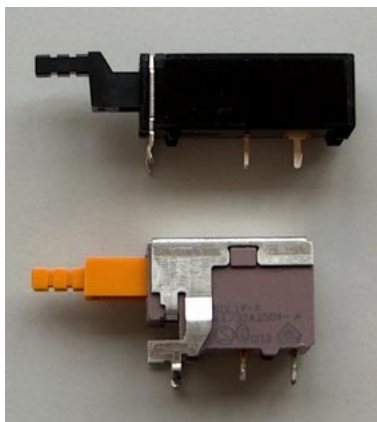
**05.06** TYPENUMBER(S): **FR740/00, FR984/00S, FR994/00S, FR985/00, FR986/00S, FR995/00, FR996/00S**

**INFORMATION** : In course of production the mains switch (item 1056) has been changed. New mains switches are used from mains board layout stage .4 onwards.

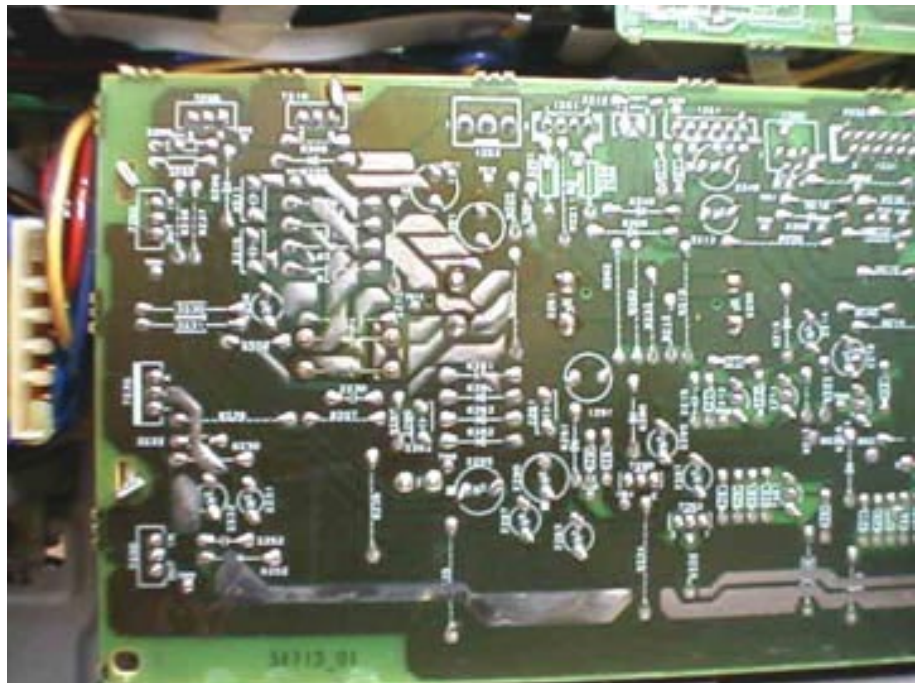
**SYMPTOM** : **IRIS CODE 1 1 6 L**

PC board turns brown from components 6250, 6251 and all over the area of 6210, 6211, 6212, 6213, 7250, 7230, 7260, 7295, 7210 on the Supply Board (pos. 1104-A). The area around the diodes 6250 and 6251 is the worst brown area on the PC board after few months of operating.

**CURE** : The PC board browning effect is caused by excessive heat generated by the supply regulators and the power devices.

There will be no short term solution as there are no safety or reliability issues. The operating temperature of the semiconductor junction is within the specification of the devices. The temperature of the PC board is also within the safety limits.

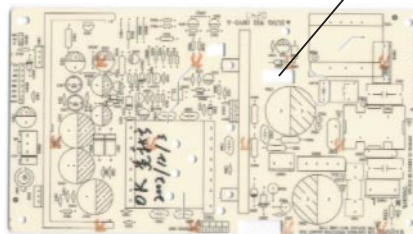
hole(s) added  
(Transformer is  
removed for  
clearer view)

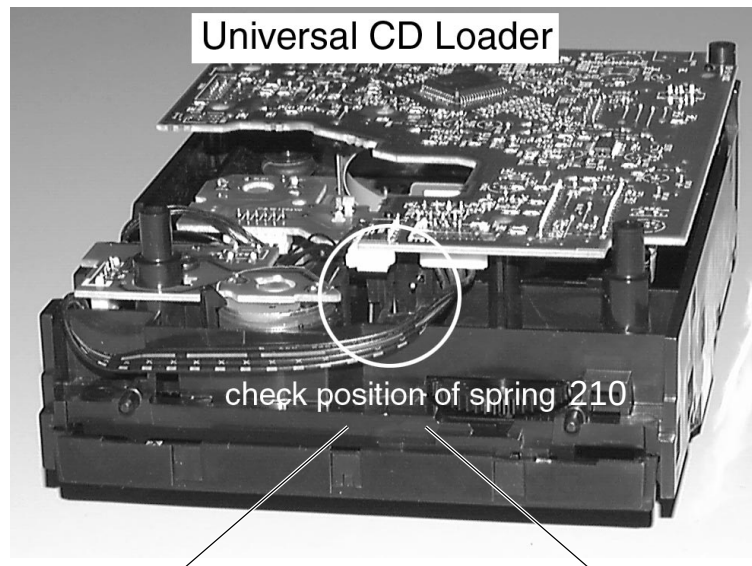
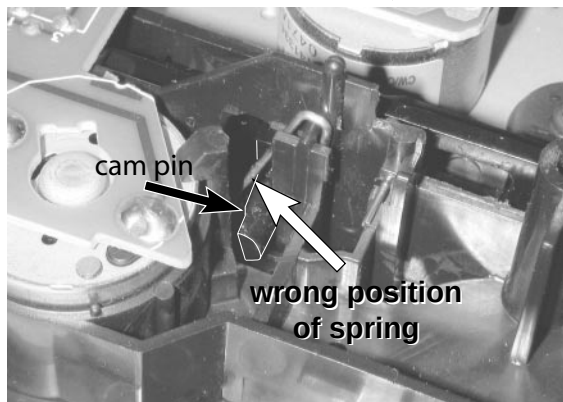
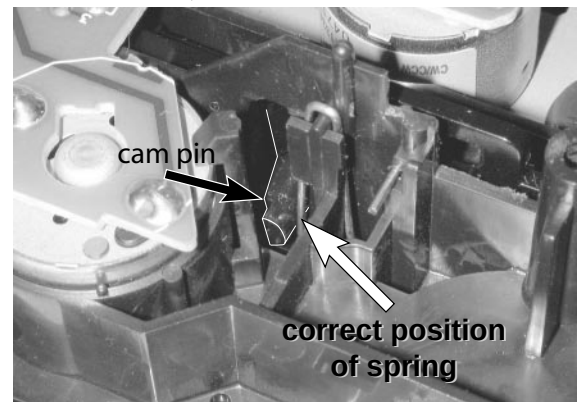
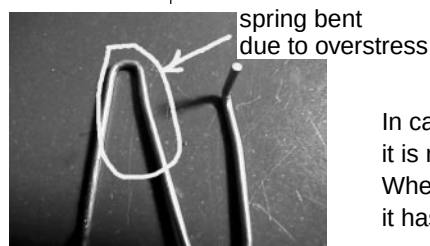
**SYMPTOM** : **IRIS CODE 1 6 2 6**  
CD tray does not open fully.

**CURE** : The problem is most probably caused by a wrong mounted spring 210. The spring is mounted on the wrong side of the cam pin protruding through the cabinet frame. For details see pictures below.

In case the spring has been found in the "wrong position", it is recommended to check it before re-aligning. When the spring is deformed as shown in the left picture, it has to be straightened before mounting it again.
