# Service Bulletin

Bulletin No.: 21-NA-169

**Subject:** Diagnostic Tip for DTCs Set at a Low Mileage for 9T45/50/60 Automatic Transmissions

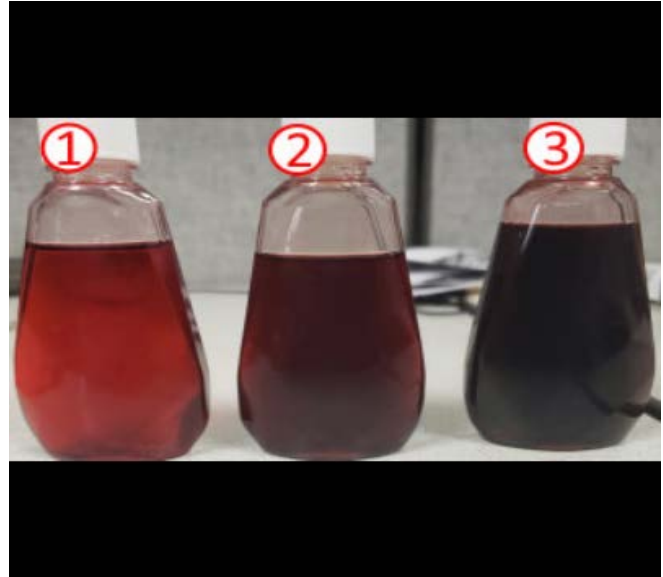
5840393

9. If fluid level is correct, then check condition of the fluid:
  - The fluid should be red or brown.
  - The fluid should be transparent so that objects or writing can be seen through it. Sample #1 is an example of acceptable fluid. Sample #2 is an example of very dark fluid. Sample #3 is an example of black fluid.

- In addition to checking the fluid color and transparency, the fluid should be checked for an odor of burnt fluid. If the fluid is very dark, black, or has a burnt odor it would indicate clutch damage has occurred internally in the transmission and it would need to be removed from the vehicle and investigated.
