# SERVICE BULLETIN

from: TRIO-KENWOOD COMMUNICATIONS, INC.

SUBJECT: SERVICE NOTES ON TS-820

DATE 10-25-77

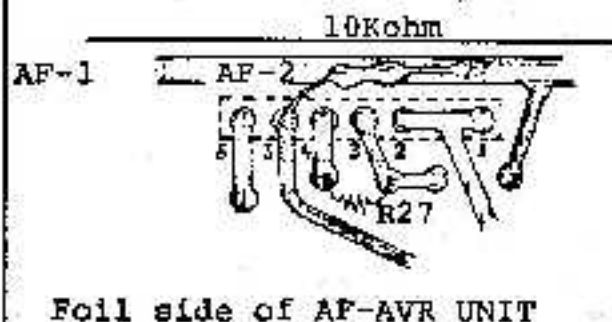
Fig. 1

We have had a few reports of the TS-820 RIT tuning being "rubbery". The following information will solve this.

1. Remove resistor R27 (1Kohm) on AF-AVR UNIT (X49-1080-00).
2. Install a 10Kohm resistor on foil side of AF-AVR UNIT --- see Figure 1.
3. Install a 1Kohm resistor on RIT control --- see Figure 2.
4. Install a capacitor (3.3 $\mu$ F-10 $\mu$ F) between RIT control and ground --- see Figure 2.
5. Adjust VR-2 on AF-AVR UNIT (X49-1080-00) for the same frequency as the center position of the RIT control.
