| <b>HYUNDAI</b> NEW THINKING.<br>NEW POSSIBILITIES.<br><br><b>Technical Service Bulletin</b> | | GROUP | NUMBER |
| | | <b>AUTOMATIC TRANSMISSION</b> | <b>13-AT-014</b> |
| | | <b>JULY 2013</b> | Tucson (LM), Santa Fe (CM/AN/NC), Sonata (YF), Elantra (UD/MD/GD/JK), Accent (RB), Azera (TG/HG), Veloster Turbo (FS) |
| <b>SUBJECT:</b> | <b>ATM INPUT AND OUTPUT SPEED SENSOR<br/>DTC P0717, P0721 AND P0722</b> | | |

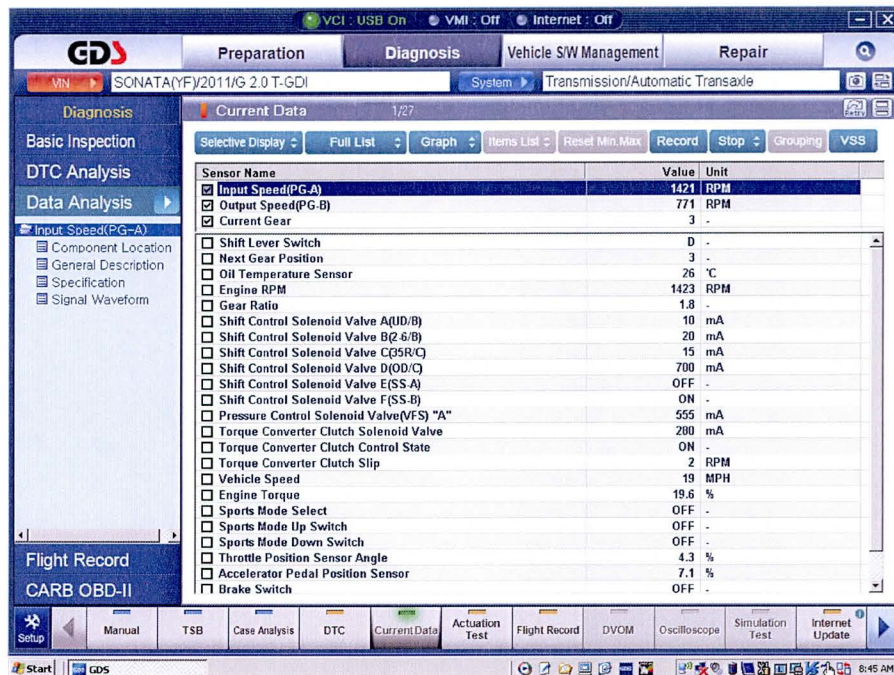
- Using a GDS, check for DTC in the "Automatic Transaxle" menu. **Record the DTC and description.** Delete the DTC.
- From the GDS, select the following parameters. Drive the vehicle and monitor the sensors.
  - Vehicle and A/T menu.
  - "Current Data"
  - Input speed and output speed sensors.
