# Blind Spot Monitor DTC U0232, U0233, C1AC1, C1AC2, C1AB6, or C1AB7

| YEAR(S) | MODEL(S) | ADDITIONAL INFORMATION |
|---|---|---|
| 2016 - 2018 | Tacoma | |

Some 2016 – 2018 model year Tacoma vehicles may exhibit a Blind Spot Monitor System Warning message with any of the following Diagnostic Trouble Codes (DTCs) present.

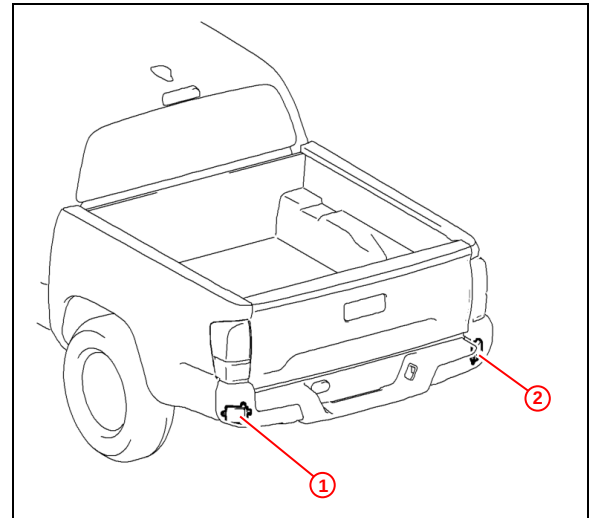
Figure 1.

| 1 | Blind Spot Monitor Sensor LH(Master) |
| 2 | Blind Spot Monitor Sensor RH(Slave) |

3. Replace both blind spot monitor sensors.
  - A. Remove the blind spot monitor sensor.  
Refer to TIS, applicable model and model year Repair Manual:
    - [2016](#) / [2017](#) / [2018](#) Tacoma: *Audio/Visual/Telematics – Park Assist/Monitoring – “Park Assist/Monitoring: Blind Spot Monitor Sensor Removal”*
  - B. Install the blind spot monitor sensor with the three nuts.  
**Torque: 9.0 N\*m (92 kgf\*cm, 80 in\*lbft)**
