## GENERAL T.I. BULLETIN INDEX

| T.I. No. | Issue | Subject | Products Affected | Date |
|---|---|---|---|---|
| Gn 001 | 1 | Tappet Adjustment | Perkins 1000 Series Engines | Mar. 90 |

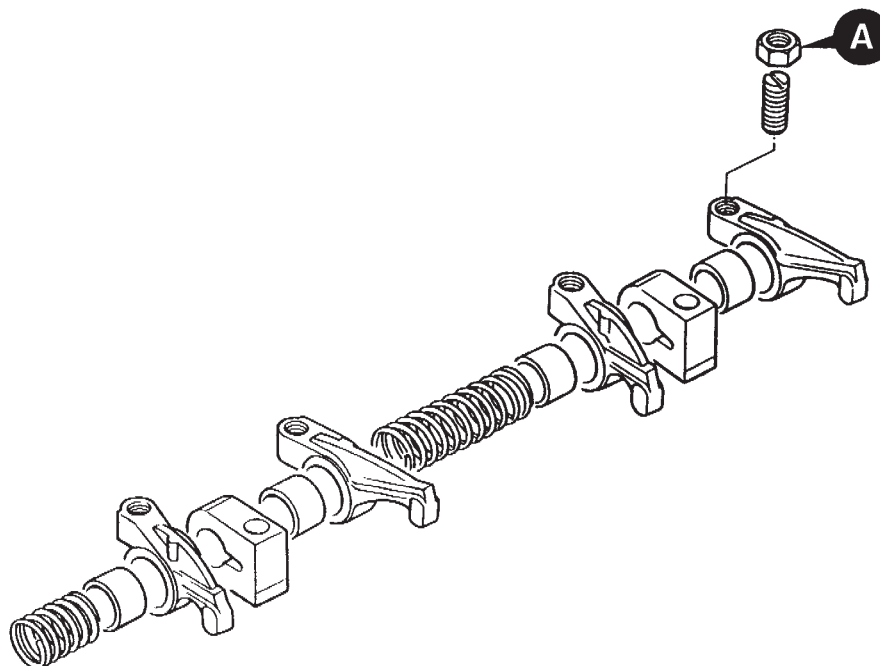
When tappet adjustment is required, it is important to re-torque the adjusting screw lock nut **A**. If this is not correctly actioned the adjusting screw will become loose which could cause damage to the tappet assembly and push rod.

Lock Nut Torque - 20 lbs ft.

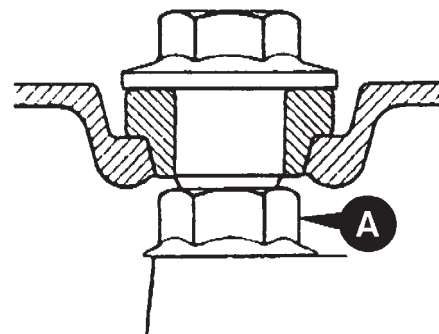
Flanged nuts **A** replace the three nuts and washers securing the rocker shaft to the cylinder head. The single bolt and washer is replaced by a flanged bolt.

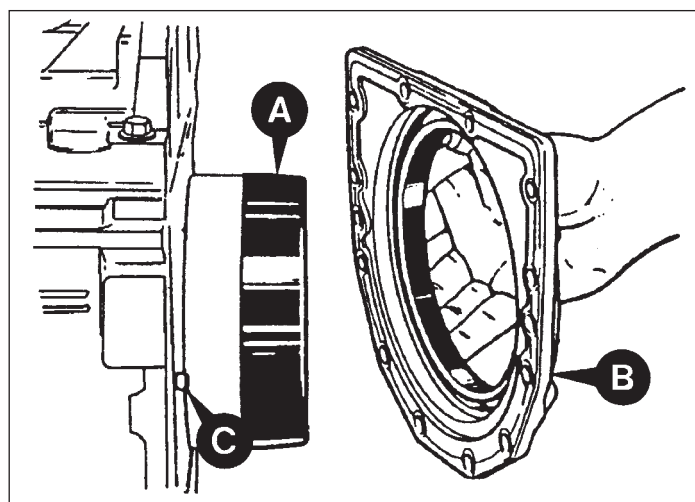
A number of reports by Perkins have been received concerning crankshaft rear main oil seal leaks. Little or no detail is completed in the comments section of the warranty claim form. Information given in the comments section will enable Perkins to identify the exact fault and take the correct remedial action.

If oil is leaking past the rear seal, oil will normally be found inside the flywheel housing with some evidence of leakage from the low inspection plate.

- 1 Remove the transmission.
- 2 Remove the flywheel using guide studs (remove two diametrically opposite bolts and temporarily fit guide studs).
- 3 Remove seal housing **B** setscrews. Using an appropriate lever gently pry the seal housing away from cylinder block, taking care not to damage the housing.
- 4 Press out old seal and fit replacement, using tool number PD.145D (see Perkins Service Manual), this will pre-set the seal depth as required.

**Note:** The service tool will set seal to 4 different depths, on new engines position 1 should be used.

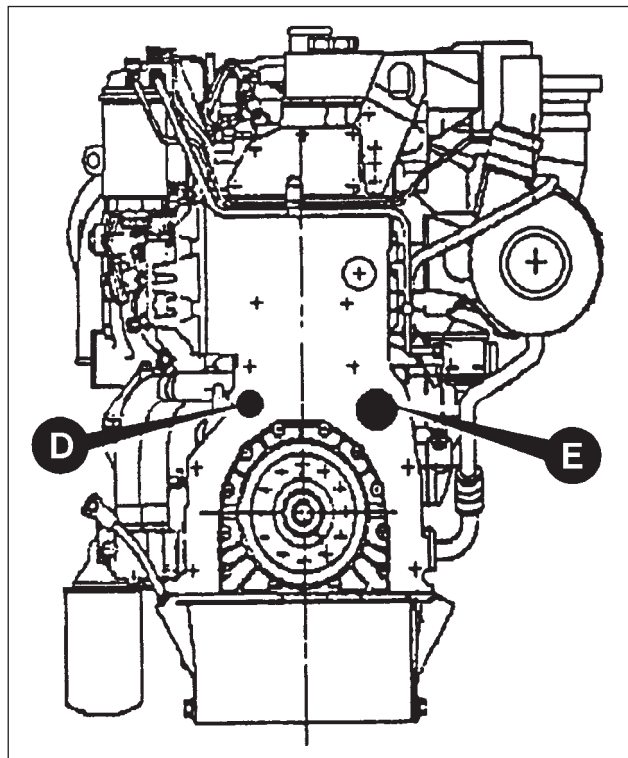
A leak from this area can usually be identified by a trace of oil along the contact face of block and flywheel housing on the fuel pump side of the engine.

- 1.1 Remove the transmission.
- 1.2 Remove the flywheel using guide studs (remove two diametrically opposite bolts and temporarily fit guide studs).
- 1.3 Remove the starter motor.
- 1.4 Remove the flywheel housing (it may be necessary to tap the housing using a soft hammer to disengage the housing dowels).
- 1.5 Remove the threaded gallery plug **D** located top left of cylinder block using appropriate allen key.
- 1.6 Fit a new plug/washer using Loctite 574 Multigasket and torque to 85 Nm (62.5 lbf ft).
- 1.7 Refit flywheel housing and torque securing screws M10 to 44 Nm (33 lbf ft) and M12 to 75 Nm (55 lbf ft).
- 1.8 Refit flywheel using guide studs and torque retaining bolts to 105 Nm (77 lbf ft).

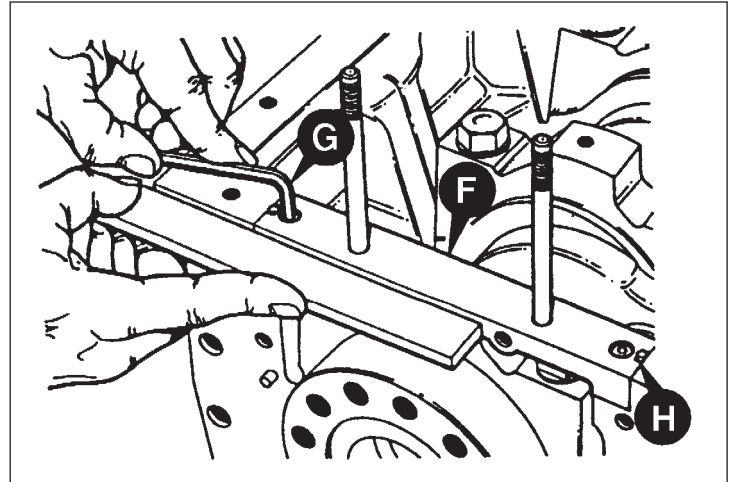
Lubrication oil leakage from the bridge piece **F** can be identified in two ways; oil may be seen around the sump rear face or oil will be evident inside the flywheel housing. There are two possible causes for leakage from the bridge piece, misalignment and/or lack of sealant.

- 3.1 Remove the flywheel using guide studs (remove two diametrically opposite bolts and temporarily fit guide studs).
- 3.2 Remove the starter motor.
- 3.3 Remove the flywheel housing (it may be necessary to tap the housing using a soft hammer to disengage the housing dowels).
- 3.4 Remove the rear seal housing as described in the section titled 'REAR OIL SEAL HOUSING'.
- 3.5 Remove the lubrication oil sump.

- 3.6 Release the two securing capscrews **G** in the bridge piece remove the bridge piece and old sealant from all faces. Loosely refit the bridge piece and align the face of the bridge piece to the rear block face using a straight edge as shown. Alignment to be within 0.05 mm (0.002 in). Tighten the securing cap screws to 9 Nm (6 lbf ft).
- 3.7 Apply Loctite 574 Multigasket to bridge piece end slots **H** using applicator gun until sealant can be seen coming from the chamfered edges of the bridge piece contact face with the cylinder block.
- 3.8 Refit flywheel housing and torque securing screws M10 to 44 Nm (33 lbf ft) and M12 to 75 Nm (55 lbf ft).
- 3.9 Refit flywheel using guide studs and torque retaining bolts to 105 Nm (77 lbf ft).

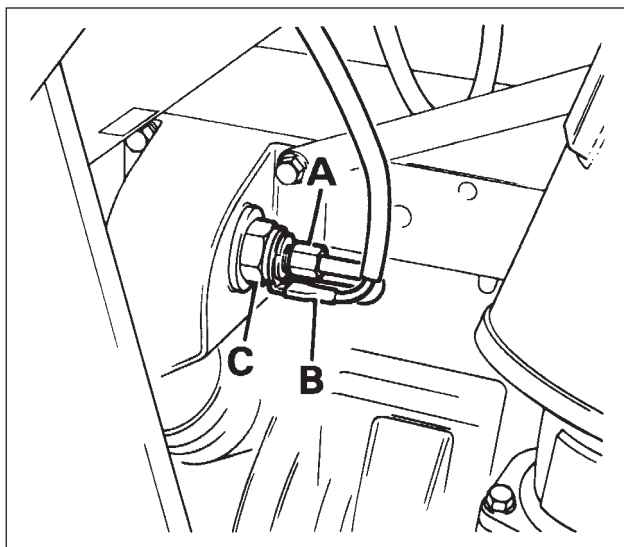
A problem has occurred several times where the inside of the induction manifold has been found to be wet and the turbocharger has been returned as faulty. After investigation, the turbocharger was found to have no fault.

If the inside of the induction manifold is wet, check that there is not a fuel leak from the fuelled starting aid (if fitted):

- 2.1.3 Start the engine and operate it at low speed. Check that there is no fuel leakage from the valve of the starting aid.
- 2.1.4 If there is no leakage, remove the plug from the induction manifold and fit the starting aid. Connect the fuel pipe to the starting aid and remove the air from the pipe as described above. Connect the electrical connector to the starting aid.

- 2.1.5 If there is a leak from the valve of the starting aid, fit a new starting aid.

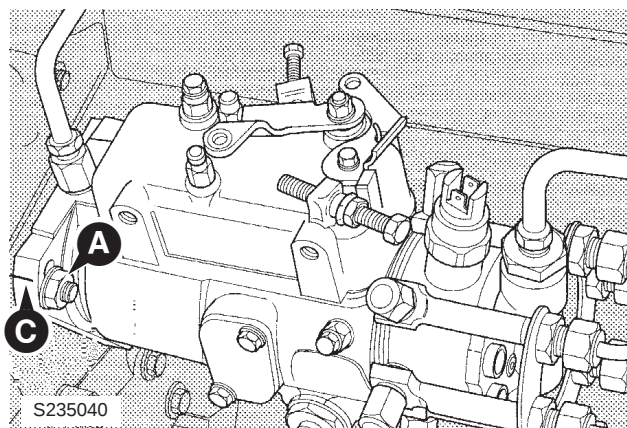
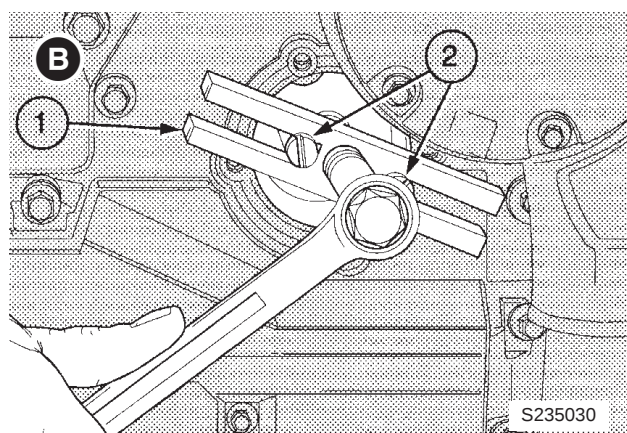
**SUBJECT:** Fuel Injection Pump - Seal Failure

- 4.5** Loosen the drive gear of the fuel injection pump with the puller PD155C and adaptors PD155B/5, as shown at **B** (items 1 and 2).
- 4.6** Remove the fuel pump; ensure that the key does not fall from the drive shaft.
