HIGH CLUTCH EFFORT/CLUTCH FLUID LEAK - CRACKED MOUNT

TECHNICAL SERVICE BULLETIN

Reference Number(s): 90-16-7, Date of Issue: August 1, 1990

CLUTCH - HIGH EFFORT - DASH CRACKED IN CLUTCH MASTER CYLINDER AREA-VEHICLES BUILT BEFORE 6/15/90

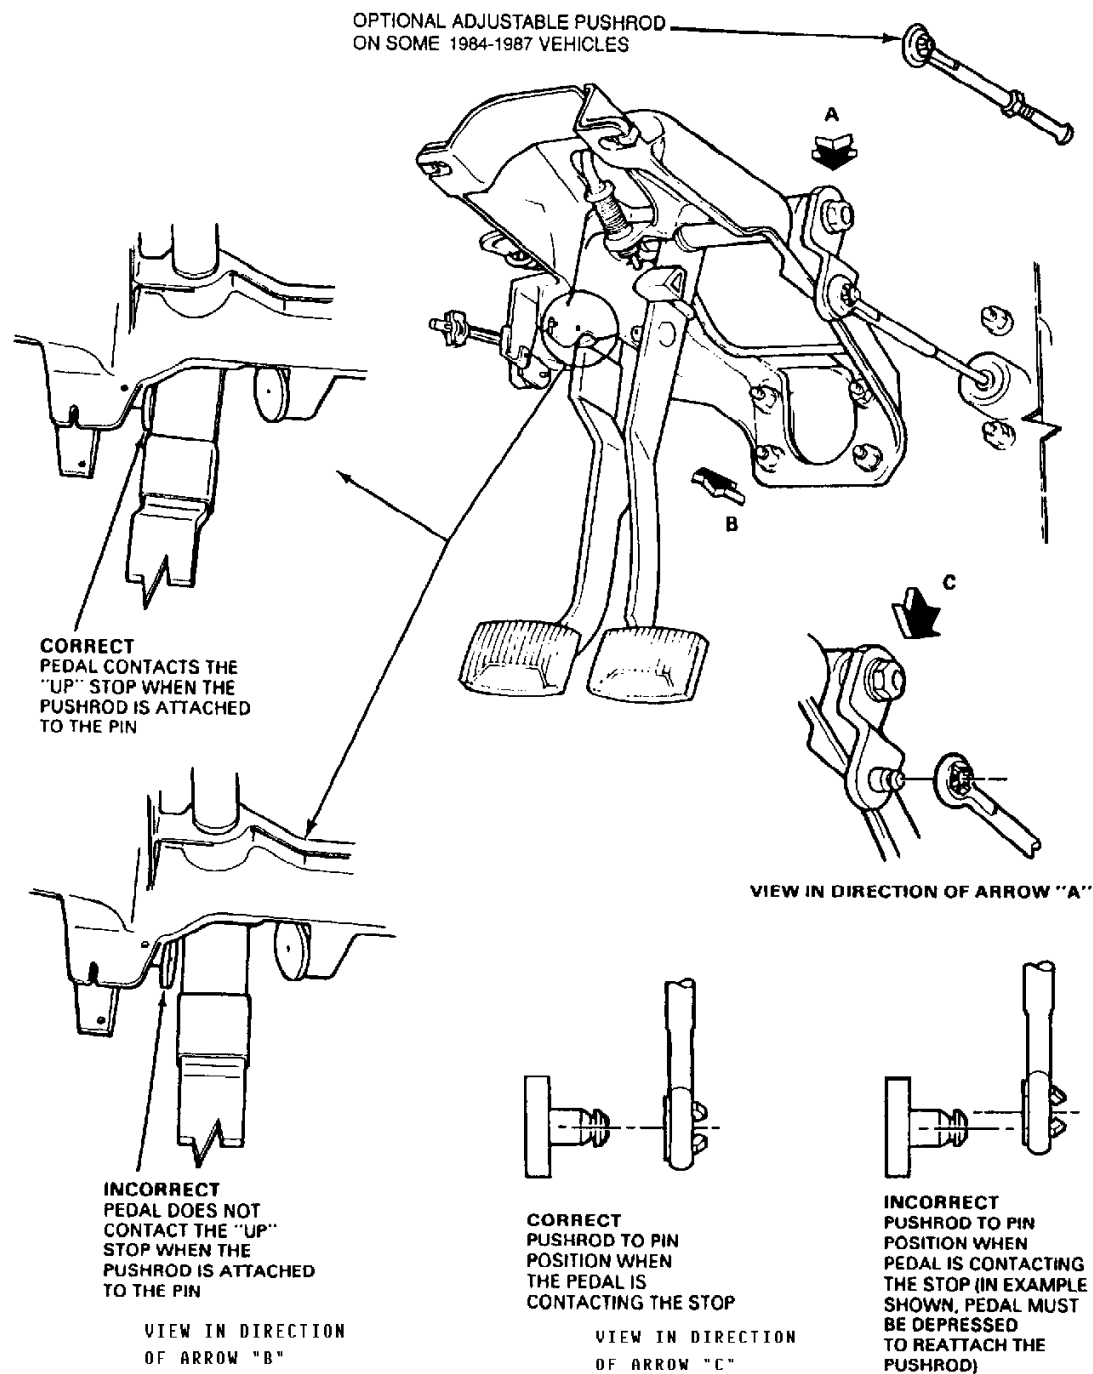
Fig. 1: Inspection Points for Clutch Pedal Assembly

- b. Make sure the hole in the pushrod lines up with the pin, for those units requiring a minimal force

for installation, [Fig. 1](#) .

- c. If it does not line up correctly, install an adjustable pushrod (except 1988 and later models) or replace the clutch release lever (required on 1988 and later models), cutting a new seat on the cross shaft splines.

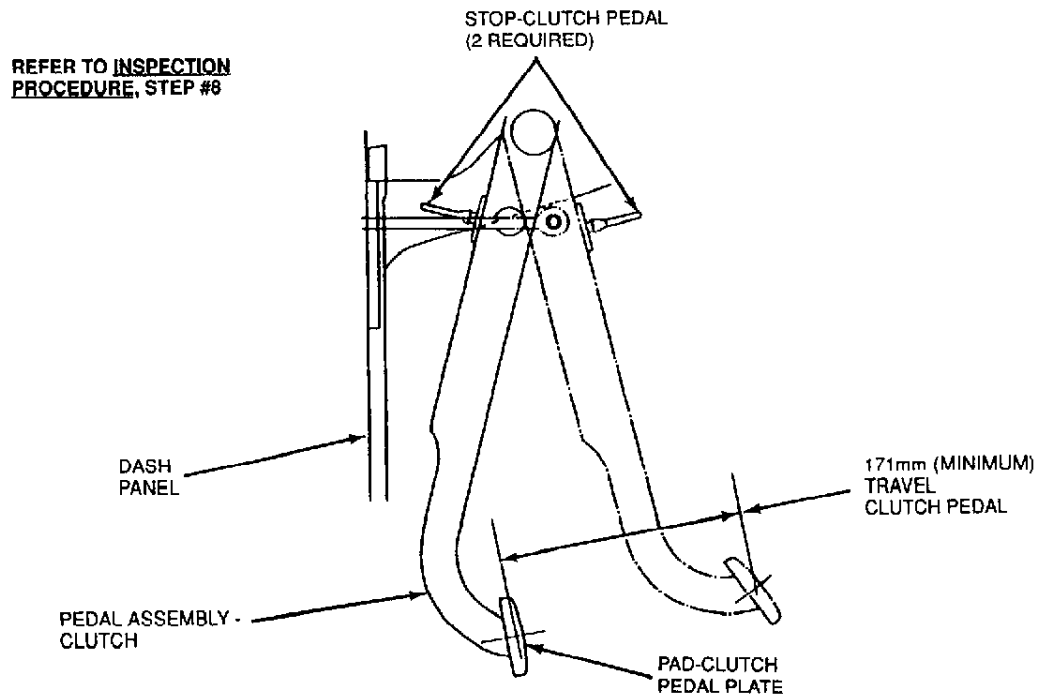
[Fig. 2: Clutch pedal Travel](#)

7. Test drive the truck again, checking for improved clutch release.
8. If there is no improvement, inspect the truck for adequate release bearing travel.
 - * It should be 11mm or greater for full pedal travel.
 - * Pedal travel at the center of the pedal pad should be 6.75" (171mm minimum) or more, [Fig. 2](#).

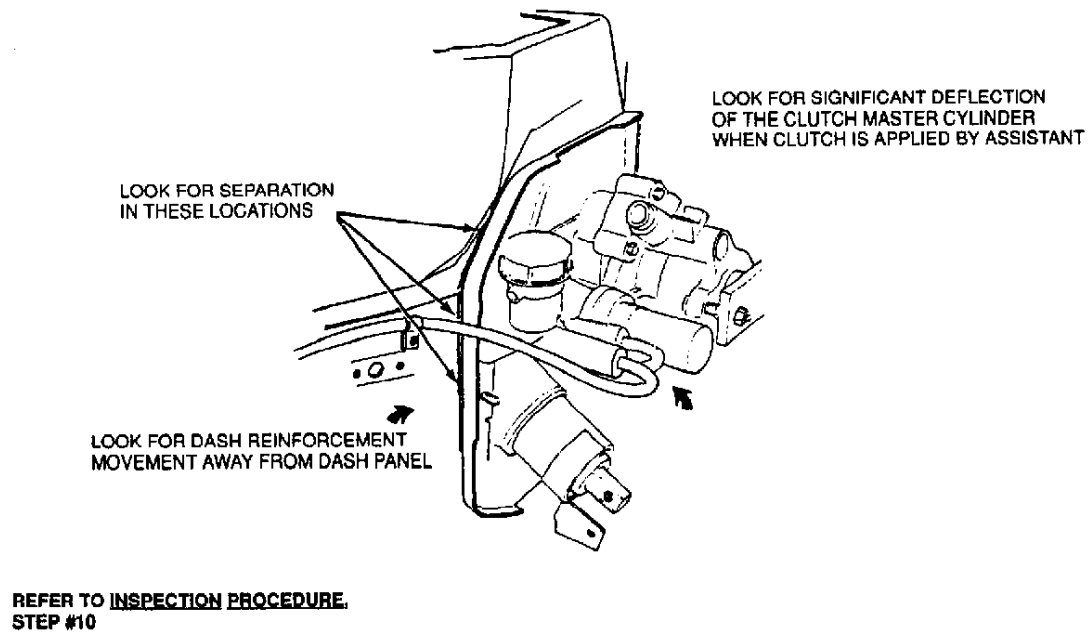
Fig. 3: Checking Reinforcement (Dash Reinforcement Points)

9. Release bearing travel and gear grinding noise may indicate the following concerns.
 - * If the release bearing is 11mm or greater and there is grinding of one or two gears only, the concern is probably with the transmission.
 - * If all gears grind, the concern may be with the clutch and/ or pilot bearing which will need replacing.
 - * If the release travel is less than 11mm, check the clutch hydraulic system for air and bleed as necessary.
10. If the release travel is still less than 11mm, with all of the above items eliminated, proceed as follows:
 - a. Raise the hood, while an assistant operates the clutch pedal.
 - b. Watch the clutch master cylinder for significant deflection.
 - c. Look for the dash reinforcement moving away from the dash, Figure 3.

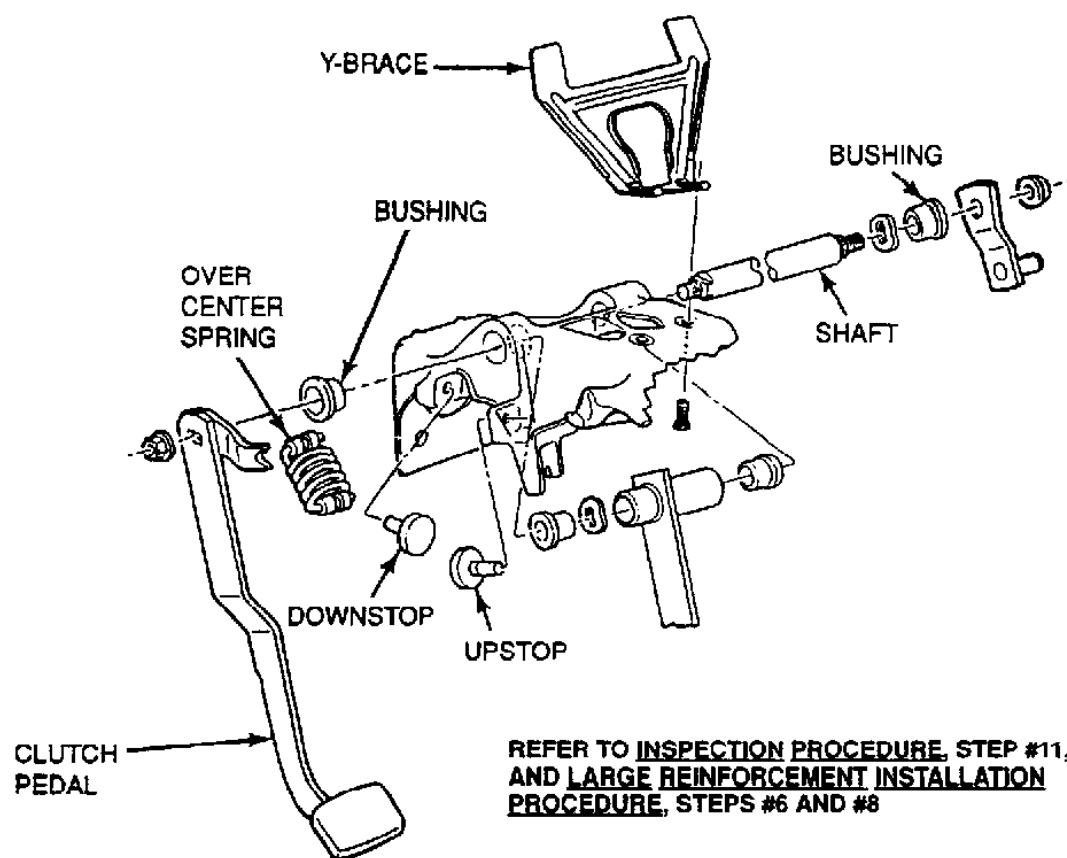
Fig. 4: View of Y-Brace & Clutch Linkage

- d. In 1987 and earlier models, look down inside the cowl cover at the cowl where it is attached to the dash reinforcement. Check for pulled spot welds.
11. If there is significant movement of the dash or clutch master cylinder, proceed as follows:
 - a. Remove the steering column and its dash toe plate and seal.
 - b. Inspect the dash inside the cab and look for:
 - * Pulled spot welds and cracked or torn sheet metal.
 - * Cracks in the brake and clutch pedal support.
 - * Missing Y-brace fasteners and a broken or detached Y-brace, [Fig. 4](#).

8. Thoroughly inspect the brake and clutch support again for cracks in the casting and worn bushings. Also, inspect the "Y" brace for cracks and missing fasteners. Replace as necessary, [Fig. 4](#).
9. Remove excess body sealer in the area of the clutch master cylinder, inside the dash.
10. Carefully remove the cowl top cover 12 fasteners (7 in front, 5 in rear).

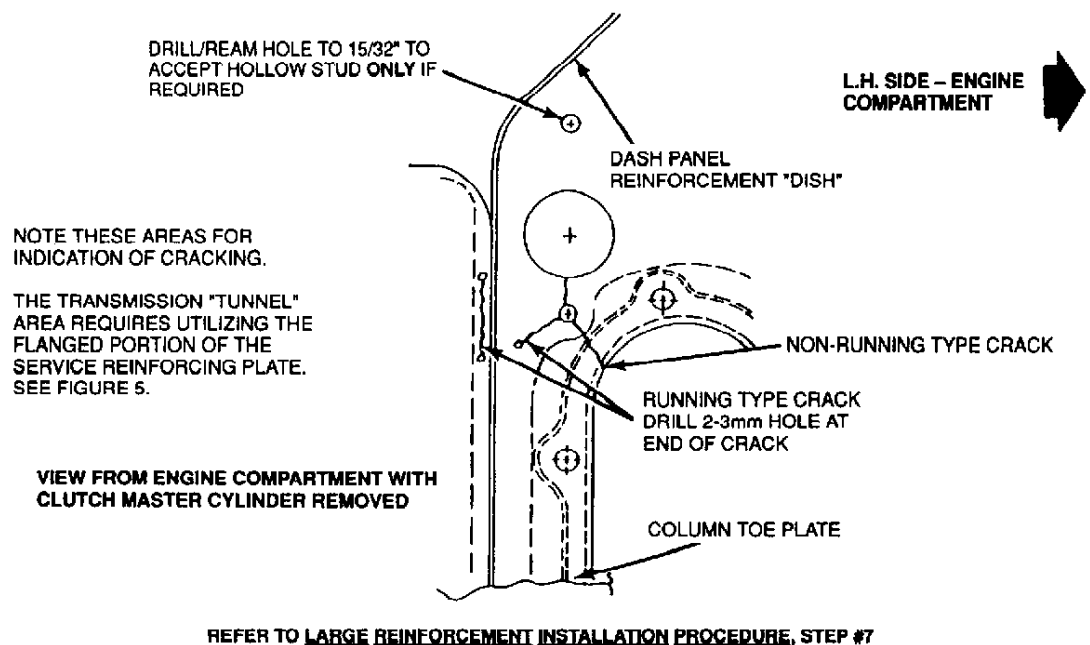
Fig. 8: Repairing Cracks

7. Check for cracks.
 - a. Pull back the floor covering and dash sound insulator. (It may be helpful to remove the accelerator pedal.)
 - b. Inspect the area for pulled welds and torn dash sheet metal.

- c. If there are cracks that have not run out, stop them by drilling a 2-3mm hole at the end, [Fig. 8](#).

NOTE: Welding or brazing is not recommended, because it could be a source of future blind side corrosion.
