## PRODUCT CAMPAIGN BULLETIN

**APPLICABILITY:** 2017-19MY Impreza  
2018-19MY Crosstrek  
**SUBJECT:** Ignition Coil Short Circuit

**NUMBER:** WUQ-02R  
**NHTSA ID:** 19V-743  
**DATE:** 10/22/19  
**REVISED:** 12/02/19

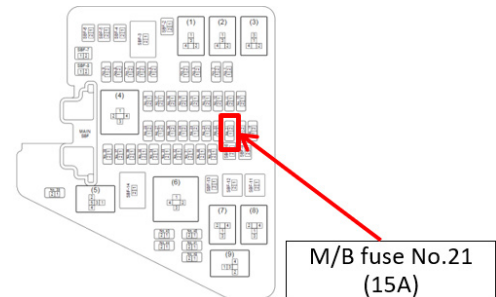
**Step 3:** Remove the lid from the under-hood Main Fuse Box (M/B) and inspect Fuse 21. Is Fuse 21 blown?

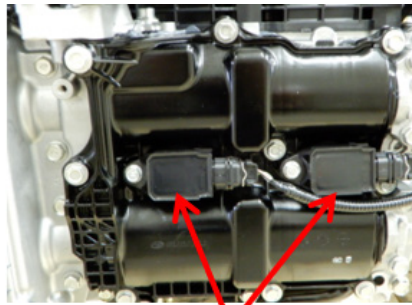
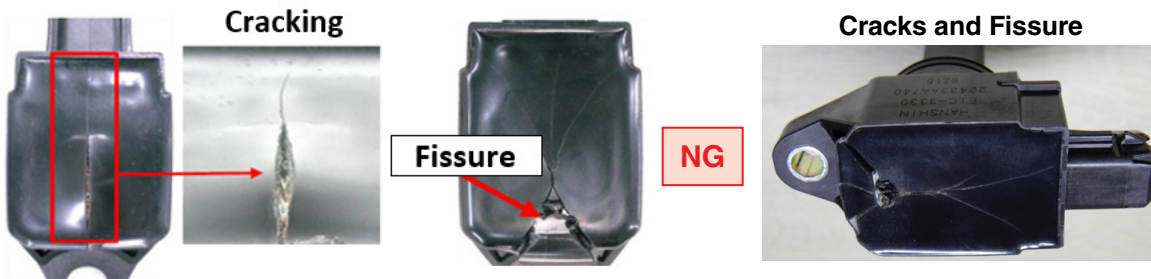
Ignition Coil Check Points

**Step 4:** Inspect all 4 ignition coils CLOSELY for any damage, cracking, fissures, etc. Coil removal is NOT necessary as any damage will be external. Were any cracks, fissures or other damage found on any of the 4 ignition coils?

**YES:** Replace any damaged coil(s) (rare case) following the procedure in the applicable Service Manual then proceed to **Step 5** and using the SSM, check for any stored DTCs.
