# Front Exhaust Pipe Catalyst Rattle Noise and/or MIL "ON" DTC P0420

Service  
Category Engine/Hybrid System

| YEAR(S) | MODEL(S) | ADDITIONAL INFORMATION |
|---|---|---|
| 2010 | Tacoma | VDS(s): NX4CN, NX4GN, PX4EN, TX4CN, TX4GN, UX4EN |

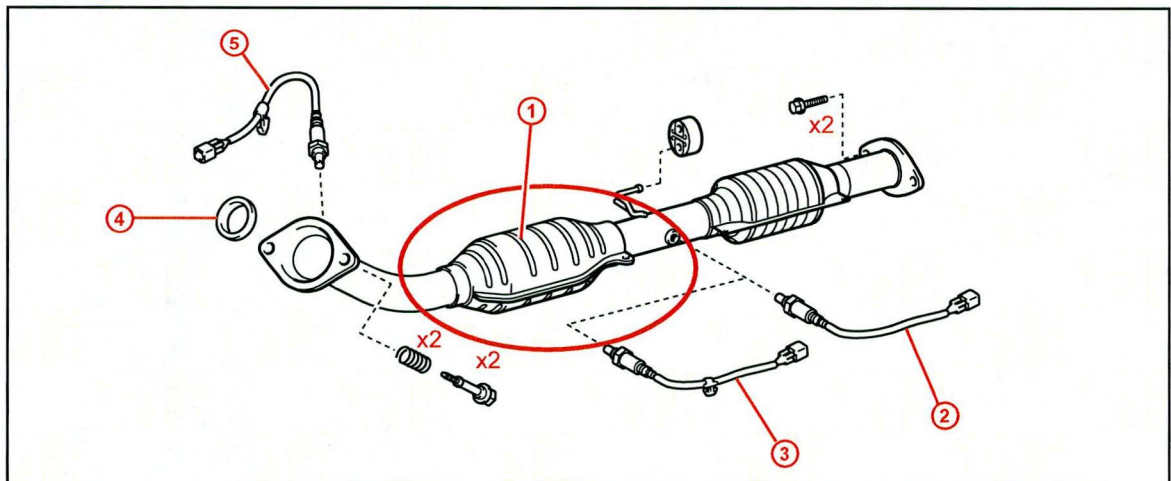
Figure 1. 2TR-FE Front Exhaust Pipe Components

3. Increase the engine speed and listen to the catalytic converter section on the front exhaust pipe assembly for a rattle noise.

4. Did the noise appear to be the loudest at the catalytic converter section of the front exhaust pipe assembly?
  - **YES** — Continue to step 5.
  - **NO** — This bulletin does NOT apply. Continue diagnosis using the applicable Repair Manual.
5. Replace the front exhaust pipe assembly.  
 Refer to the Technical Information System (TIS), applicable model and model year Repair Manual:
  - 2010 Tacoma:  
*Engine/Hybrid Systems – Intake/Exhaust – “2TR-FE Exhaust: Exhaust Pipe: Removal / Installation”*
6. Test drive vehicle to confirm repair.
