# Service Bulletin

Bulletin No.: 19-NA-076

**Subject: Blue or Black Screen and Service Rear Vision System Message on Radio Display Shifting into Reverse**

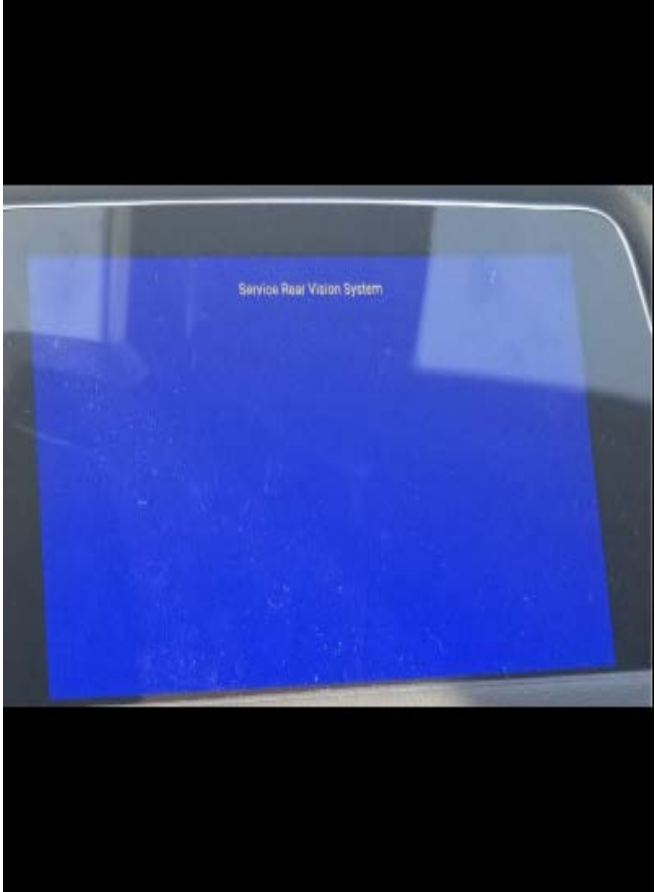
| Condition | <p>Some customers may comment on a blue or black screen with Service Rear Vision System message when shifting into Reverse.</p> <p><b>Tip: (Truck only)</b> Refer to Service Bulletin # <b>18-NA-383</b> for additional steps and how to identify if this is a water intrusion issue.</p> <p><b>Surround / Trailer Camera (UV2, UVS, or UVI) Systems</b></p> <p>The <b>blue</b> screen (with Service Rear Vision message), or <b>black</b> screen (with red triangle and no camera icon) condition can occur multiple times within the same power cycle and may return to normal functionality on the next power cycle. Or if this condition exists, it will occur every time the rear view is displayed to the customer within the same power cycle and may return to normal functionality on the next power cycle after the A11 radio enters and exits sleep cycle. A Diagnostic Trouble Code (DTC) B101D Symptom Byte 3C and/or 39 may be stored as a history DTC in the Video Processing Module (VPM) without any camera-related concern; If there are no DTCs setting in the VPM, and all DTCs are setting in the radio, refer to Service Bulletin # 21-NA-048.</p> <p>Blue Screen</p> |
