**mars 202435
Lessons
Learned**

- Product Name: MARS Report No 381
- Issue Date: July 2024
- Product Code: MARS 202435, MARS 202436, MARS 202437

MARS 202435

Collision in daylight and good visibility

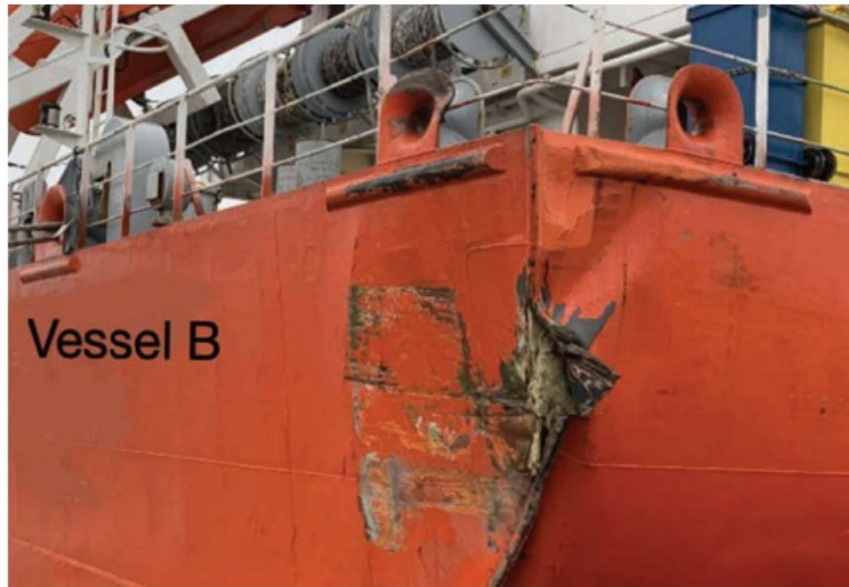
In daylight and good visibility, cargo vessel A was making about 12 knots with a lone OOW on the bridge. Auto-pilot was being used for helm control and the OOW was occupied with administrative tasks. The radar was on but targets were not being acquired and alarms were not activated.

Meanwhile, about five nm away from vessel A, vessel B had recently stopped and was drifting due to technical difficulties with the main engine. This vessel's lone OOW had not updated the vessel status to 'not under command' (NUC) on the AIS, nor were the required NUC day signals raised. Vessel A maintained its course and speed, with a steady bearing and decreasing range to vessel B.

Over the next 20 minutes, vessel A's OOW continued to undertake other duties on the bridge and was not monitoring nearby traffic. As vessel A approached the drifting vessel B on a virtual collision course a crew member who had been working on deck ran to the bridge and alerted the OOW to the developing situation. Still making a speed of 12 knots, the OOW immediately used the autopilot to initiate a turn to starboard before switching to hand steering to increase the rudder angle. However, the turn was not sufficient to avoid collision 10 seconds later. Vessel A's port side struck vessel B's starboard quarter, resulting in hull damage to both vessels above the waterline.

The preliminary assessment found, among other things, that the ECDIS unit on both vessels was set to silent mode, with all audible alarms deactivated while underway. Also, although vessel B was visible on both of vessel A's radars, the target had not been acquired on the ARPA.

- An OOW should actively navigate the vessel and not undertake any other tasks, ever!
- Activated alarms are an asset when at sea – use them.
- If your vessel's navigational situation changes, set the appropriate instruments and signals to reflect this change in status.

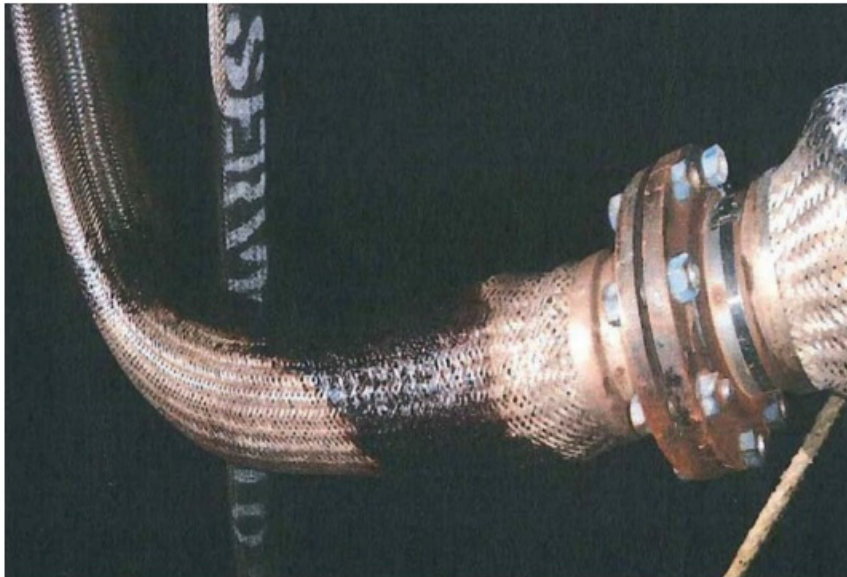
A tanker had berthed for discharge operations and had also ordered bunkers. A bunker barge arrived at about 2:15 in the morning and was secured on the port side of the tanker. The bunker hose, supplied by the bunker barge, was connected to the tanker's bunker manifold and surveyed to the extent possible by the tanker crew. Everything appeared correct and bunkering commenced with an initial rate of 40 tonnes/hr.

The bunkering station reported normal operations and no leaks so the rate was gradually increased to 180 tonnes/hr. Soon after the rate increase, a minor leak was observed in the hose and the bunkering was stopped. A small quantity of oil had spread on deck and was cleaned. No oil was seen to be released into the sea.

The bunker hose had apparently been tested under pressure four months earlier but was now clearly less than adequate for the job.

- Visual inspection of a bunker hose before use is necessary but cannot guarantee the integrity of the hose under full operating pressure.
- Vigilance at the bunkering station is a primary defence against pollution. When bunkering in darkness, ensure the hose is well lit and visible along its entire length.

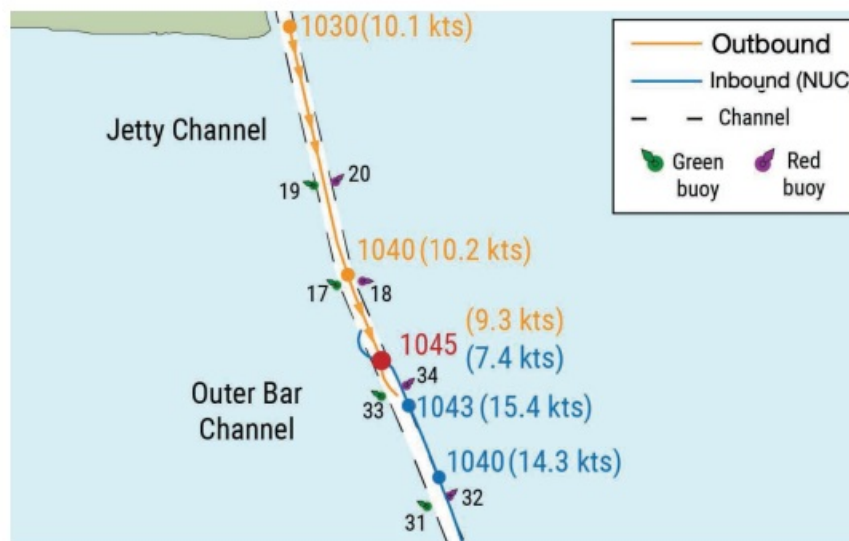
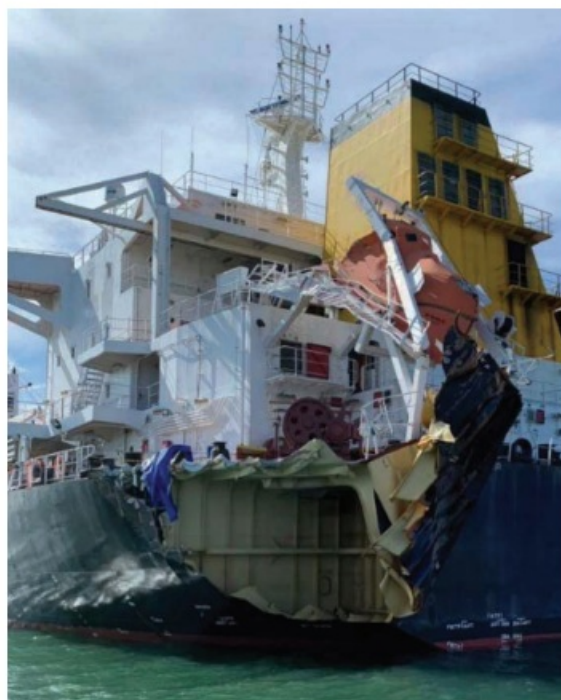
Shortly before the two vessels met, the main engine alarm detection panel on the inbound vessel recorded a high oil mist density reading, and the main engine shut down automatically. This also caused the loss of the bow thruster. The remaining electrical equipment and instruments, including the steering gear, continued to be powered. The vessel was now drifting and Not Under Command (NUC).

at 9.3 knots, the bow of the NUC vessel struck the port quarter of the outbound, peeling back about 12 metres of that vessel's hull plating forward of the transom and wrapping it around the stern.

The official investigation found that the automatic shutdown of main engine on the inbound vessel was likely due to a false alarm. The investigation posited that the oil mist detector had sensed water vapour resulting from the engine maintenance and incorrectly identified it as oil mist. This had falsely triggered the alarm and ensured the automatic shutdown.

- Cooling water can be introduced into engine lube oil systems during maintenance. Ambient air conditions, such as high humidity or extreme cold temperatures, can also increase the water content within engine lube oil sumps. An elevated quantity of water in lube oil systems can trigger false alarms in engine crankcase oil mist detectors (and lead to an engine shutdown).
- After an engine's crankcase is opened and exposed to cold or humid conditions during maintenance and repair, it is good practice for engine crews to inspect and test the lubricating oil system for water intrusion and ensure lube oil purifying equipment is functioning properly to remove any water or other contamination in the lube oil.

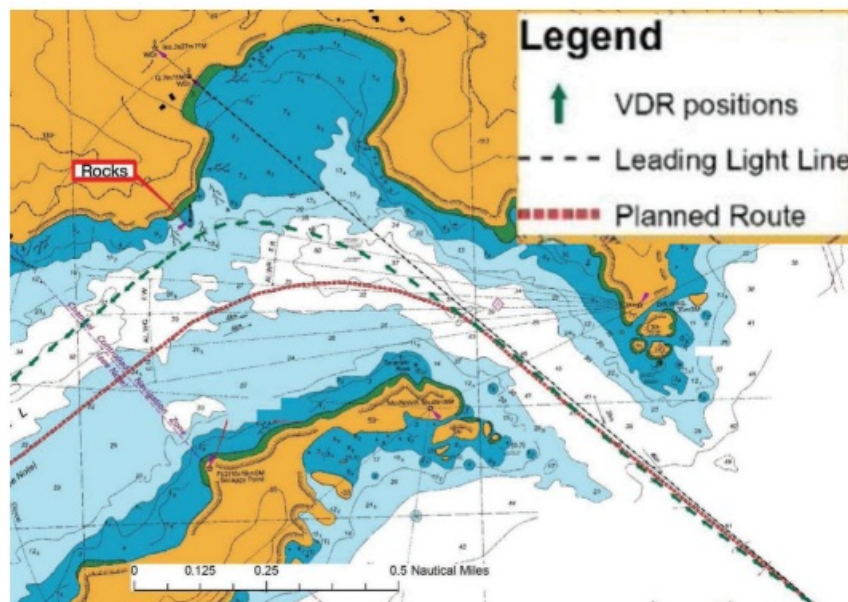
Nonetheless, the pilot soon realized that the ship was not turning to port as expected, so he ordered five degrees of port rudder followed by 10 degrees in quick succession. The ship was now to the right of the intended track and the cross-track distance from the intended track was increasing rapidly to starboard.

The staff captain noticed the predictor on the ECDIS/Radar display had the ship passing over the land ahead and to starboard. He suggested to the Master that they increase the rate of turn. The Master reassured the staff captain that the cross currents were strong and would bring the ship back to the middle of the channel, reiterating

Soon, an off-track alarm visually flashed on the ECDIS, although audible alarms had been muted before entering the restricted waterway. The ship had departed the predefined safety corridor either side of the planned track, but this information was not brought to the attention of the Master or pilot. Yet, by now they both realized that the ship was proceeding dangerously close to the rocks on the starboard side. Twenty degrees of port rudder was ordered, immediately followed by maximum port rudder. The ship responded with a rapid turn to port. When the ship was approaching the closest point to the rocks on the starboard side, the Master ordered maximum helm to starboard in an attempt to arrest the rapid port turn and prevent the stern from striking the rocks. The ship's bilge keel and the starboard propeller nonetheless made contact as they passed the rocks. The ship was then navigated back to the centre of the channel and continued on its passage to port without further incident.

- The concept of allowing a ship to depart from an intended track in the belief that other influences, such as tide in this case, would return the ship to that track carries a high risk when maneuvering large ships in narrow waterways where margins for error are small. There is less risk involved when a ship is kept strictly to the intended track by increasing or decreasing its rate of turn in response to the influences of factors such as tide and wind.

- Also, the above maneuvering method leaves other members of the bridge team tasked with monitoring the progress of the ship against the planned track in limbo. How can an officer or Master 'challenge' the person with the con if the situation is intentionally obscure or undefined?

- Good BRM practices help to ensure that the best decisions are made and any errors or malfunctions of equipment are identified and corrected before an incident can develop. In order to achieve this objective and navigate a ship safely, a shared understanding of the passage plan by the entire bridge team is critical.

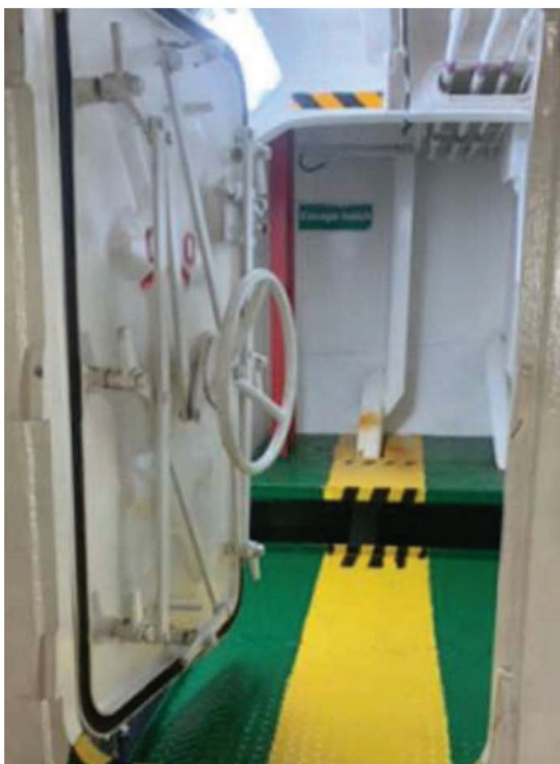
During a safety walkaround on a vessel, it was observed that several type C watertight doors (doors that must remain closed at all times and opened only when personnel pass through them) were routinely kept open while

underway. It was expressly indicated in the vessel's procedures that these doors must remain closed while at sea.

A review of similar cases on two other fleet vessels found that watertight doors were left open after the regular engine room walk around, as this was a regular activity and there was 'no point to open and close [them] each time.' It was also found that some crew were not aware of the relevant SOLAS and SMS requirements or the importance of keeping type C watertight doors closed at sea in case of emergency.

- Watertight doors are critical elements in preventing the ingress of water from one compartment to another during flooding or accidents. The seaworthiness of the vessel depends on their proper use.
- As with many safety-critical elements on a vessel, acceptance of procedures such as keeping type C watertight doors closed by crew is dependent on the safety leadership of senior officers and the Master.
