KEITHLEY DMM7512 7.5 Digit Graphical Multimeter Instruction Manual

GENERAL INFORMATION

VERSION 1.7.16 RELEASE

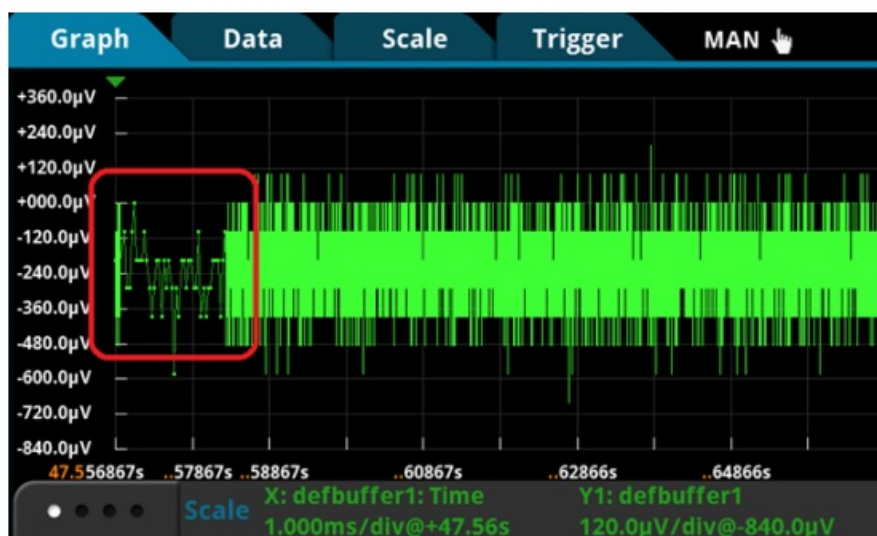
UI graph occasionally appears to be missing digitizer data

When using the UI to view bursts of digitizer data on the graph, you may see areas that appear to have missing data. See the example in the image below. Even though data is being sampled consistently throughout the viewable range, it appears as though fewer points are available in the circled area. This may only occur when more than 5,000 points are visible on the graph at once and sample rates exceed 50k.

Pan or scale the graph by touching it to force a refresh. All data will appear. The measurements were taken and

are in the buffer.
