Using the Evaporative **Emissions System Tester**

Customer Care and Aftersales

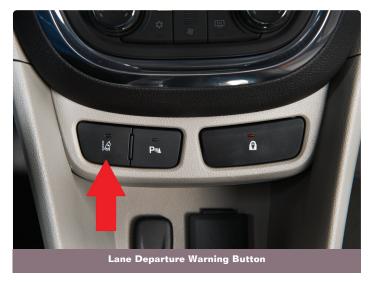
During a Pre-Delivery Inspection (PDI) of the 2013 Encore equipped with the Lane Departure Warning System (RPO UFL), a Service Front Camera message may be displayed in the Driver Information Center. DTC B101D SYM39 (Electronic Control Unit Hardware) may be found in the Front Camera Module.

This condition is a result of the vehicle being placed in Transport Mode. Vehicles with a Lane Departure Warning System should have had the Transport Mode turned off before reaching the dealership.

- 1. Turn off Transport Mode by performing the following:
 - A. Key in ignition, Off position
 - B. Turn on the hazard flashers
 - C. Press and hold the brake pedal
 - Start the engine and hold the key in the crank position for 10-15 seconds
 - E. Transport Mode Off will appear in the Driver Information Center
- Press the Lane Departure Warning button located in the center of the instrument panel below the climate controls. The button indicator will illuminate.

- Press the Lane Departure Warning button again. The button indicator will turn off.
- 4. Verify the Service Front Camera message in the Driver Information Center has cleared.
- 5. Clear all DTCs and evaluate.
- () Thanks to Ernest Haller

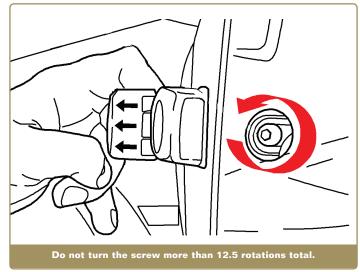
The instructions have been revised for installing the Chrome Door Handle Kit on the 2013 Malibu. To avoid damage, it is important to follow the revised instructions in the Service Information exactly. Here are the highlights.

TIP: Use a hand tool only. Do not use a power tool. Do not turn the screw more than 12.5 rotations total. Doing so will break the door handle bracket.

While holding the handle in the full open position, use a manual screwdriver to loosen the screw TEN full turns. The handle will stay in the full open position without being held.

Remove the bezel with the cylinder/cover and blank cylinder from the door. If unable to remove the bezel, complete one full turn of the screw at a time until the bezel can be released. Do not turn more than 2.5 additional turns.
