EB-PU2113W PU2116W/PU2120W

PU2213B/PU2216B/PU2220B

Firmware Release Notes

Version 2.70

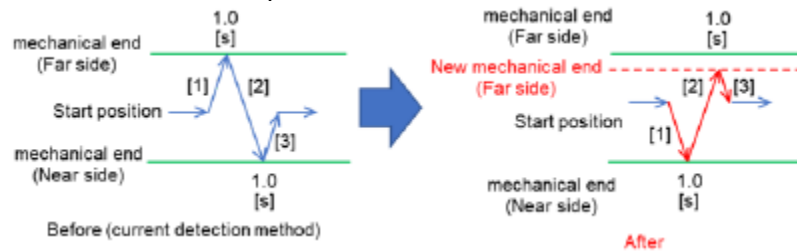
- 1) Changed detection method for distortion lens operating range during lens calibration.
Fixed the distortion error that may occur when ELPLX02/ELPLX02S is installed.

- [1] The lens group (A) moves towards the "near side mechanical end"

[2] The lens group (A) moves towards the far-side mechanical end. It stops at "New mechanical end**"

*Position of the "New mechanical end" is located right before the far-side mechanical end

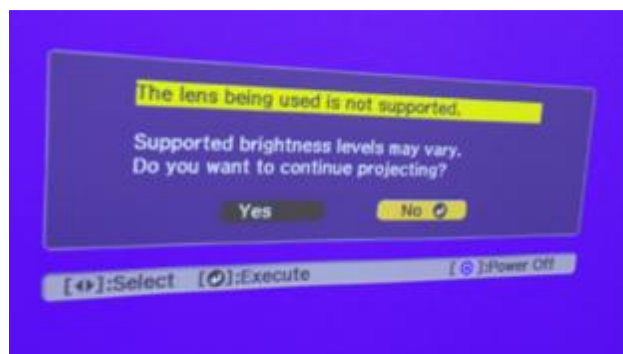
*1 The following message is displayed when unsupported lenses are attached.

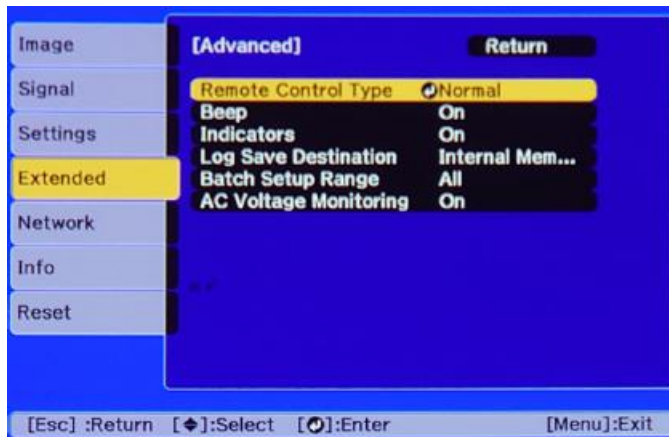
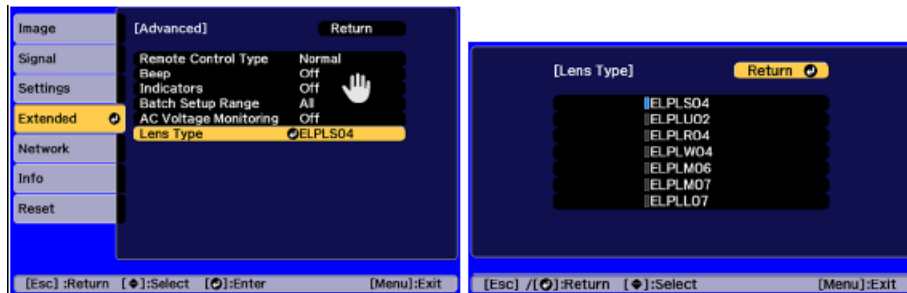
-Fixed bug where unsupported lenses could be selected in the OSD menu. The lens type item and selection menu have been deleted.
