# 2021 M2 LOW COOLANT LEVEL

**2021 M2 LOW COOLANT LEVEL** Jul 20, 2020 6:16 PM

2021 M2 WITH L9 2350 CUMMINS LOW COOLANT WHEN TANK IS FULL ANYWAY TO REPAIR FLOAT IN TANK WHICH CONTROLS SENSOR THE CUMMINS TROUBLE SHOOT SHOWES 3 WIRE SENSOR ONLY 2 WIRE IN THIS ONE I THINK THE TROUBLE IS IN THE TANK THE COOLANT SENSOR GOES IN BOTTOM INTO A DRY HOLE

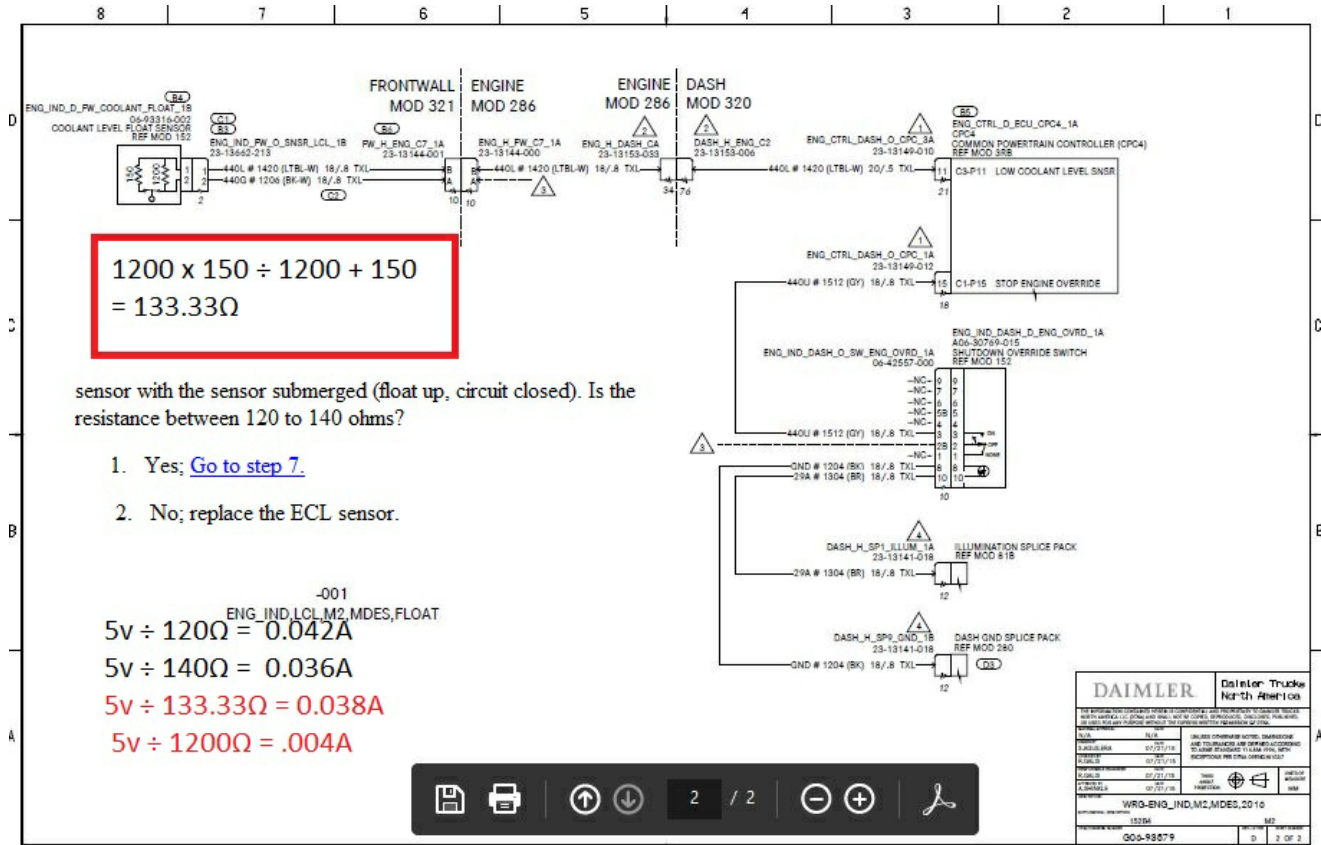
133 +or- = full. 1200 +or- = low. Somewhere below 133 would me short circuit fault. Somewhere above 1200 would be open circuit fault.

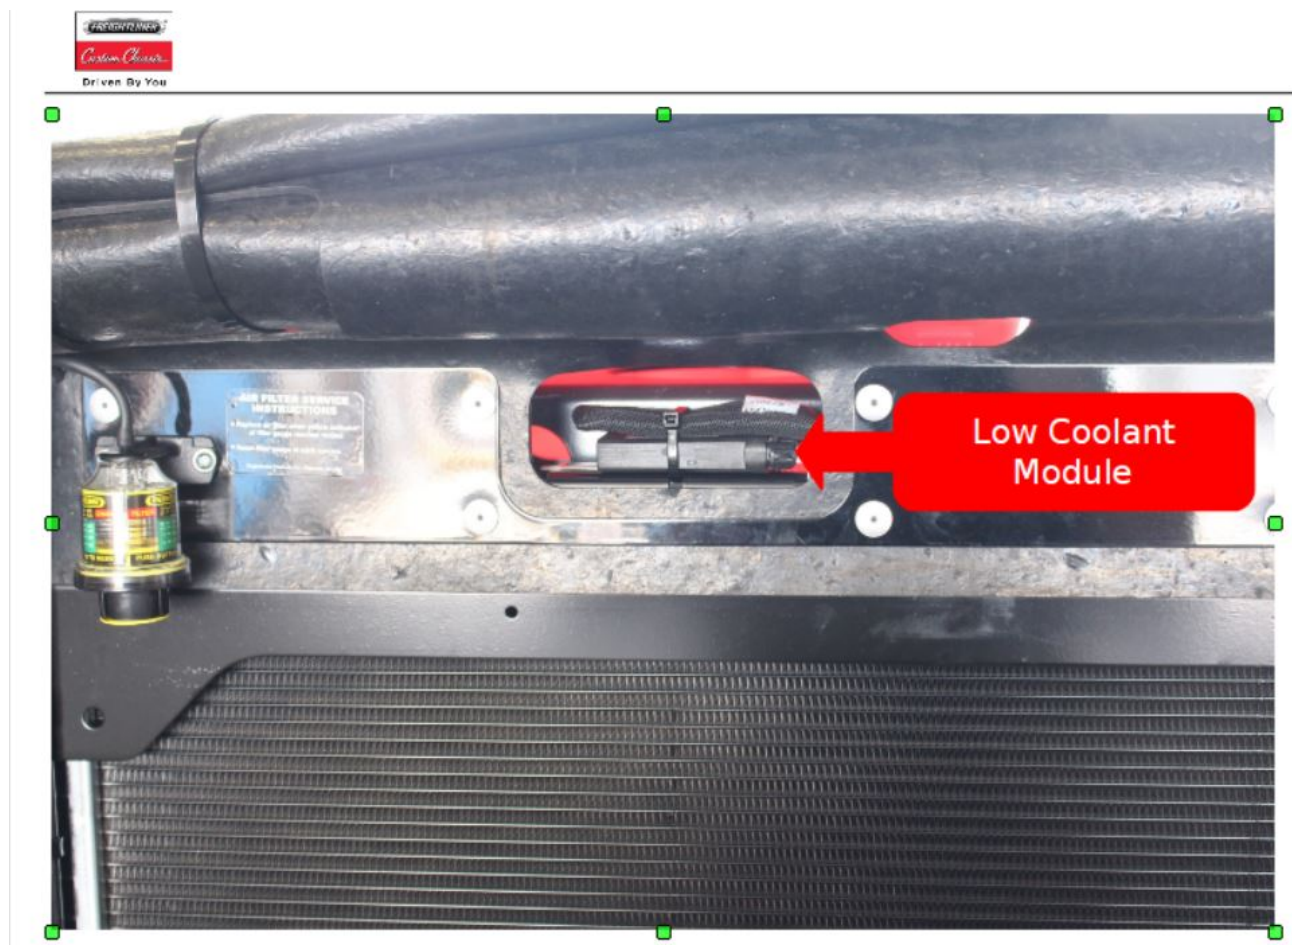
This one?

Yep! Medallian? Converts a 5 volt signal into a a/c voltage that goes into the coolant and that voltage changes when touching coolant.

can be coding due to voltage in the coolant. But 99.9% of the time a new LCL sensor and module fixes it.
