# DMM7512 7½ Digit Graphical Multimeter

## Version 1.7.16 Firmware Release Notes

Keithley Instruments  
28775 Aurora Road  
Cleveland, Ohio 44139  
1-800-833-9200  
[tek.com/keithley](http://tek.com/keithley)

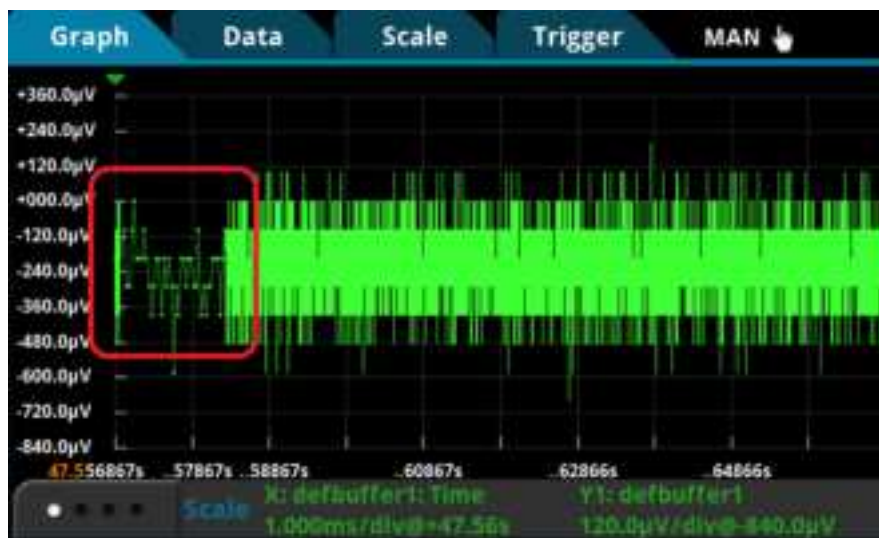
PR54974, UI graph occasionally appears to be missing digitizer data  
PR54934

When using the UI to view bursts of digitizer data on the graph, you may see areas that appear to have missing data. See the example in the image below. Even though data is being sampled consistently throughout the viewable range, it appears as though fewer points are available in the circled area.

This may only occur when more than 5,000 points are visible on the graph at once and sample rates exceed 50k.

**Workaround:**

Pan or scale the graph by touching it to force a refresh. All data will appear. The measurements were taken and are in the buffer.
