# MULTIMEDIA REPAIR GUIDE

### Touch 2 & Touch 2 with Go

This document is intended to help technicians to solve issues related to the multimedia system Touch 2 (with Go) only.

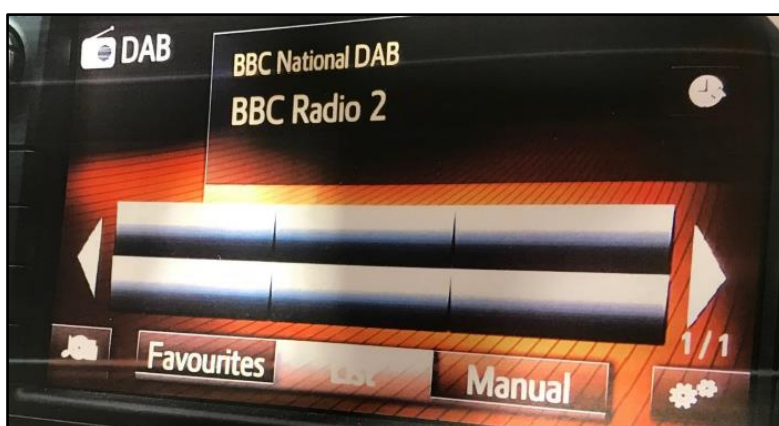
- DAB station list not showing the radio stations.
- At one point, no DAB stations are displayed but when putting the vehicle into reverse, the system displays the reversing camera, and when returning to the normal, DAB screen all DAB stations are displayed as normal.

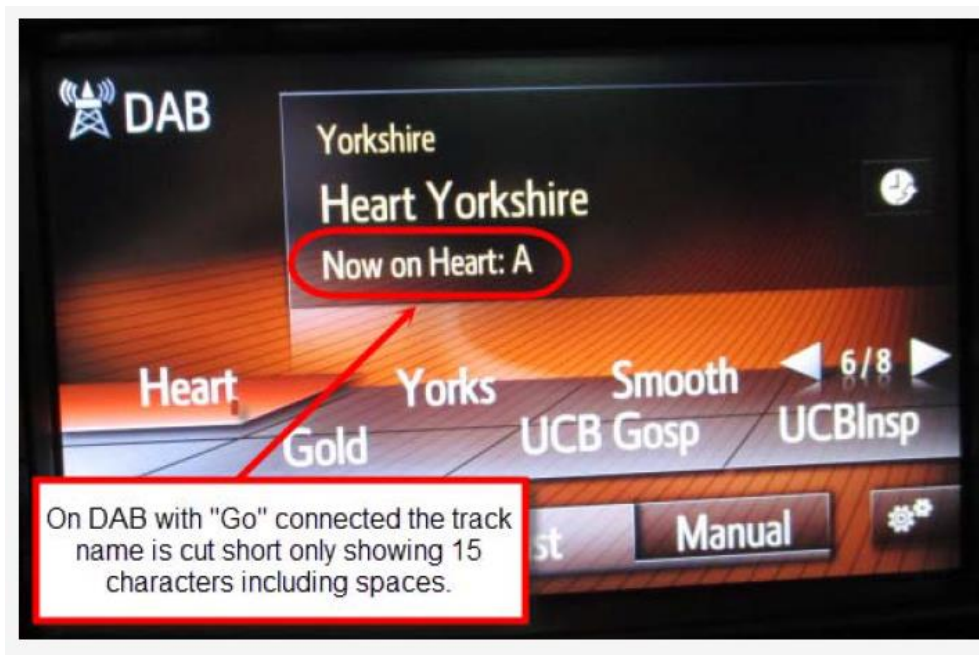
When the audio is set to DAB only the first 15 digits are shown when the track and radio show data is displayed but when using FM the full data is shown

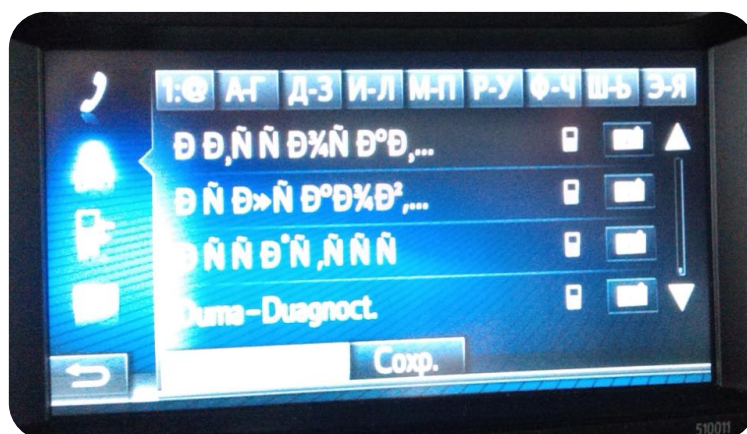
- Impossible to find contact names while using standard alphabet buttons on screen
- The phone book can't be downloaded in full volume and is saved in random order (not A-Z)
- The phone book is downloaded with unreadable names (in Russian)

TMR supposed that probable cause of the reported issue could be software, which not correctly operating with Russian letters.

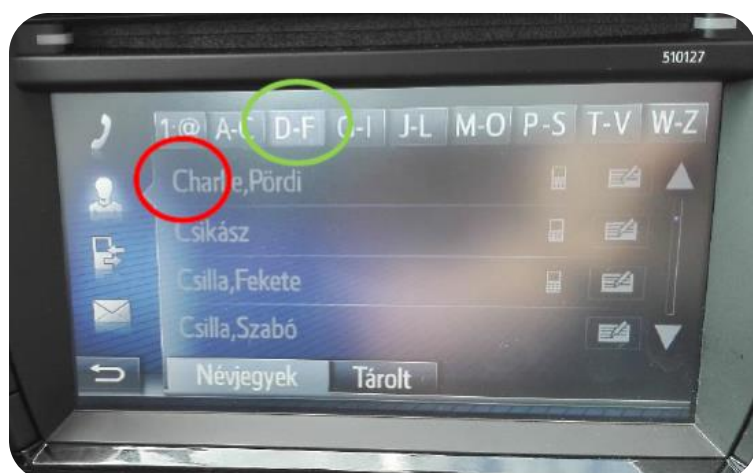
The names are in alphabetical order but when pushing a letter, the system shows names starting with previous letter.

Selected starting letter "D-F" - Listed contacts from "C"

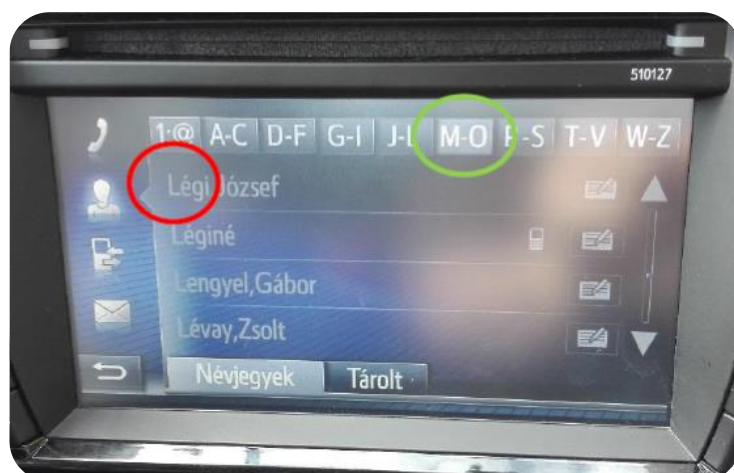
Selected starting "M-O" - Listed contacts from "L"

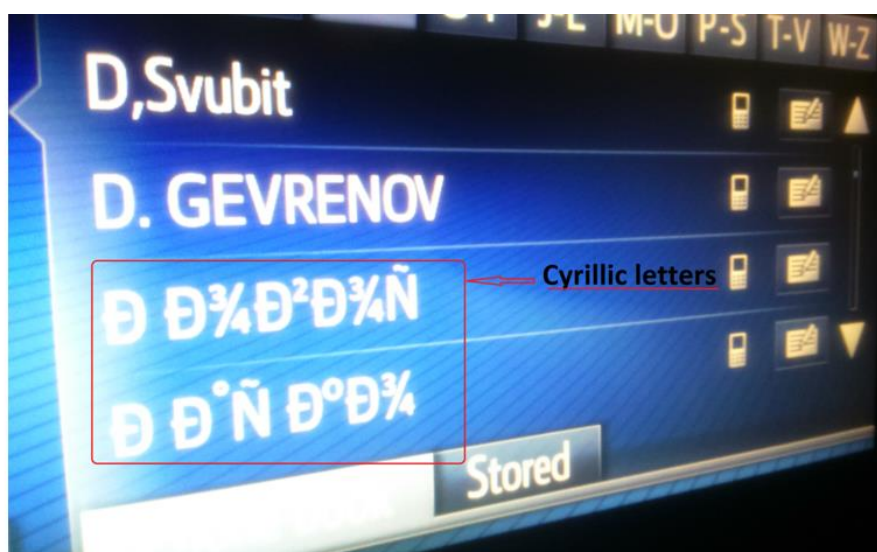
The problem is that when transferring the phonebook (with Cyrillic alphabet) from the phone to the Touch2 unit, strange symbols appeared on the screen instead of Cyrillic letters.

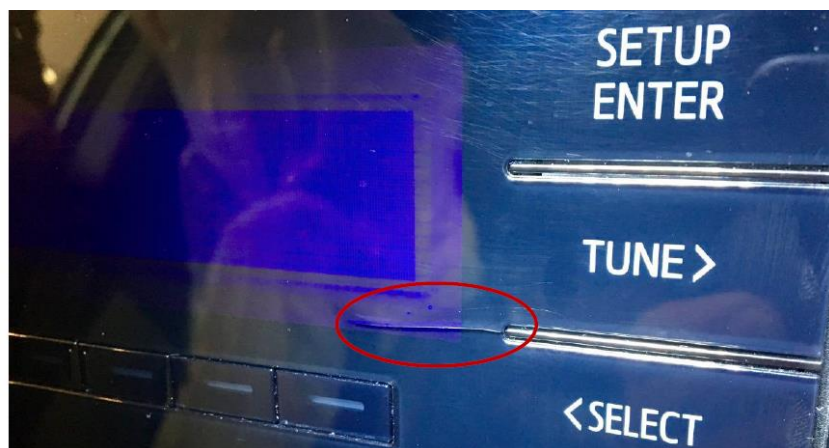
Visible crack on the radio panel starting from the area between two buttons "TUNE>" and "<SELECT".

Using chemical cleaning products can cause solvent crack on Basic Audio unit face panel at 40°C after 2 hours. If you want to clean the Display audio, please use a damp cloth.

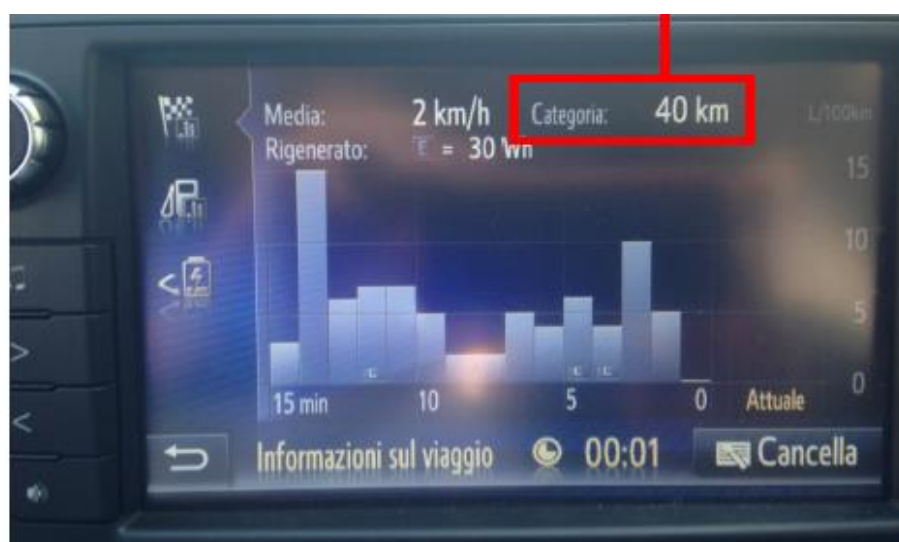
Translation errors in the "car" and "ASL" screen when language is set to Italian.

UNDER THE VIEW  
"CAR", THE TERM  
"RANGE" HAS BEEN  
TRANSLATED AS  
"CATEGORIA"  
INSTEAD OF  
"AUTONOMIA"

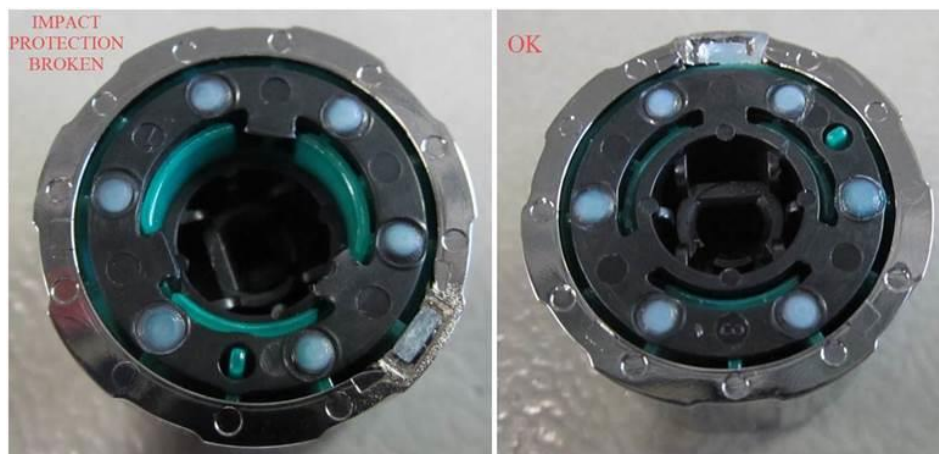
This phenomenon may be due to a break of the impact protection of the volume knob.

Replace the knob button.

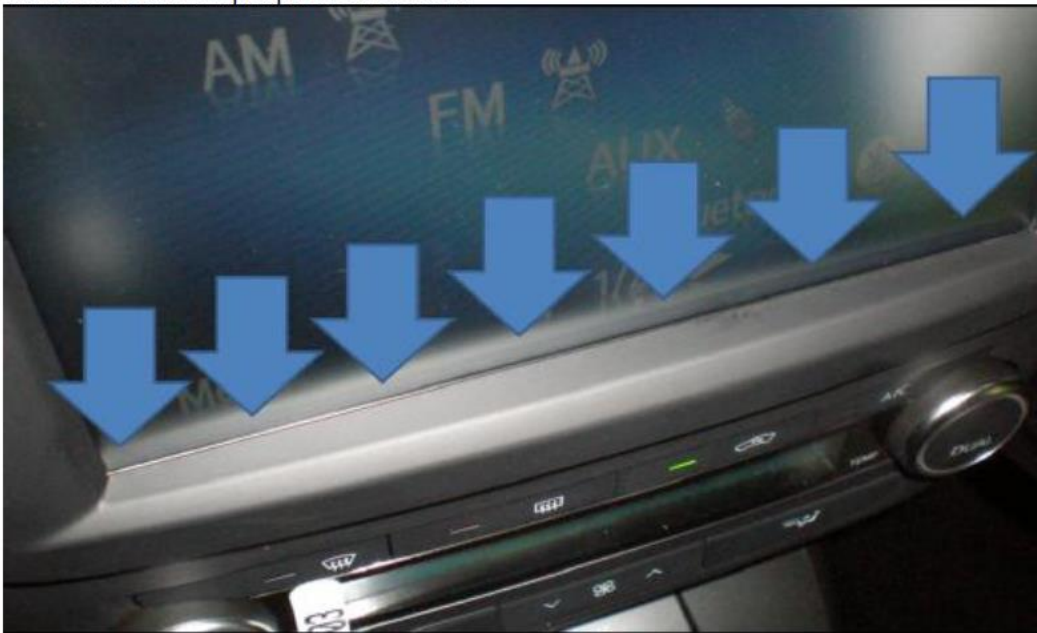
### STEP 2: Visually check claimed vehicle for any obvious signs of contamination.

Use lint-free cloth to wipe clean display and Center Cluster Finish Panel completely from contaminations.

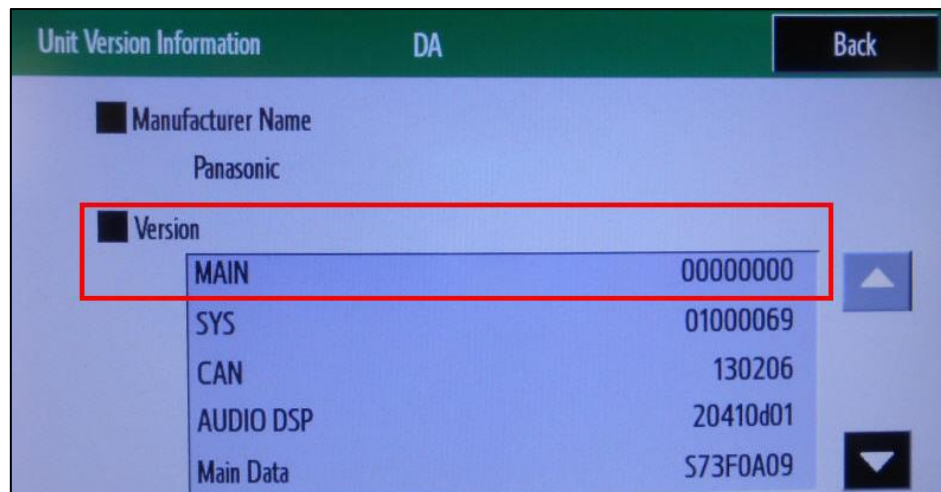
Display Audio software version is zeroed: Software version “00000000” is shown.

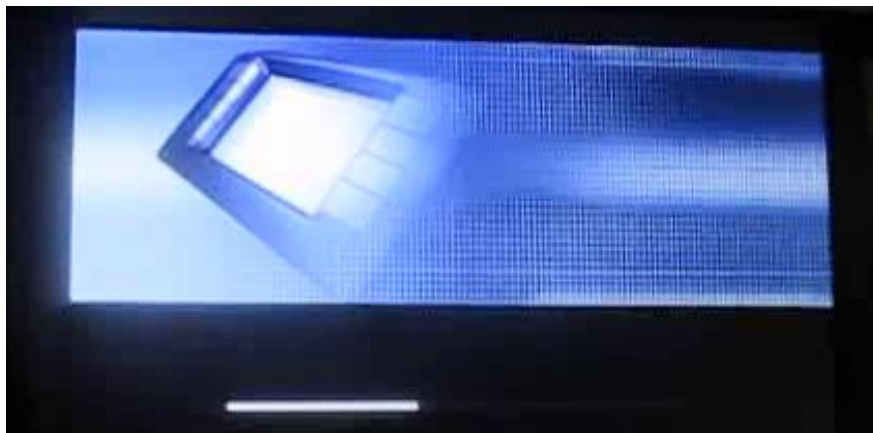
- Loading screen is continuously loading
- "HYBRID synergy drive" logo can appear
- Buttons on touch screen are inoperative

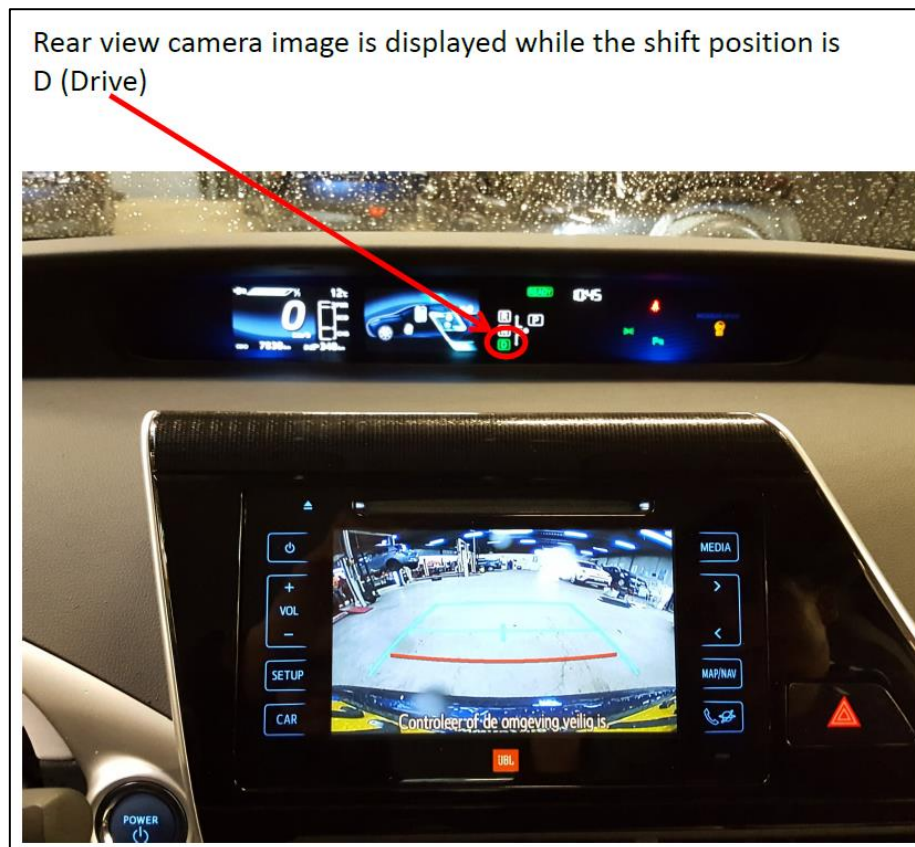
While driving with the shift position in D (Drive), the rear view camera image is displayed on the Touch 2 with Go Plus system.

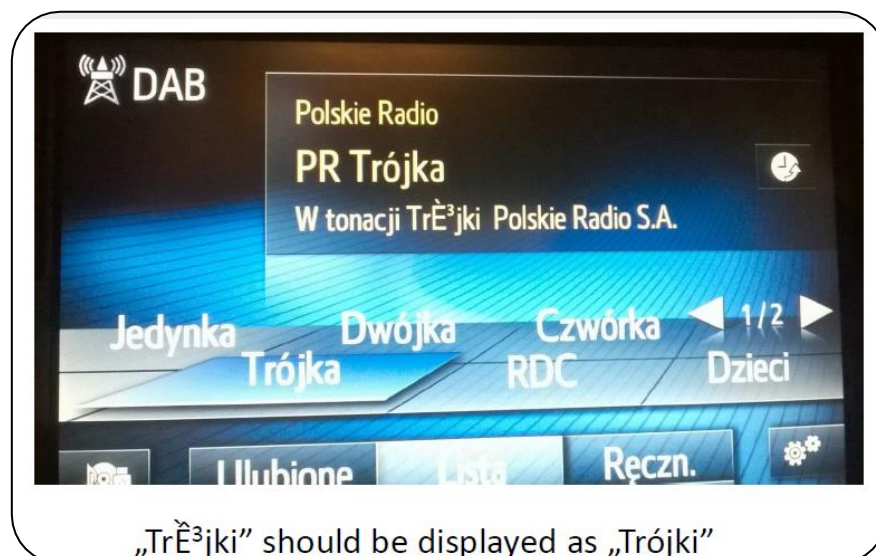
There are polish native letters (diacritical signs) missing in the radiotext field while listening to DAB radio stations.

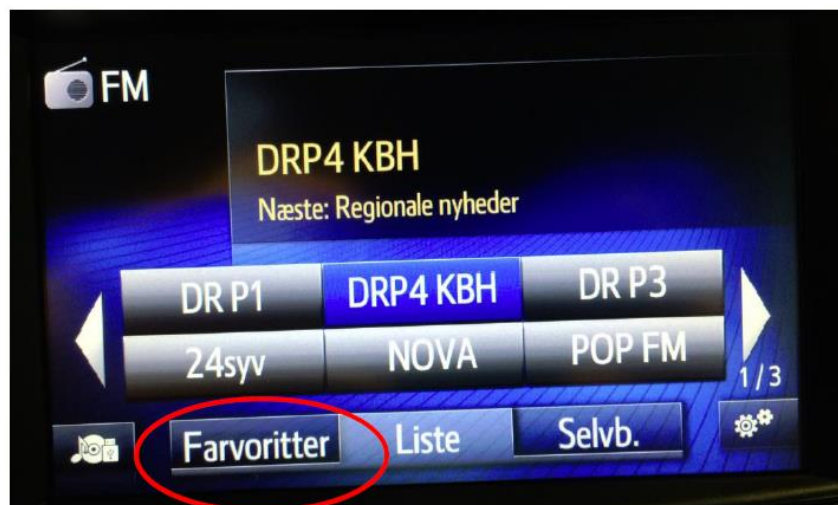
There is a spelling mistake in the audio, “Farvoritter” is not correct Danish

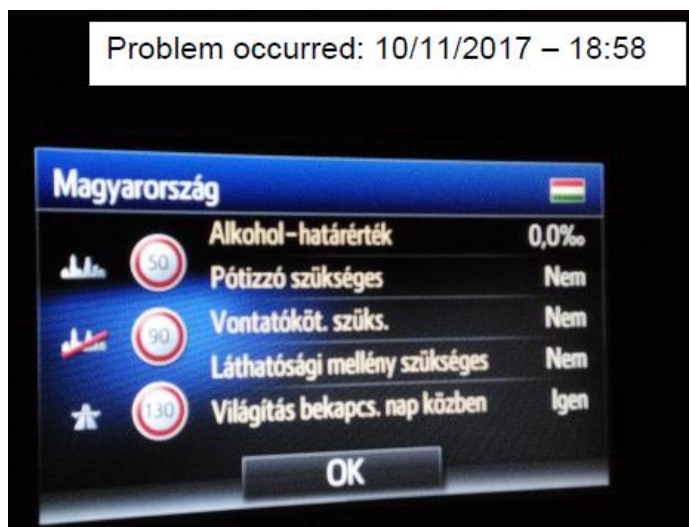
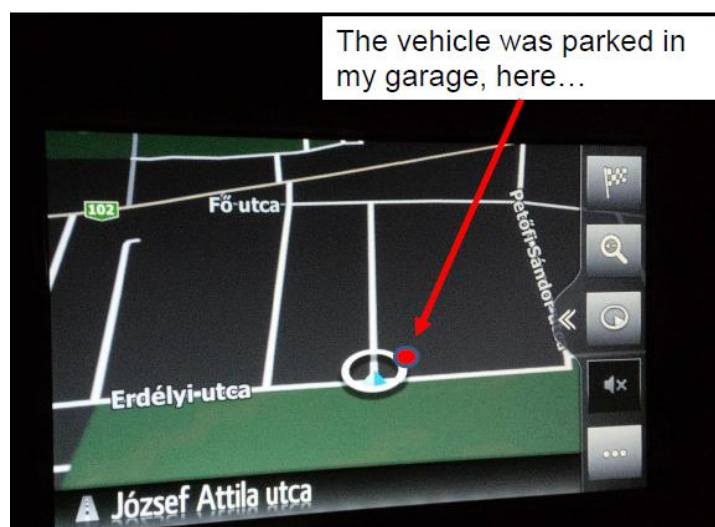
The above problem occurred at several location on the headline vehicle after updating the navigation software and database to the latest one (6.10.0WL)

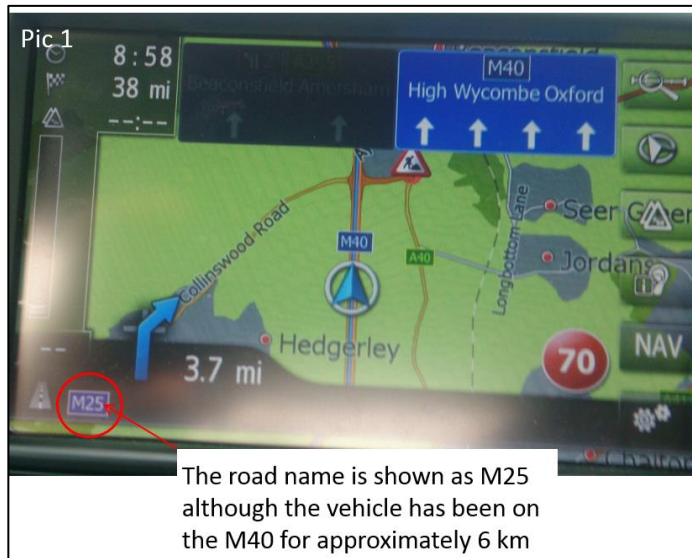
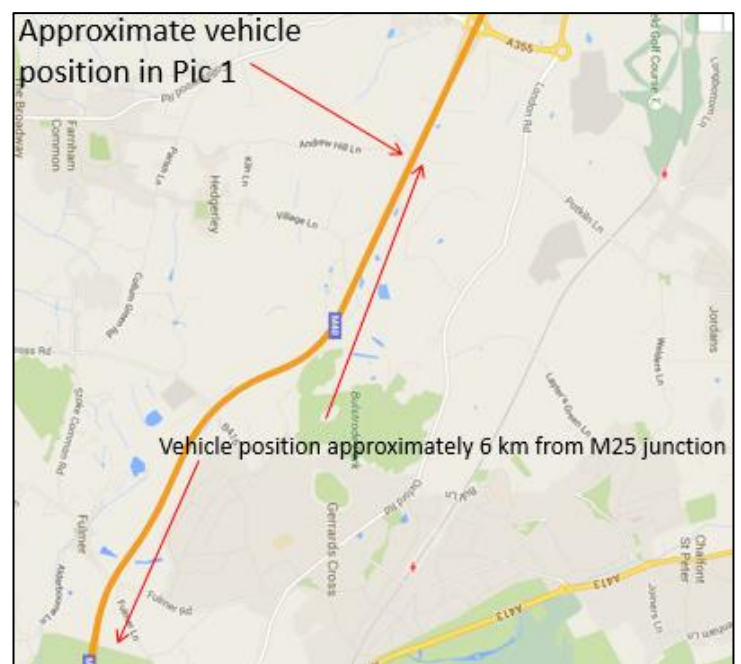
When changing road the navigation system is slow to change the name at the bottom of the screen on certain roads. Please see the attached videos for a better understanding.

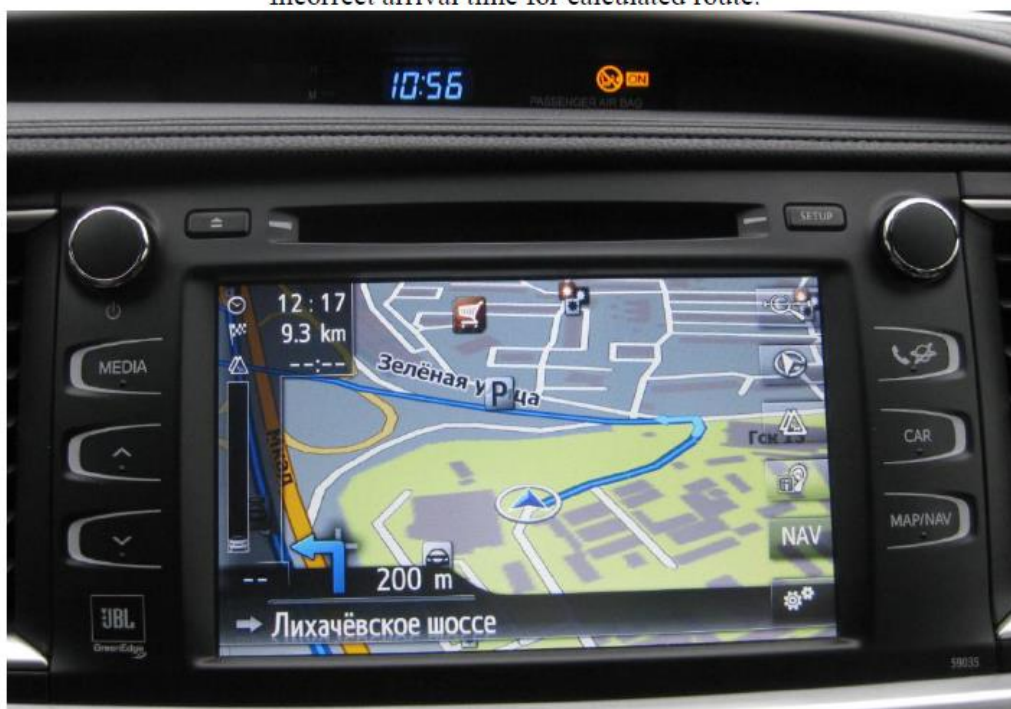
Incorrect arrival time for calculated route.

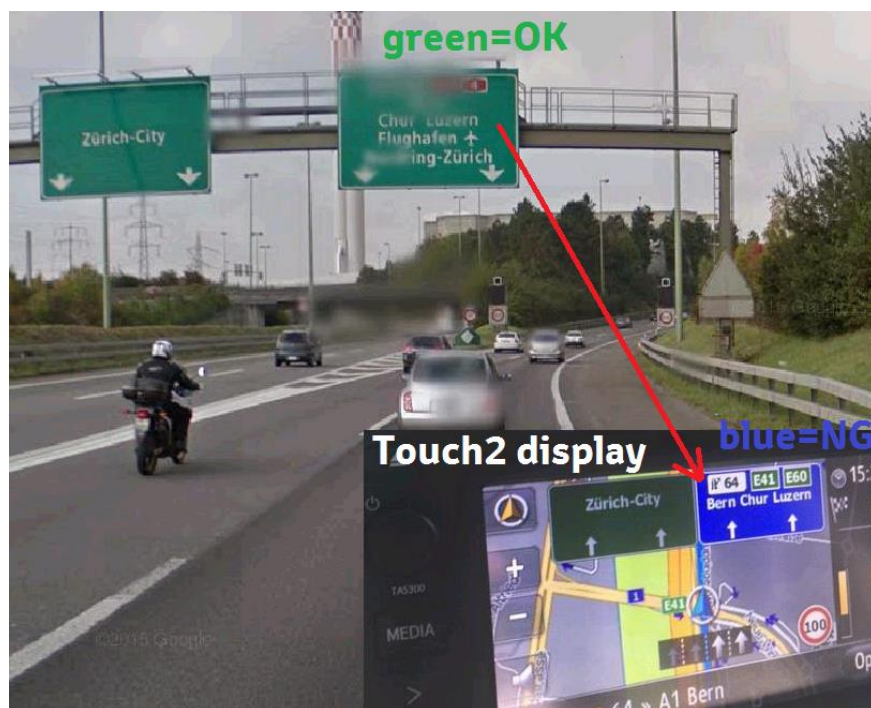
The Swiss Highway indication board are green. When programming Touch2Go, driving on the highway and having to take a crossing highway, the system displays the crossing highway with a blue panel as an exit, but it's an intersection (not an exit).

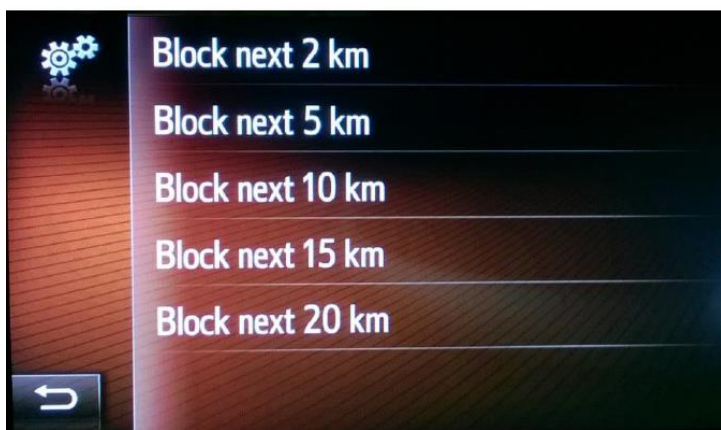
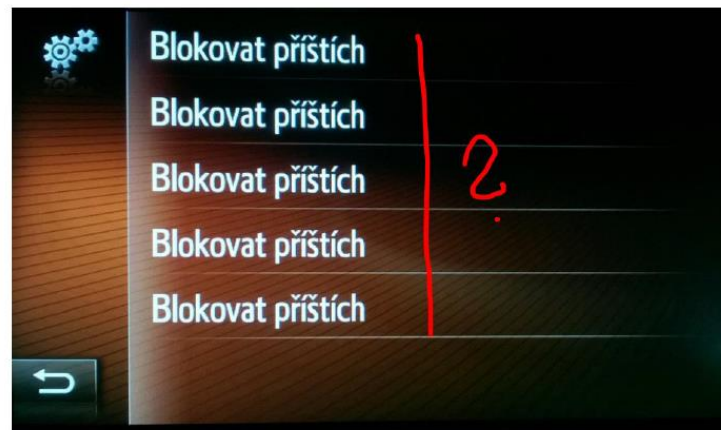
In the Czech version of the menu, the distance indicating how much road ahead to block is not shown. This distance is present in e.g. the English menu.

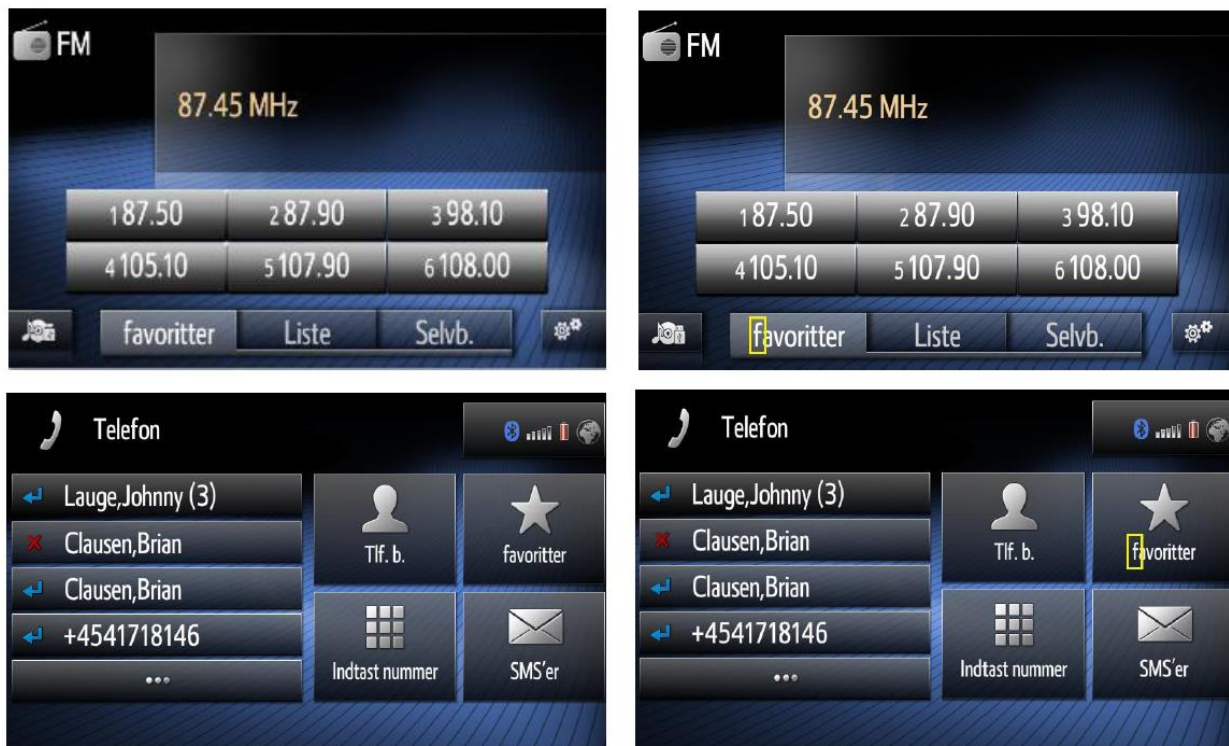
In every menu where the word favorite or favorites are displayed, the word is spelled with small “f” instead of big “F”.

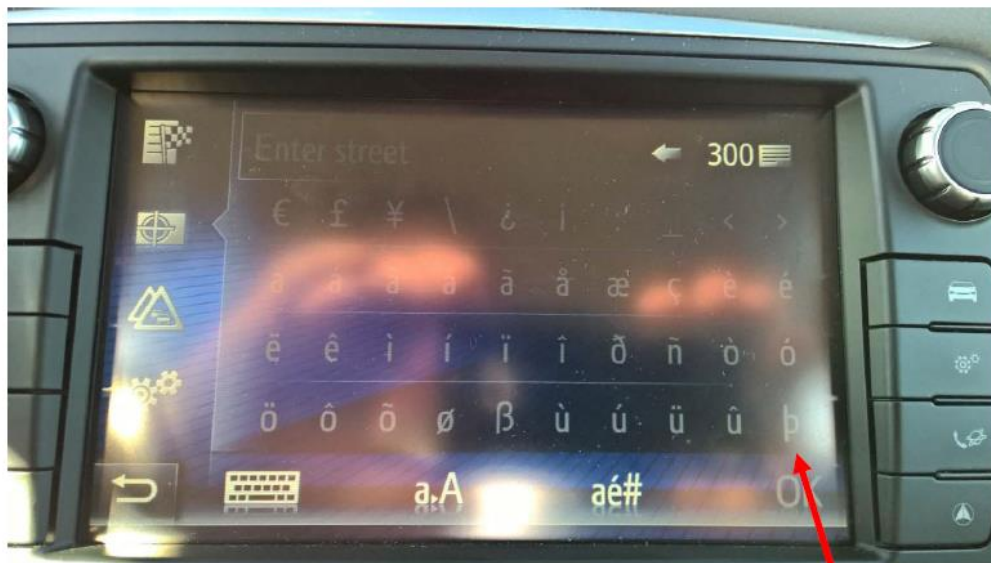
When searching a street beginning with the specific letter, the letter is unavailable. The letter is there but it is “shadowed” and cannot be selected, even if street names beginning with the letter are clearly listed when viewing postal code street-list.

**Regardless of search-criteria used, „þ“ is never available as first letter (always shadowed) when searching for streets. Streets beginning with letter „þ“ are clearly listed in when postal-code streetlists are viewed**

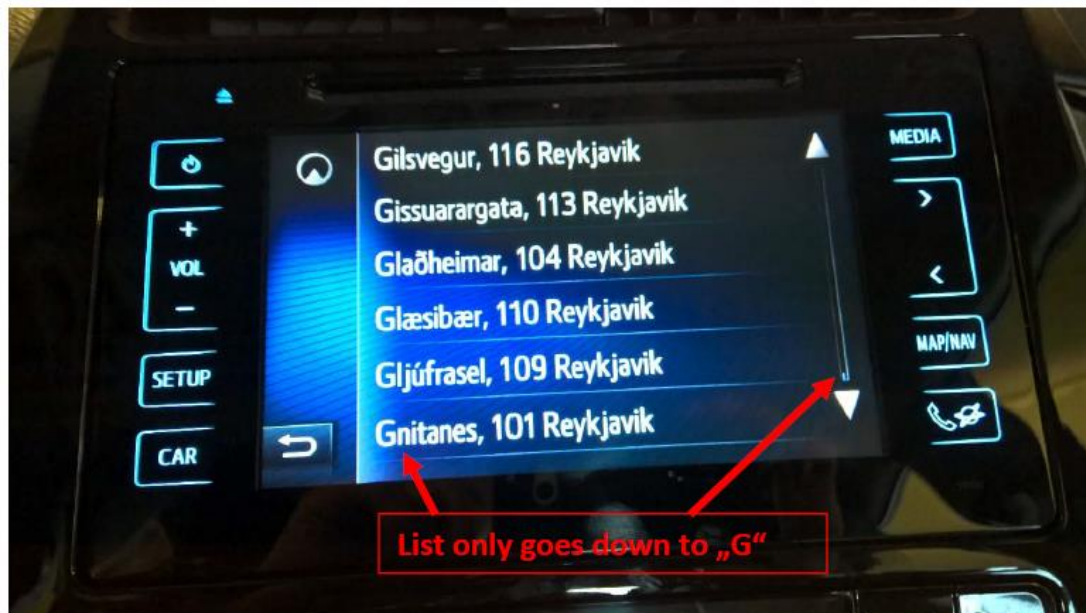
Furthermore, when “REYKJAVIK” is input to the system and street list is called up, it only shows street names from “A-G”. Street names from “G-Z” are not listed.

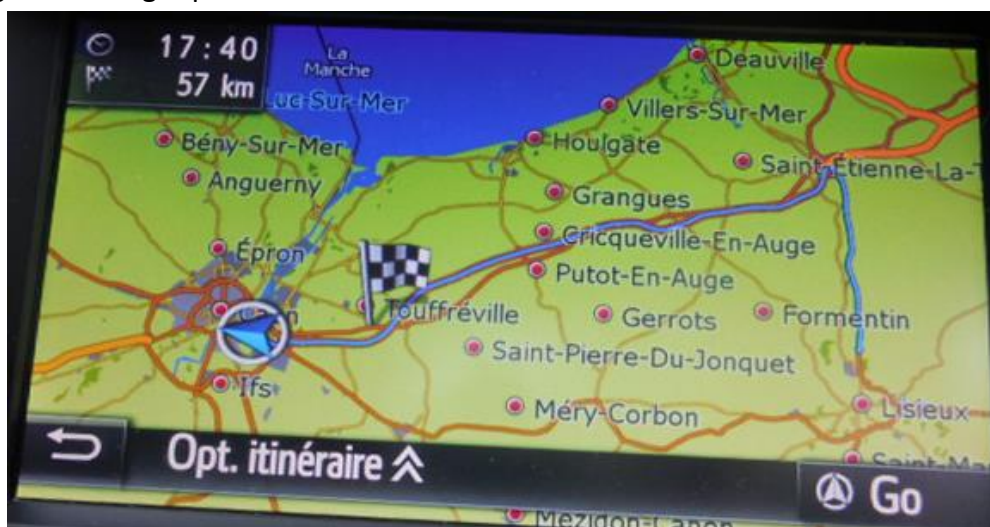
The flag is at the right place but the route is false.

This issue only happens for specific destinations in England, France and Spain.

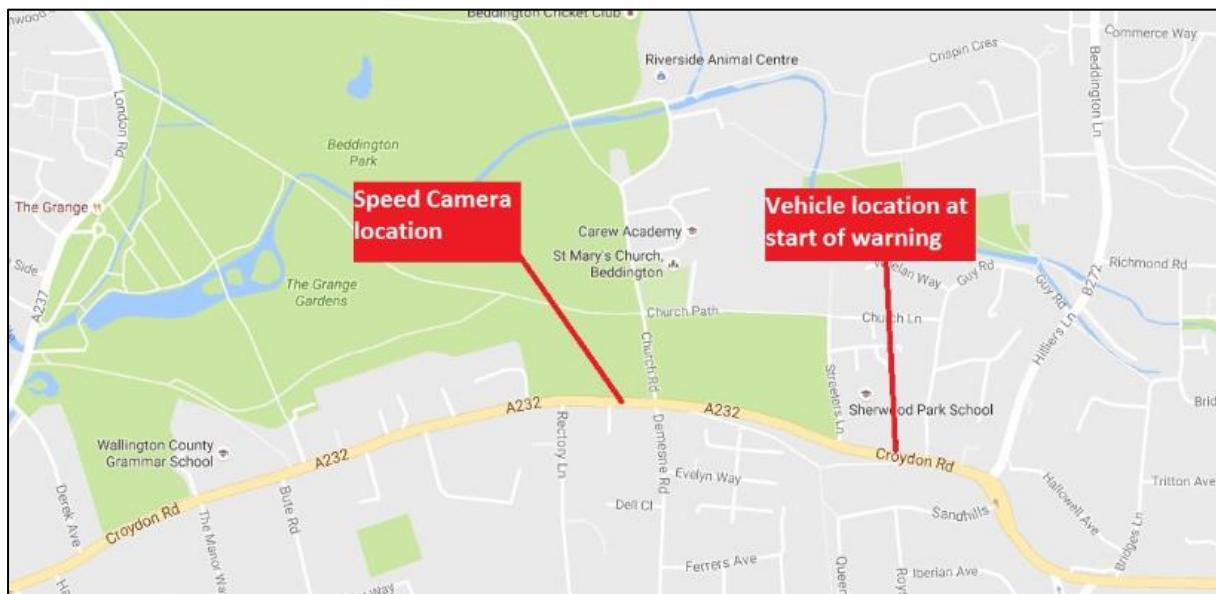
When approaching a speed camera, the speed camera sound warning/notification happens repeatedly, instead of the single 'beep' warning.

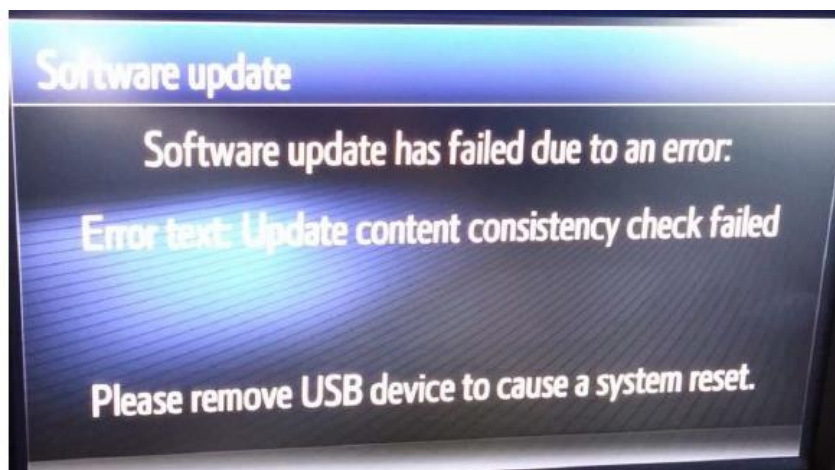
When trying to update the Navigation Software (Extension Box) with 4.4.1WL, update fails and error message appears:

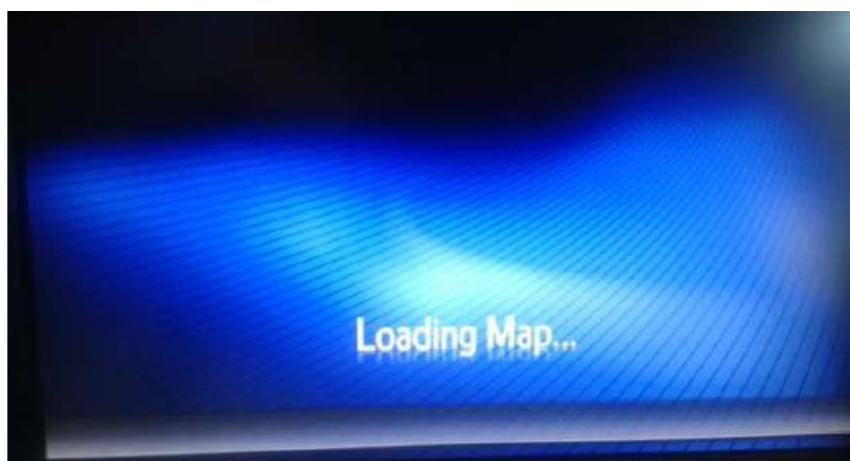
However, when trying to check the function of the navigation, it is impossible to load the map. Display stays on "Loading map", the map doesn't load.
