# SK® 62TE

Fits: 62TE 2007-17

## Corrects / Prevents / Reduces

TCC Slip/Shudder, Overheating, Drainback,  
Delay or No Forward or Reverse, Coasting  
6-5 UD Apply Clunk or 4-2 L/R Apply Clunk

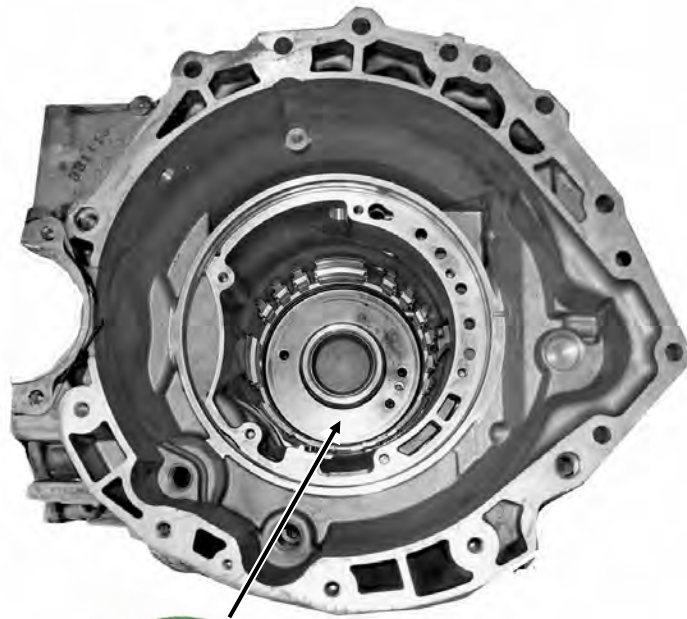
If housing is bent or has damaged holes from over tightening of retaining screws. Replace it!

TCC Control Solenoid often fails causing "Chugs" or "Kills" engine at stop. Replace it.

Install New **Non Shrinking** Gasket.

**After every repair:** Always clear codes and reset the VLP Line Pressure Counter which is found under the Special Functions tab.

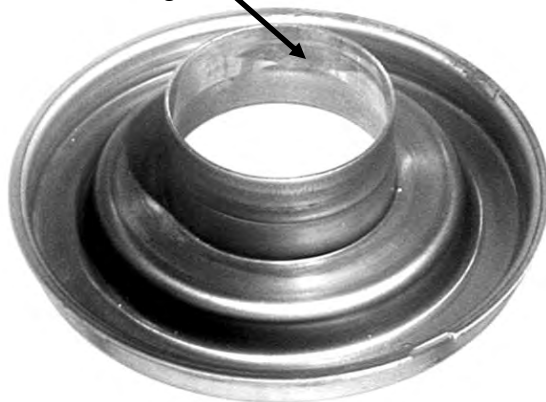
Close inspection of Underdrive piston bore will often show wear and a ridge where the piston has rubbed against the seal groove in the input hub. This ridge nibbles the seal and the wear causes a cold leak.

With a worn piston or a cut seal there will be a delay or no forward cold and sometimes limp-in on cold startup into drive until the seal warms and becomes more pliable.

Also, during a long run in 4th the seal relaxes and can fail to re-seal quickly on a 4-3 coast downshift between 28 and 19mph. The computer sees the delayed apply by watching the speed sensors and places trans in limp.

Inspect piston here  
for wear and ridge.

A temporary solution is a new piston. A better fix is to install this quality self expanding seal that is pliable enough to seal into worn area and tough enough that the ridge won't cut it. Install it with confidence.

**PLEASE:** Don't hone, sand, scrape, polish or try to fix the piston in anyway. Leave it as-is. If it's really bad, replace it and use the new expander & seal for a long term fix.

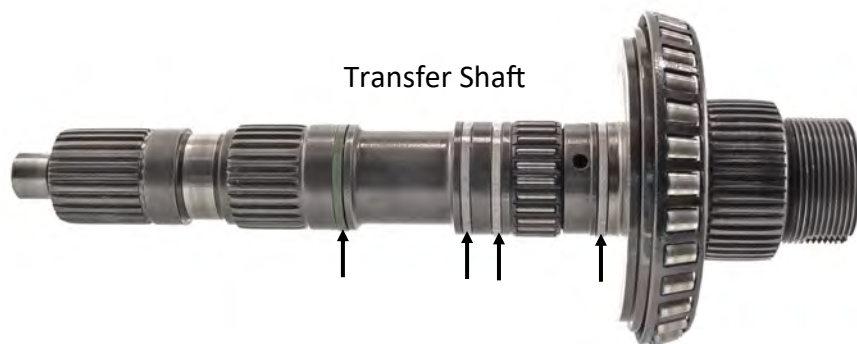
These 4 rings like to shrink dumping lube oil that can lower main line and accelerate ring land wear on the low clutch housing. 68018615AA

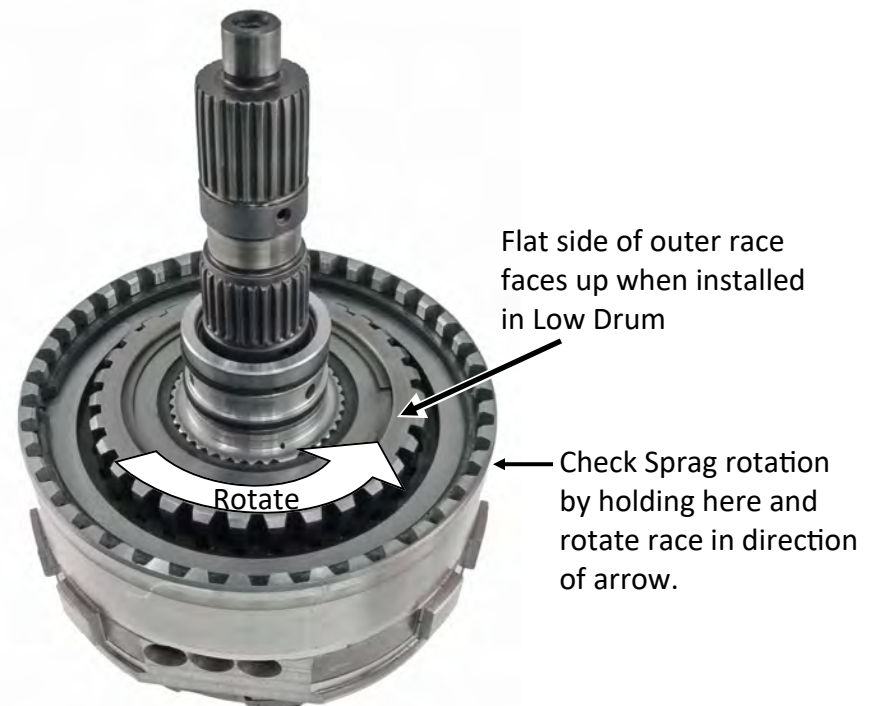
Early rotating rings usually destroy the ring grooves on low clutch housing. Later housings are notched for non rotating rings 05078800AB OE rings air check great and work excellent in these notched housings. 20-25 psi of regulated air must apply direct clutches on the bench, don't assemble unit until they do!

**Updating** the Low Clutch Housing to the latest Non-Rotating Ring type housing during overhaul is an great way to prevent rework due to ring groove damage. Even though it may not be damaged at time of overhaul, be warned, it does have a known high failure rate. Remember the customer pays for the parts now, you have to pay for them later.

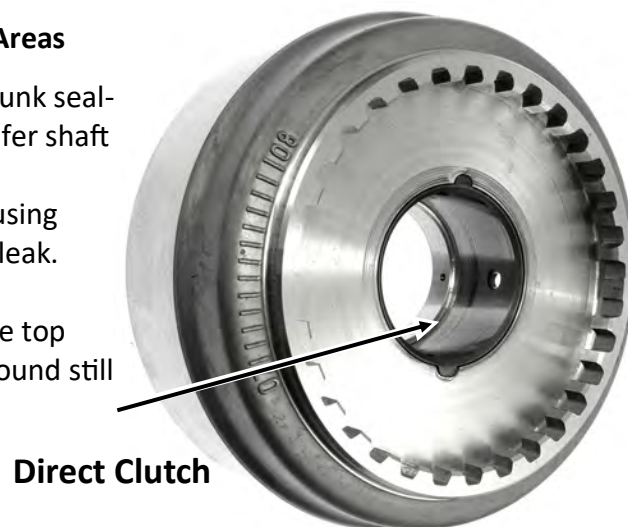
### Compounder Wear Areas

Loss of lube from shrunk sealing rings on the transfer shaft will accelerate wear on the ring tower causing Direct Drum rings to leak.

With severe wear, the top sealing ring may be found still in the drum here.
