# Pico 5161PT 1/8" ID Vacuum Line Tubing Instruction Manual

Model: 5161PT

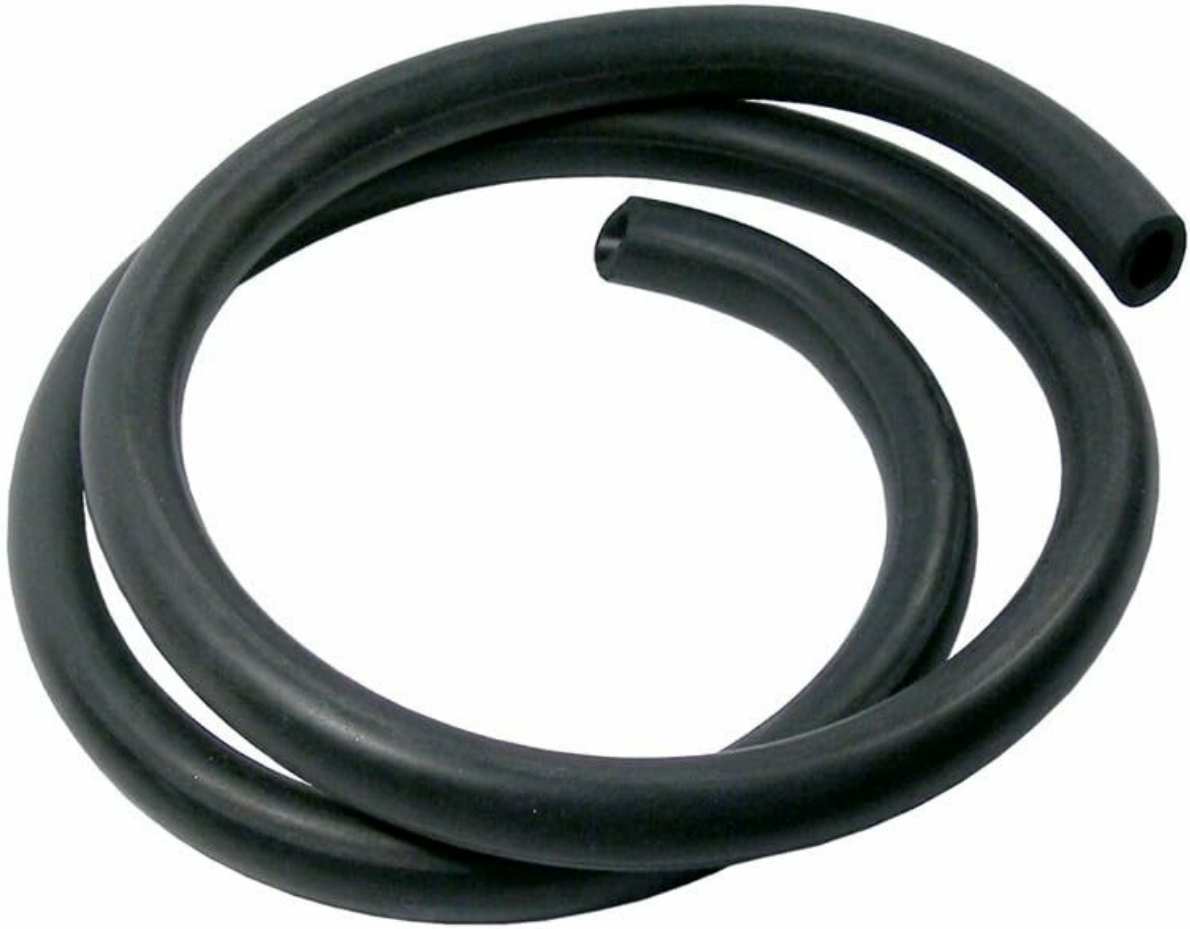
An image showing the black Pico 5161PT 1/8 inch ID Vacuum Line Tubing, coiled or packaged, highlighting its appearance and length.

<b>Brand</b>	Pico
<b>Model Number</b>	5161PT
<b>Material</b>	Plastic
<b>Color</b>	Black
<b>Internal Diameter (ID)</b>	1/8 inch
<b>Nominal Wall Thickness</b>	0.125 inch
<b>Item Length</b>	6 Feet
<b>Item Weight</b>	3.2 ounces
<b>Operating Temperature</b>	-40°F to 212°F (-40°C to 100°C)
<b>Manufacturer</b>	Pacific Industrial Components
