# Mueller Industries 511-706BG Galvanized Union Instruction Manual

Model: 511-706BG

## 1. PRODUCT OVERVIEW

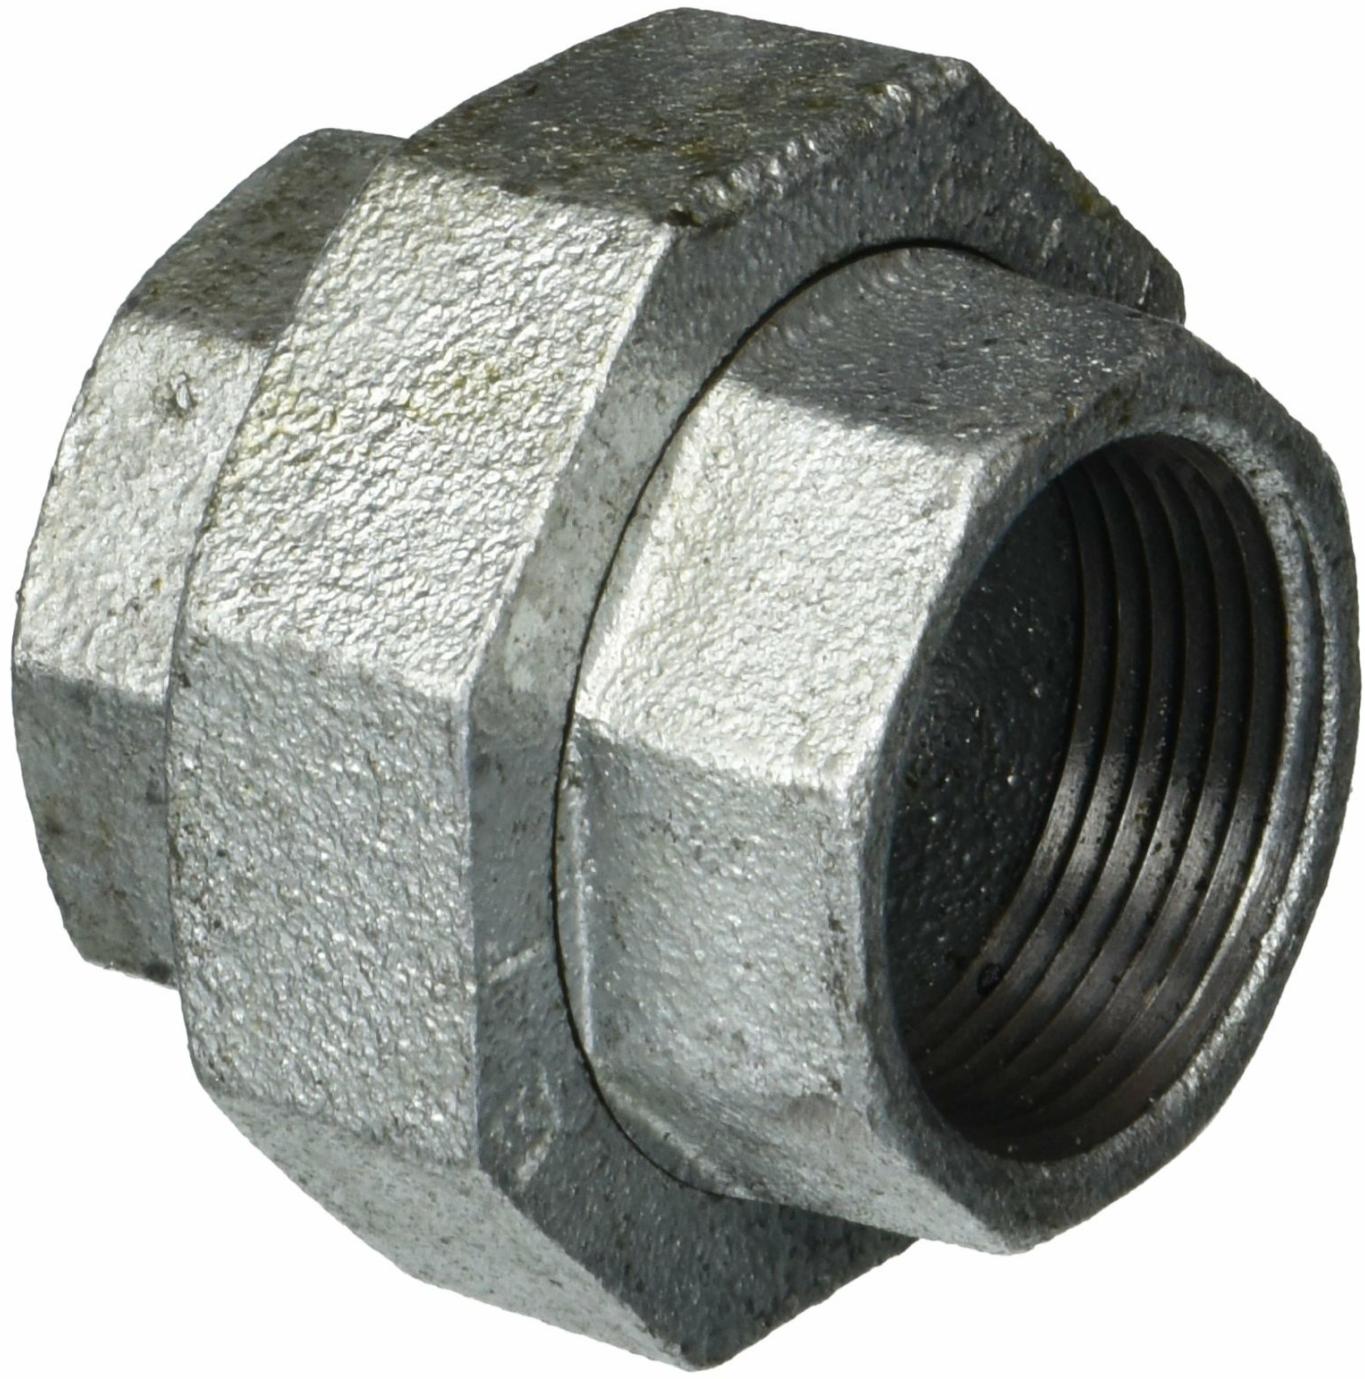
**Figure 1:** Mueller Industries 511-706BG Galvanized Union. This image displays the complete union fitting, consisting of three main parts: two threaded end pieces and a central nut, designed to connect two pipes.

The Mueller Industries 511-706BG is a 1-1/4 inch galvanized union pipe fitting. This component is designed for use in rough plumbing, pipe, and conduit accessory applications, providing a secure and detachable connection between two pipes. It is constructed from durable iron and features NPT (National Pipe Taper) threads for a reliable seal.

- Assemble Union Components:** The union consists of three parts: two threaded end pieces and a central nut. Thread one end piece onto each pipe.
- Align and Connect:** Bring the two pipe ends with their respective union pieces together. Ensure proper alignment.

A union fitting serves to connect two pipes while allowing for easy disconnection without having to rotate either pipe. This is particularly useful in plumbing systems where components may need to be removed for maintenance or replacement. The three-piece design (two threaded ends and a central nut) creates a strong, leak-proof joint that can be assembled and disassembled repeatedly.
