# Dorman 800-608 Transmission Line Connector User Manual

Model: 800-608

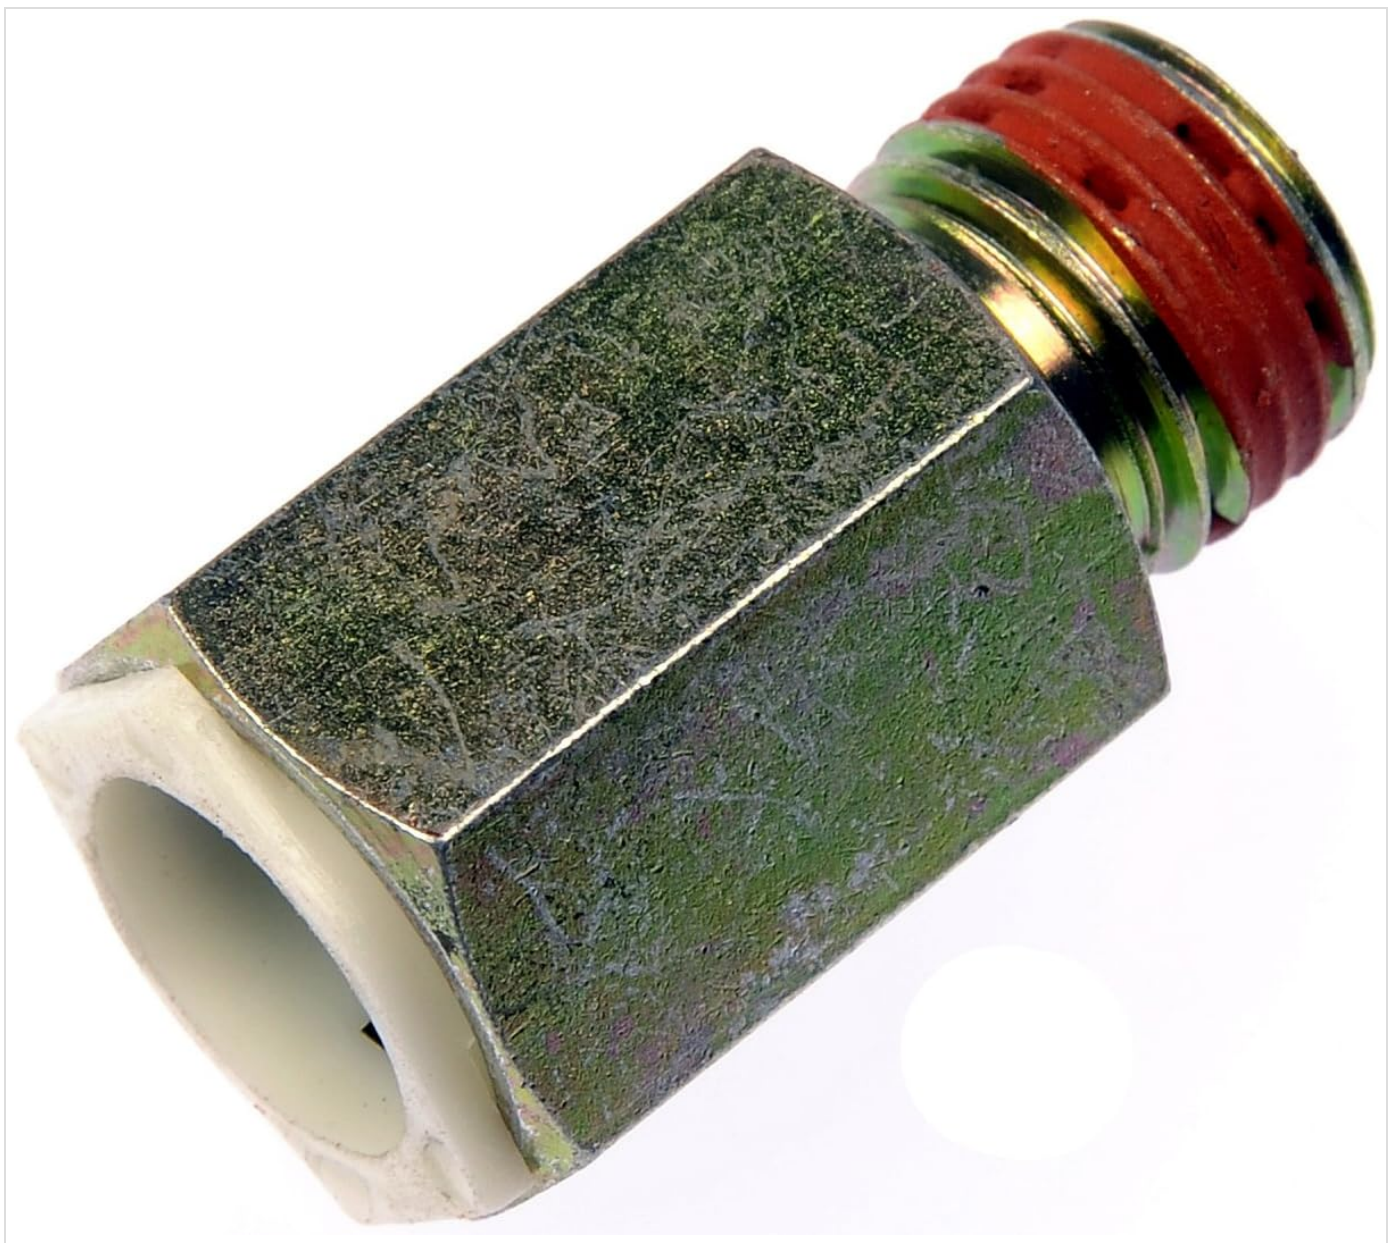
Figure 1: Angled view of the Dorman 800-608 Transmission Line Connector. This image shows the hexagonal body for wrenching, the threaded end with sealant, and the tube insertion end.

The Dorman 800-608 is a direct-fit replacement transmission line connector. It features a 5/16 inch tube connection on one end and a 1/4-18 inch thread on the other, designed for specific vehicle applications.

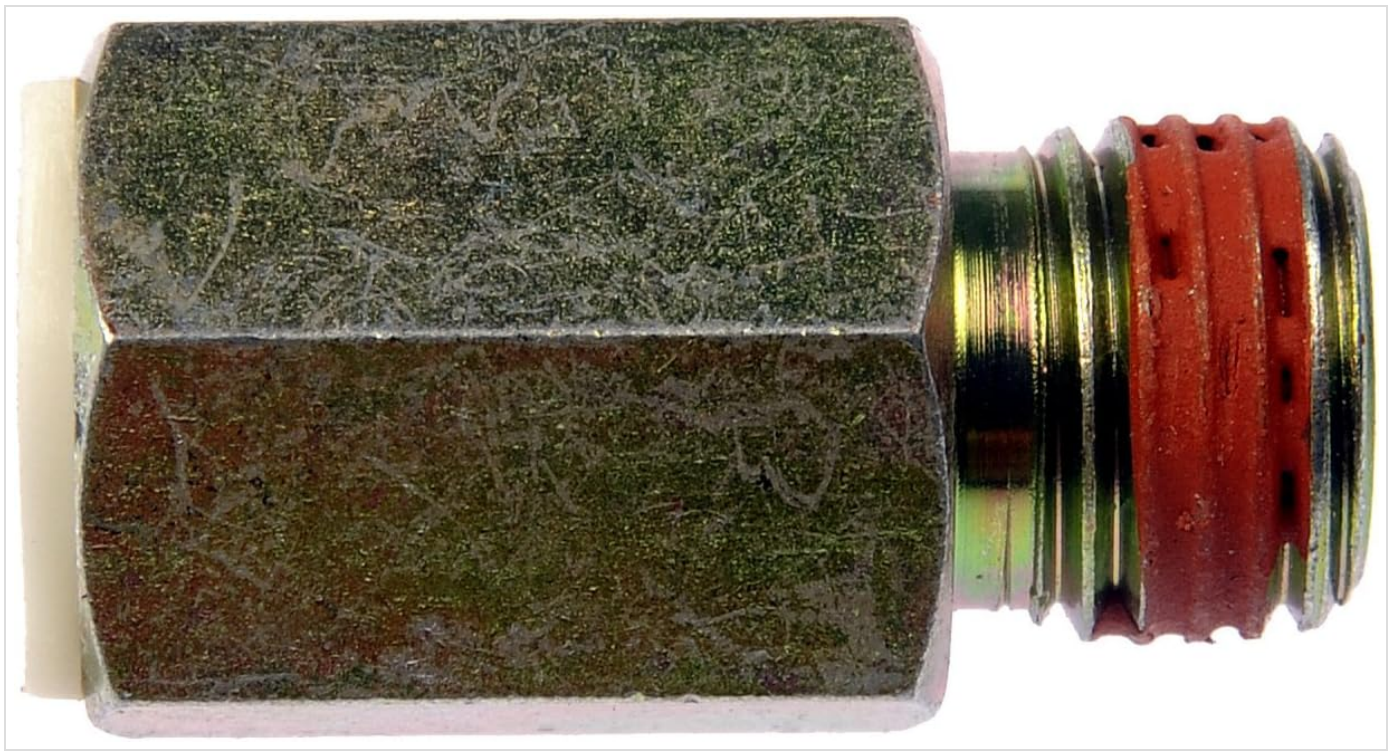
Figure 2: Side view of the Dorman 800-608 Transmission Line Connector. This image highlights the full length of the connector, detailing the threaded section and the tube connection point.
