Dorman 520-203 Front Driver Side Lower Suspension Control Arm and Ball Joint Assembly Instruction Manual

Model: 520-203 | Brand: Dorman

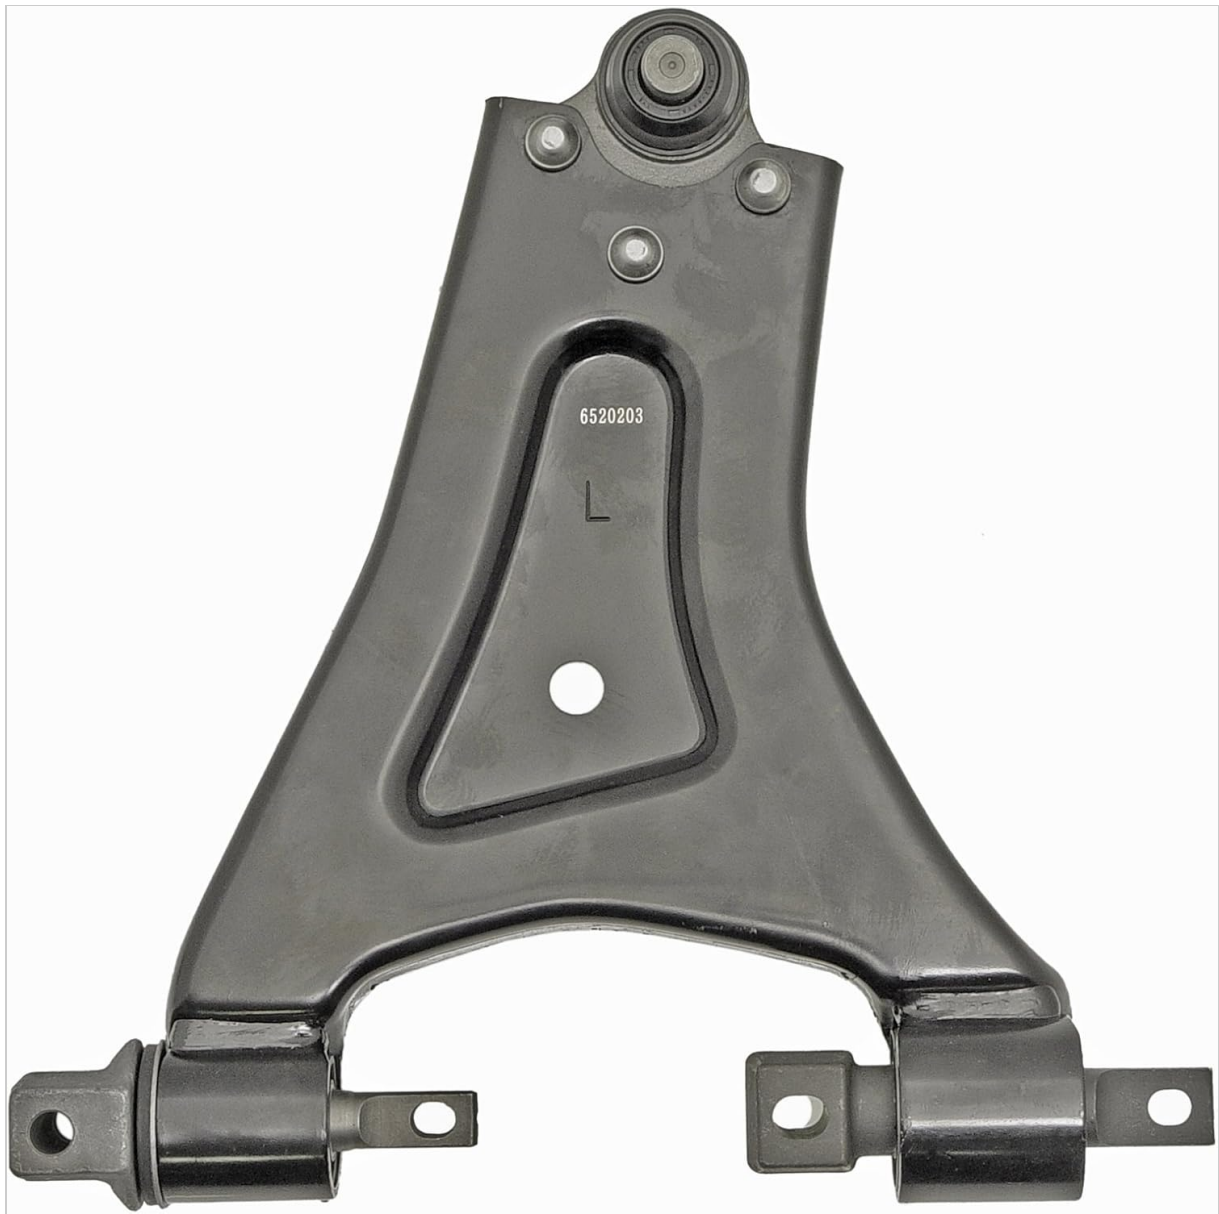
Figure 2.1: Dorman 520-203 Control Arm Assembly, main view. This image shows the complete control arm with its integrated ball joint and bushings.

The Dorman 520-203 control arm assembly is engineered to restore the vehicle's suspension performance. It includes pre-installed ball joints and bushings for a complete repair solution.

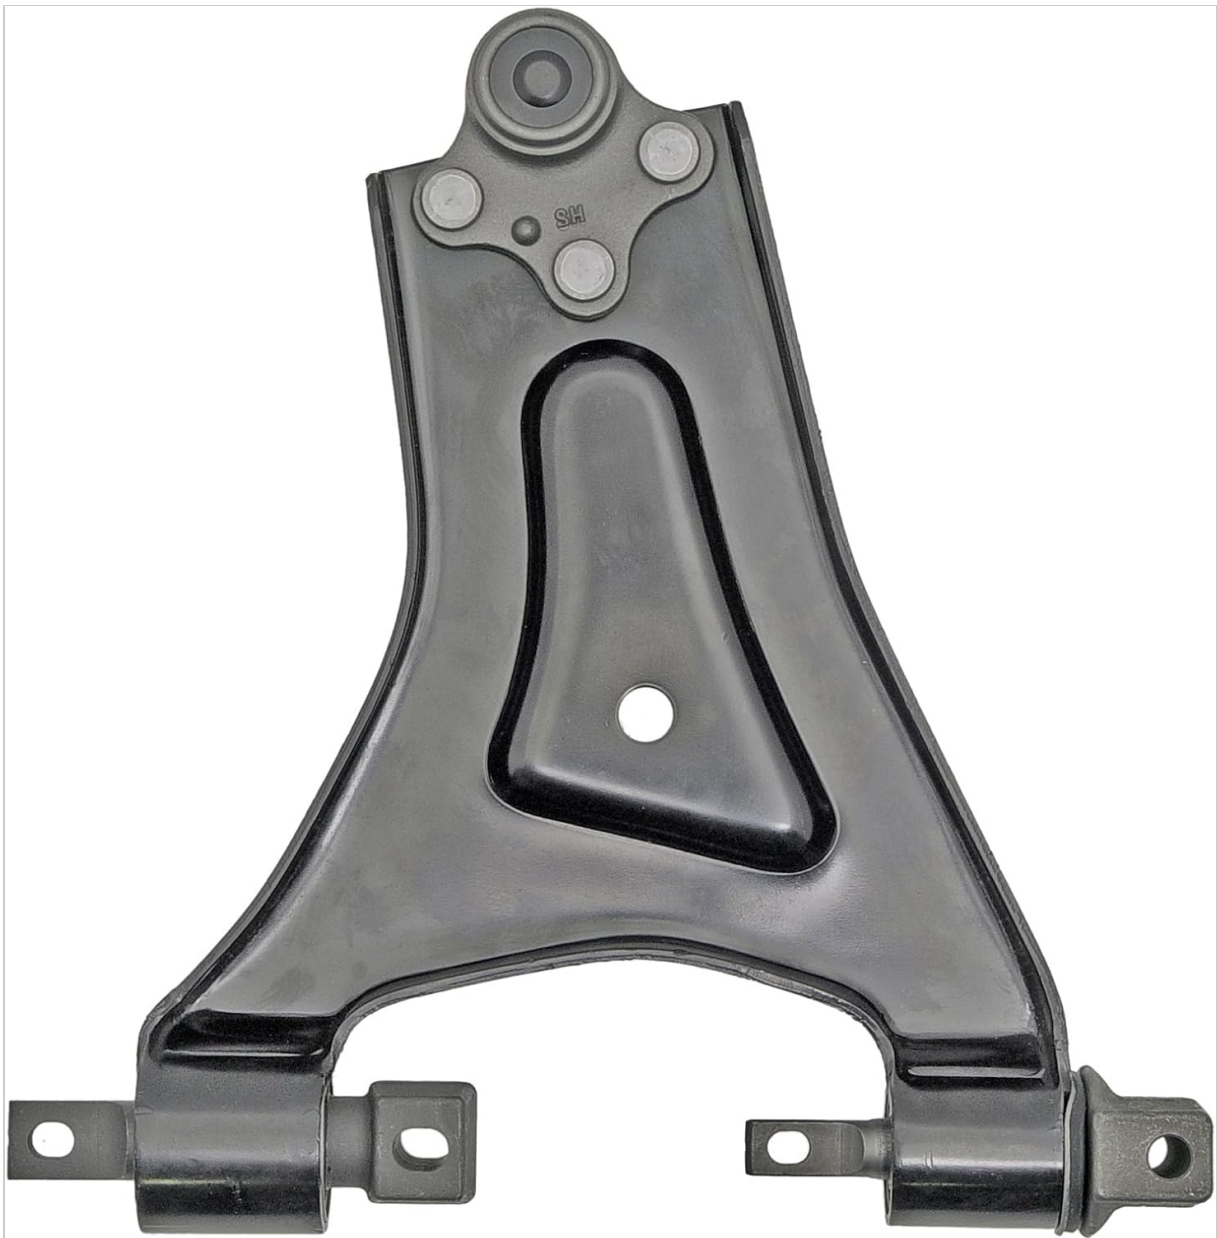
Figure 2.2: Dorman 520-203 Control Arm Assembly, alternate angle. This view highlights the structural design and attachment points of the control arm.
