Sierra International 18-2345-9 Driveshaft Bearing E-Ring Instruction Manual

Comprehensive guide for installation and maintenance of your Sierra International Driveshaft Bearing E-Ring.

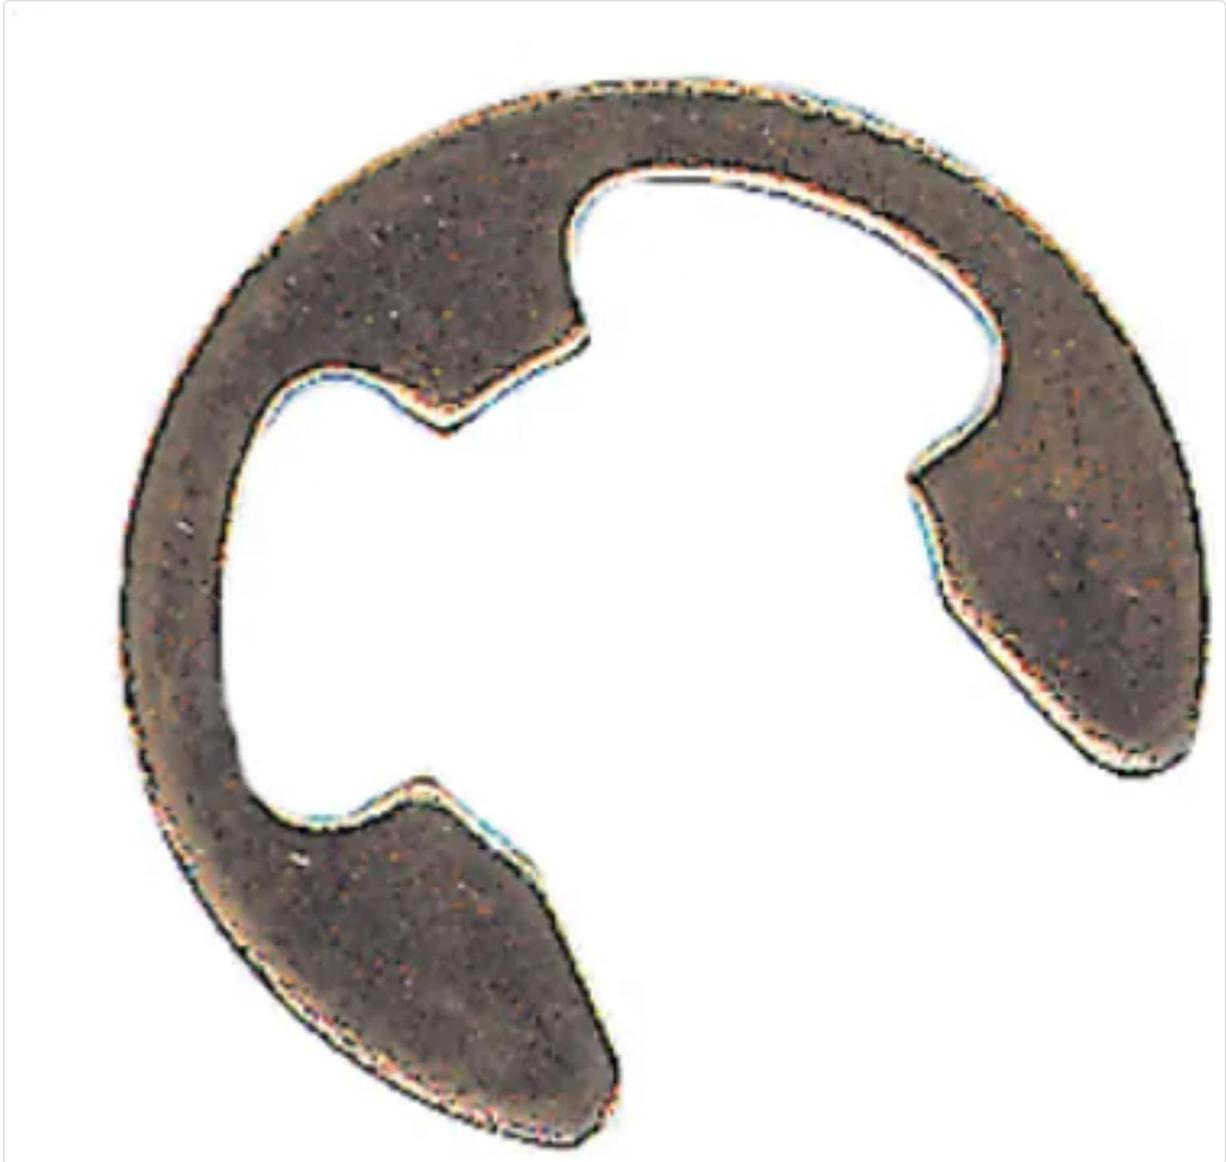
Figure 1: Sierra International 18-2345-9 Driveshaft Bearing E-Ring. This image shows the C-shaped metal clip, which is essential for securing components in a driveshaft assembly.

Before installation, ensure you have the necessary tools and that the driveshaft bearing and surrounding components are clean and free of debris. Verify that the E-ring dimensions match the requirements of your specific application. The E-ring is made of metal and measures approximately 0.39 x 0.39 x 0.39 inches.
