Timken Driveline Center Support Hanger Bearing HB31 User Manual

Model: HB31 | Brand: TIMKEN

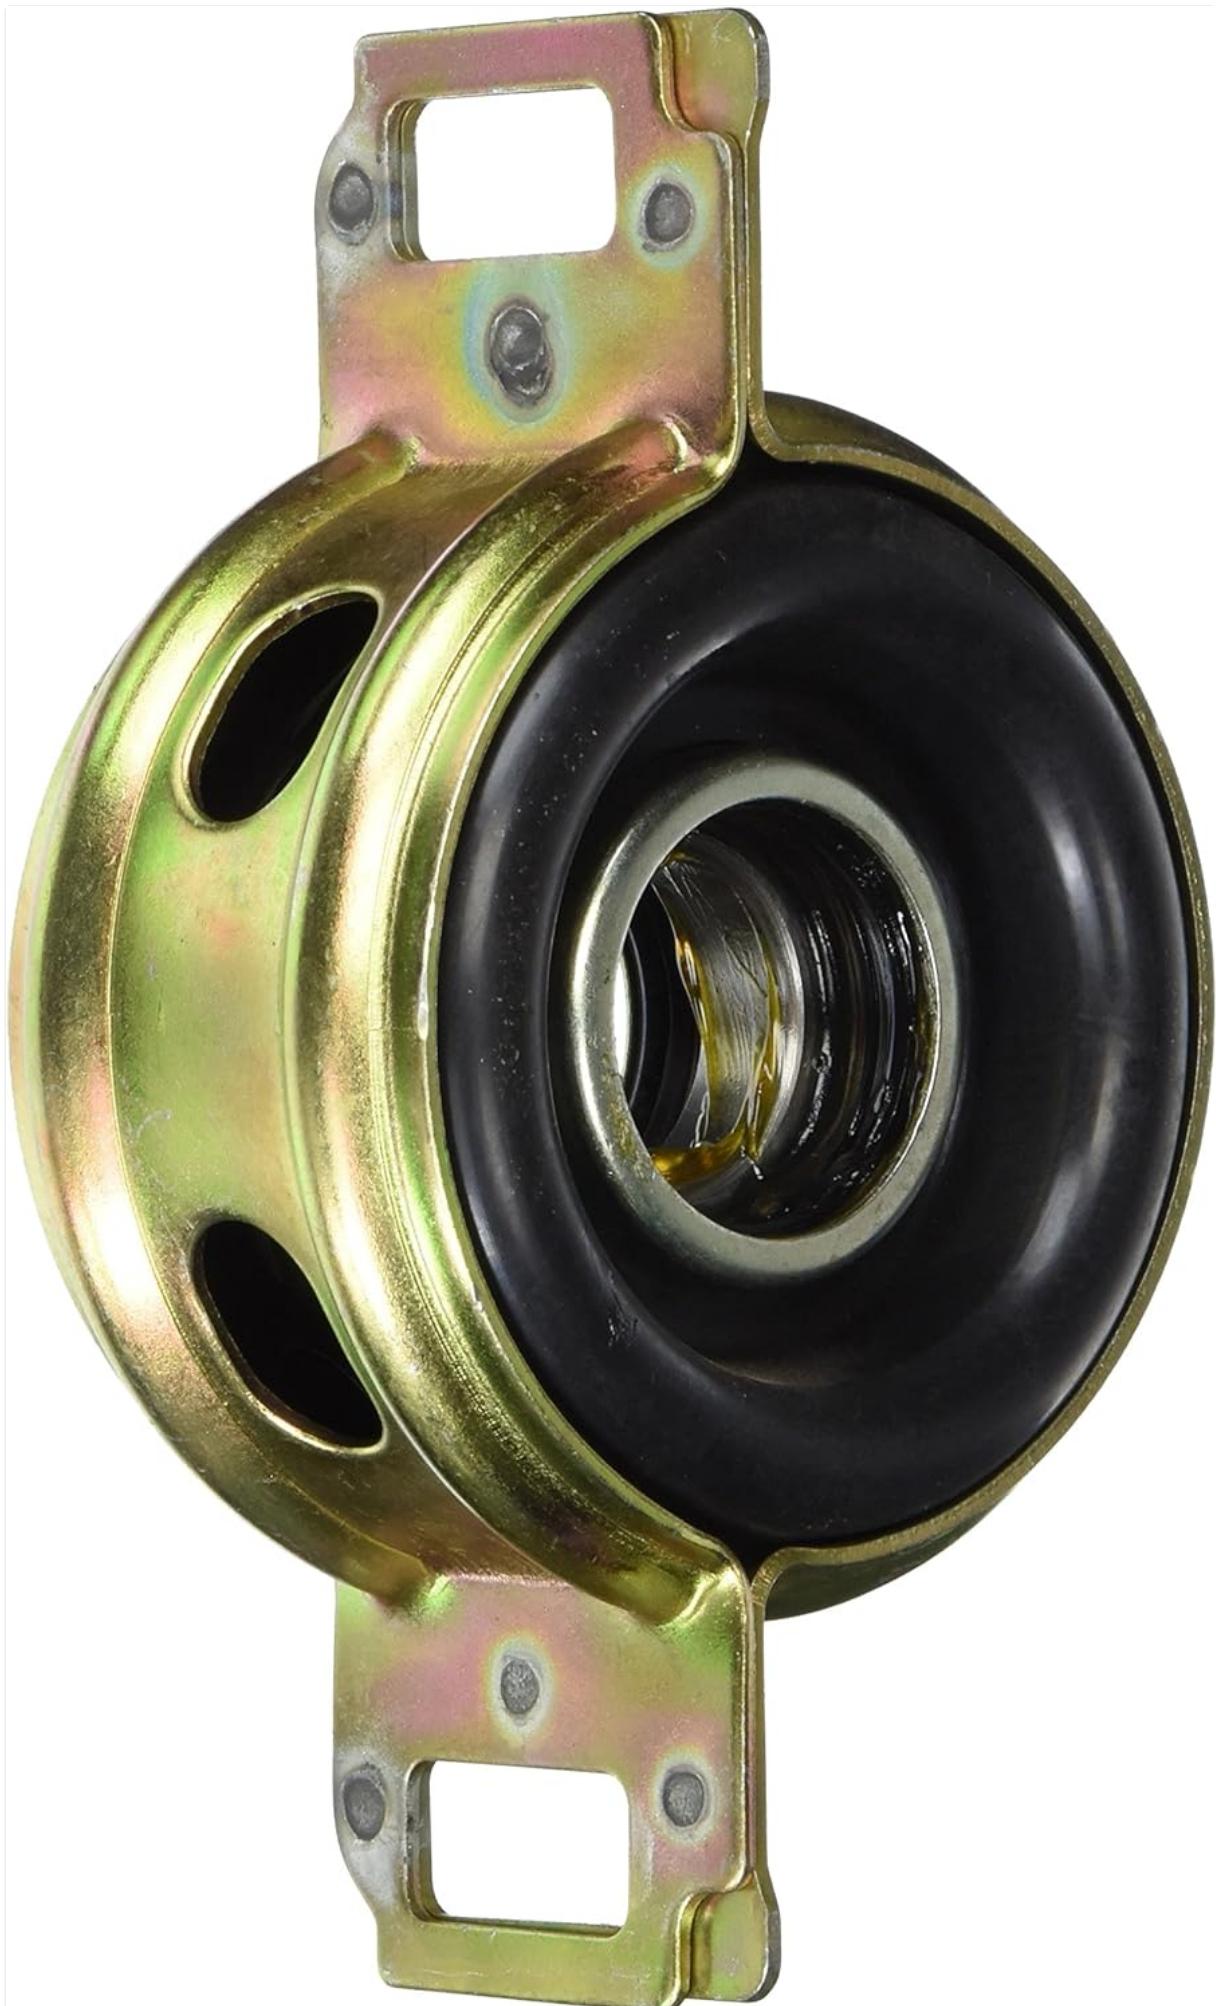
Figure 1: Timken HB31 Driveline Center Support Hanger Bearing. This image displays the complete assembly, including

the metal bracket, rubber insulator, and the central bearing unit, which is pre-greased.

The Timken HB31 is a driveline center support hanger bearing designed to support the driveshaft in vehicles, reducing vibration and maintaining proper alignment. It features a robust construction to withstand operational stresses and provide reliable performance.
