Hayward CX800Z4A

Hayward CX800Z4A Auto Air Relief Tube with Screen Replacement Manual

For Star-Clear II, Star-Clear Plus, and SwimClear Cartridge Filters

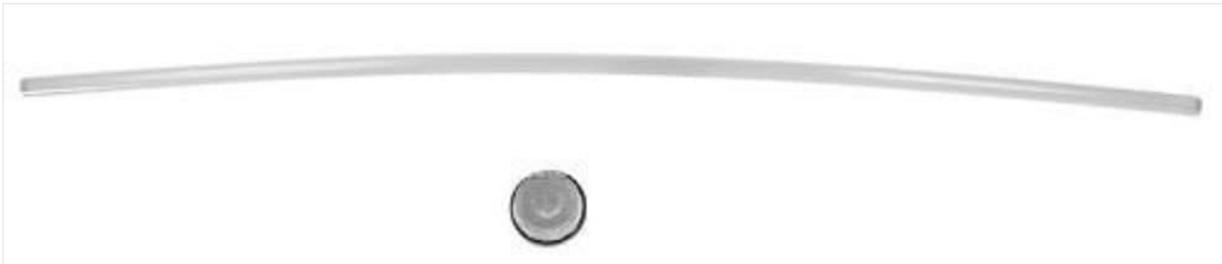
Image 1: Hayward CX800Z4A Auto Air Relief Tube with Screen. This image displays the complete replacement part, including the tube and the attached screen, ready for installation.

The Hayward CX800Z4A Auto Air Relief Tube with Screen is a genuine replacement part designed to maintain optimal performance of your Hayward cartridge filter system. This component is crucial for automatically releasing trapped air from the filter tank, ensuring efficient water filtration and preventing airlocks.

5. **Install the New Tube:** Insert the new Hayward CX800Z4A Auto Air Relief Tube with Screen into the designated opening. Ensure it is securely seated and properly oriented.
