Corteco 01031902B Oil Seal for Manual Gearbox

Model: 01031902B

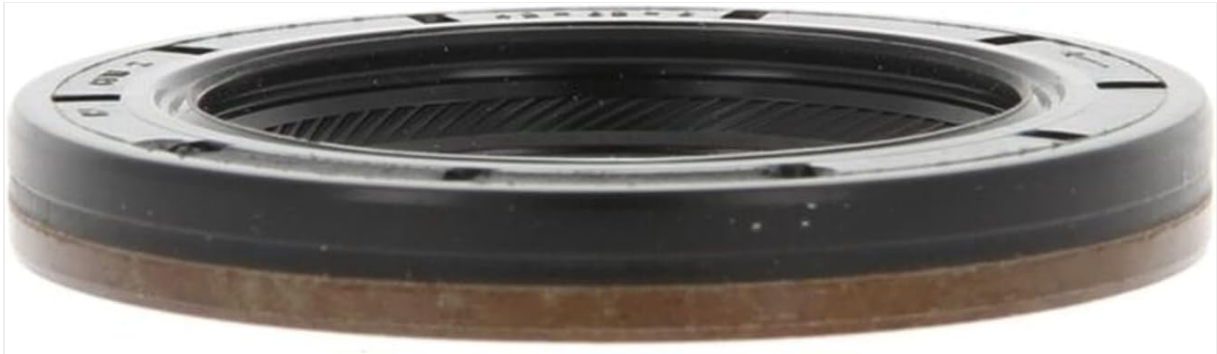
Image: Side view of the Corteco 01031902B Oil Seal, showing its profile and sealing lip. This view helps in understanding the seal's construction and proper orientation during installation.

rotating shaft and a stationary housing. The primary sealing lip, often reinforced by a garter spring, maintains constant contact with the shaft surface, preventing the escape of gearbox lubricant. The integrated dust lip provides an additional barrier against external contaminants such as dirt and moisture, protecting the main sealing lip and extending the seal's lifespan.

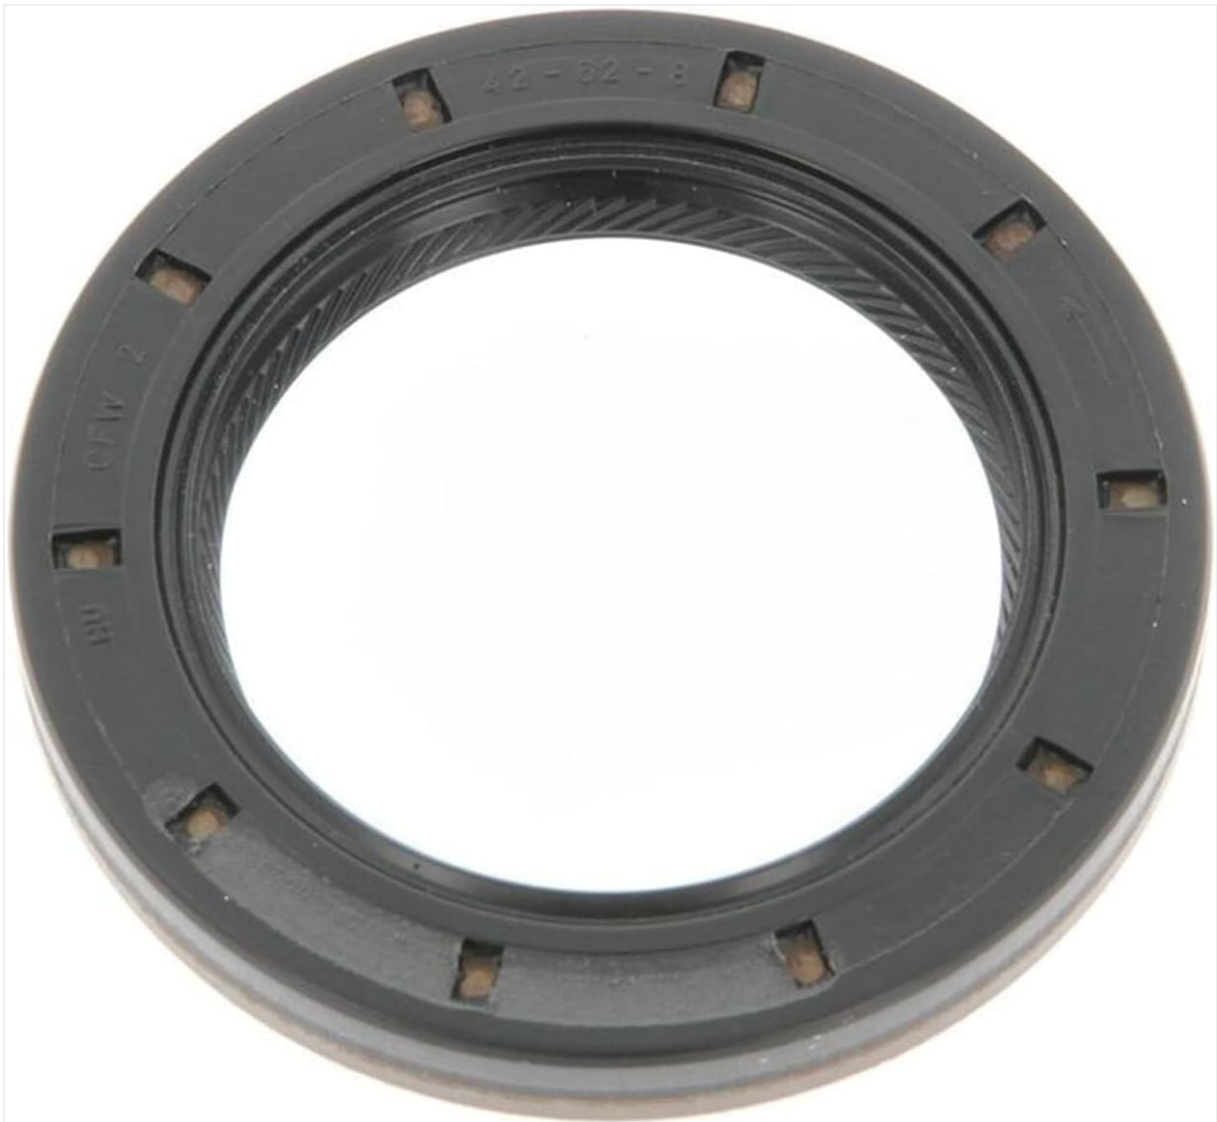
Image: Top view of the Corteco 01031902B Oil Seal, highlighting the outer diameter and the inner sealing surface. This perspective is useful for verifying the seal's dimensions and integrity before installation.

- **Outer diameter 1:** 62 mm
- **Inner diameter 1:** 42 mm
- **Height 1:** 8 mm
- **Material:** ACM (Polyacrylate)
- **Dust Cover:** With dust lip

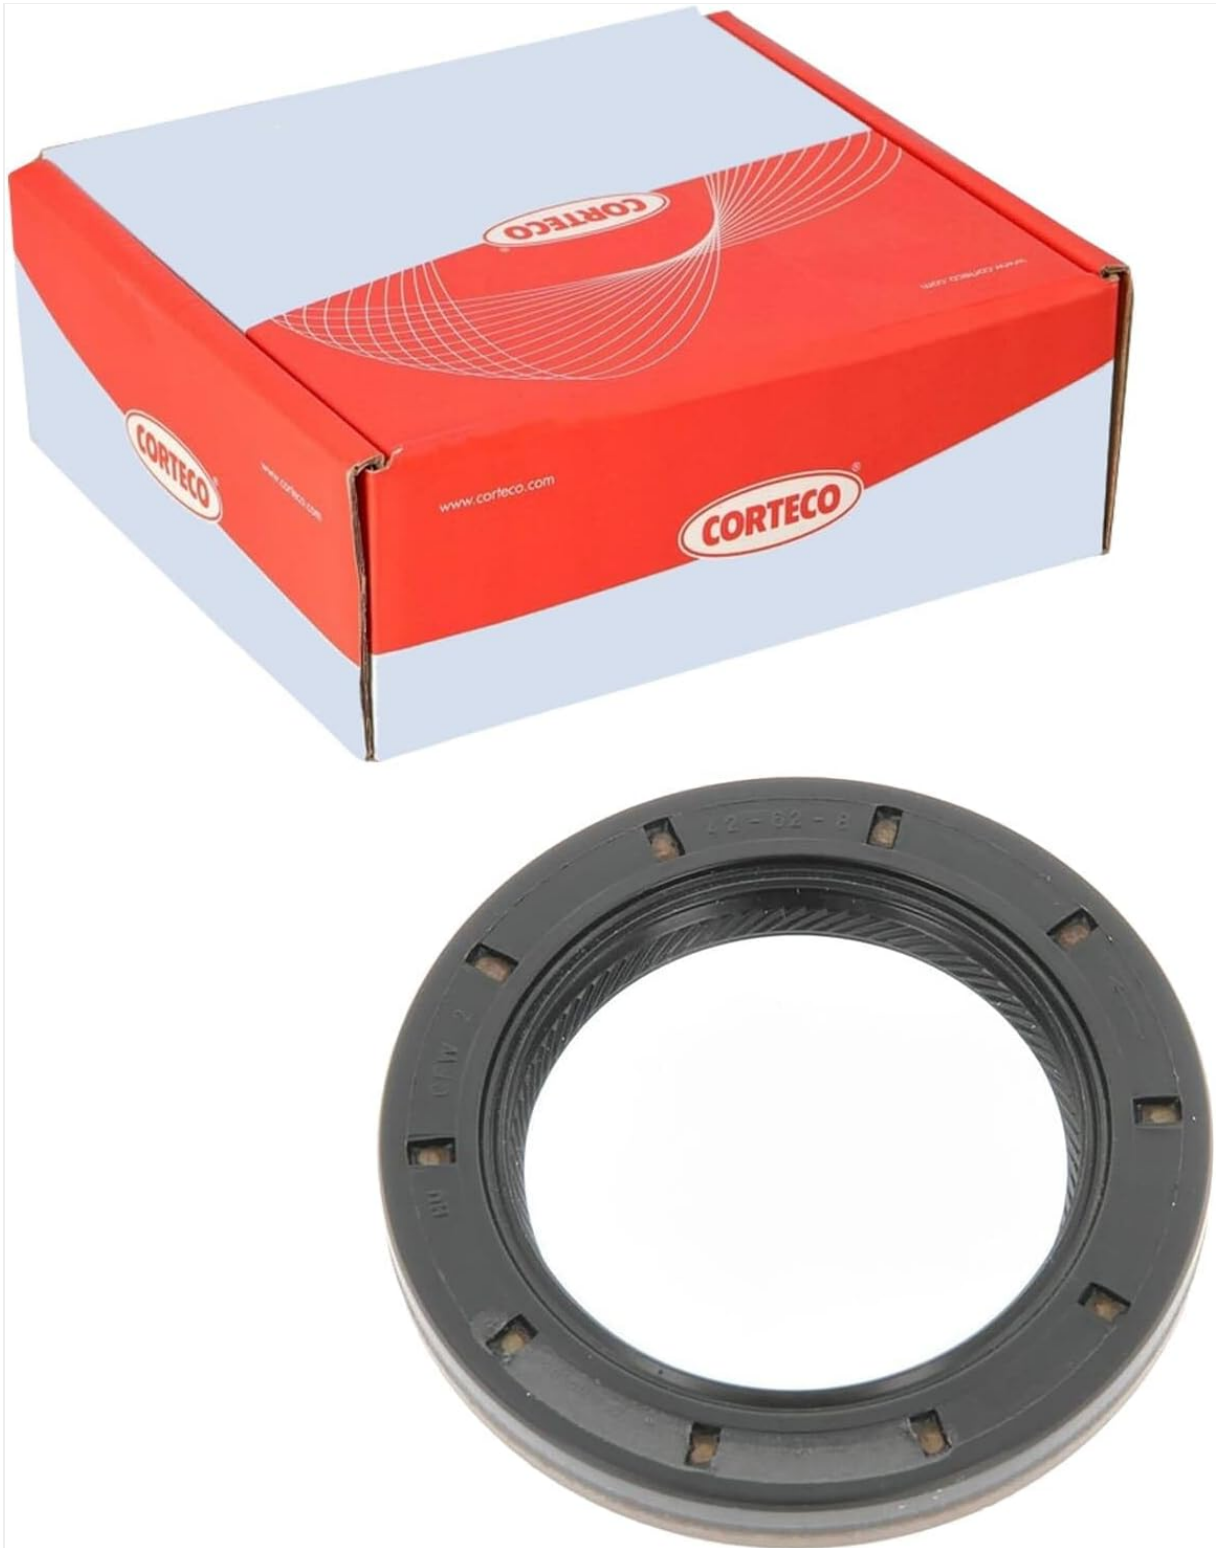
Image: The Corteco 01031902B Oil Seal shown both in its branded packaging and as a standalone component. This image provides a complete view of the product as received and its physical appearance.
