# General Motors 7812853 Transmission Control Lever Spring Instruction Manual

Model: 07812853 | Brand: General Motors

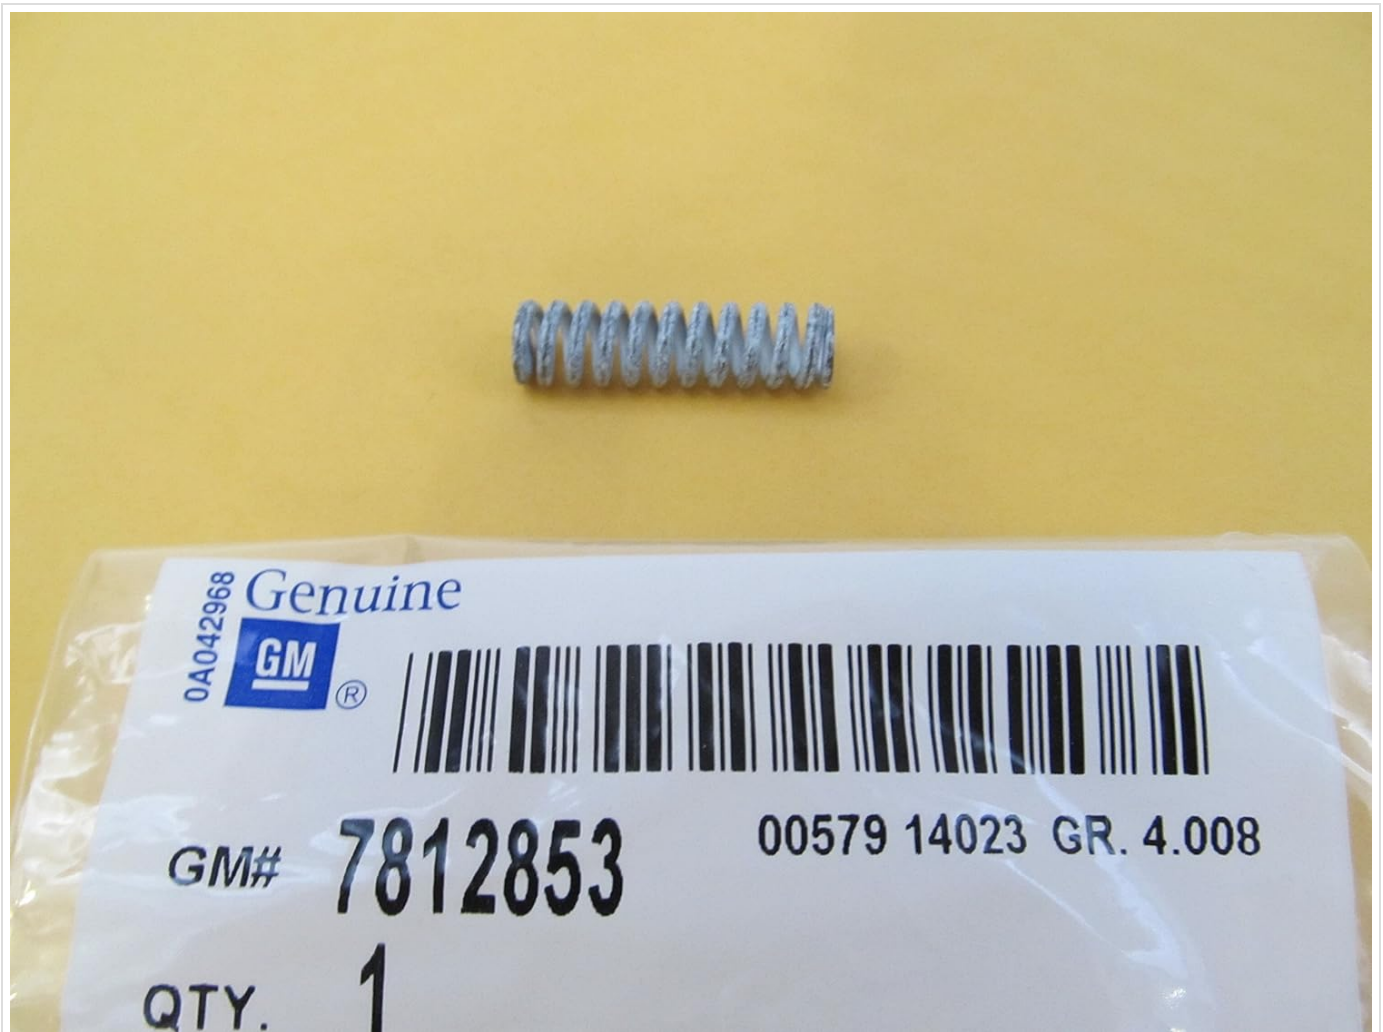
**Image 2.1:** The General Motors 7812853 Transmission Control Lever Spring, shown in its original packaging. The packaging clearly displays the GM logo and part number 7812853, confirming its authenticity. The spring itself is a small, coiled metal component, designed for precise mechanical function within the vehicle's transmission system.

The General Motors 7812853 is a genuine replacement spring for the transmission control lever. It is manufactured from alloy steel, ensuring durability and consistent performance in automotive applications.
