Dorman 521-794 Front Passenger Side Upper Suspension Control Arm and Ball Joint Assembly User Manual

Model: 521-794

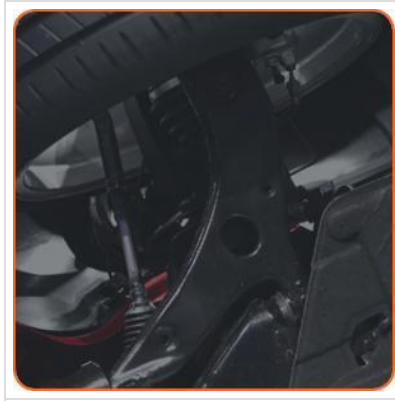
Image: A view of a vehicle's suspension, showing the location of a control arm.

- Locate the upper control arm. It connects the top of the steering knuckle to the vehicle frame.
- Support the lower control arm with a jack stand or floor jack to prevent the suspension from dropping excessively when components are disconnected.

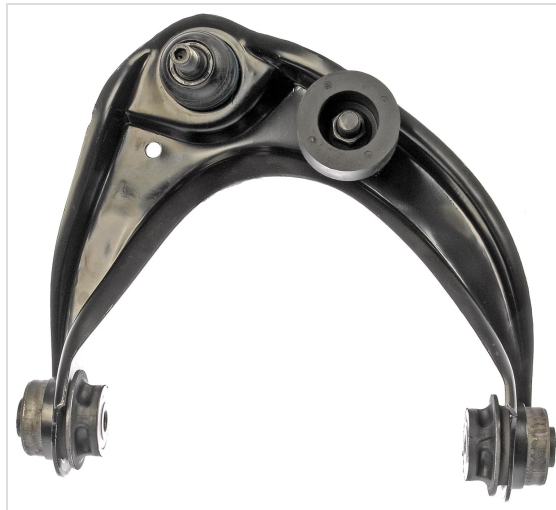
Image: The Dorman 521-794 Front Passenger Side Upper Suspension Control Arm and Ball Joint Assembly, showing the main component with pre-installed ball joint and bushings.

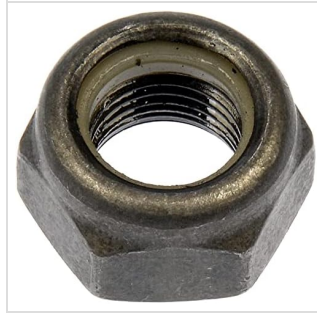
Image: A hex nut, representative of the fasteners used to secure the ball joint.

- Remove the cotter pin and castle nut from the upper ball joint stud where it connects to the steering knuckle.
- Use a ball joint separator tool or a pickle fork to separate the ball joint from the steering knuckle. Be careful not to damage the ball joint boot or other components if reusing.

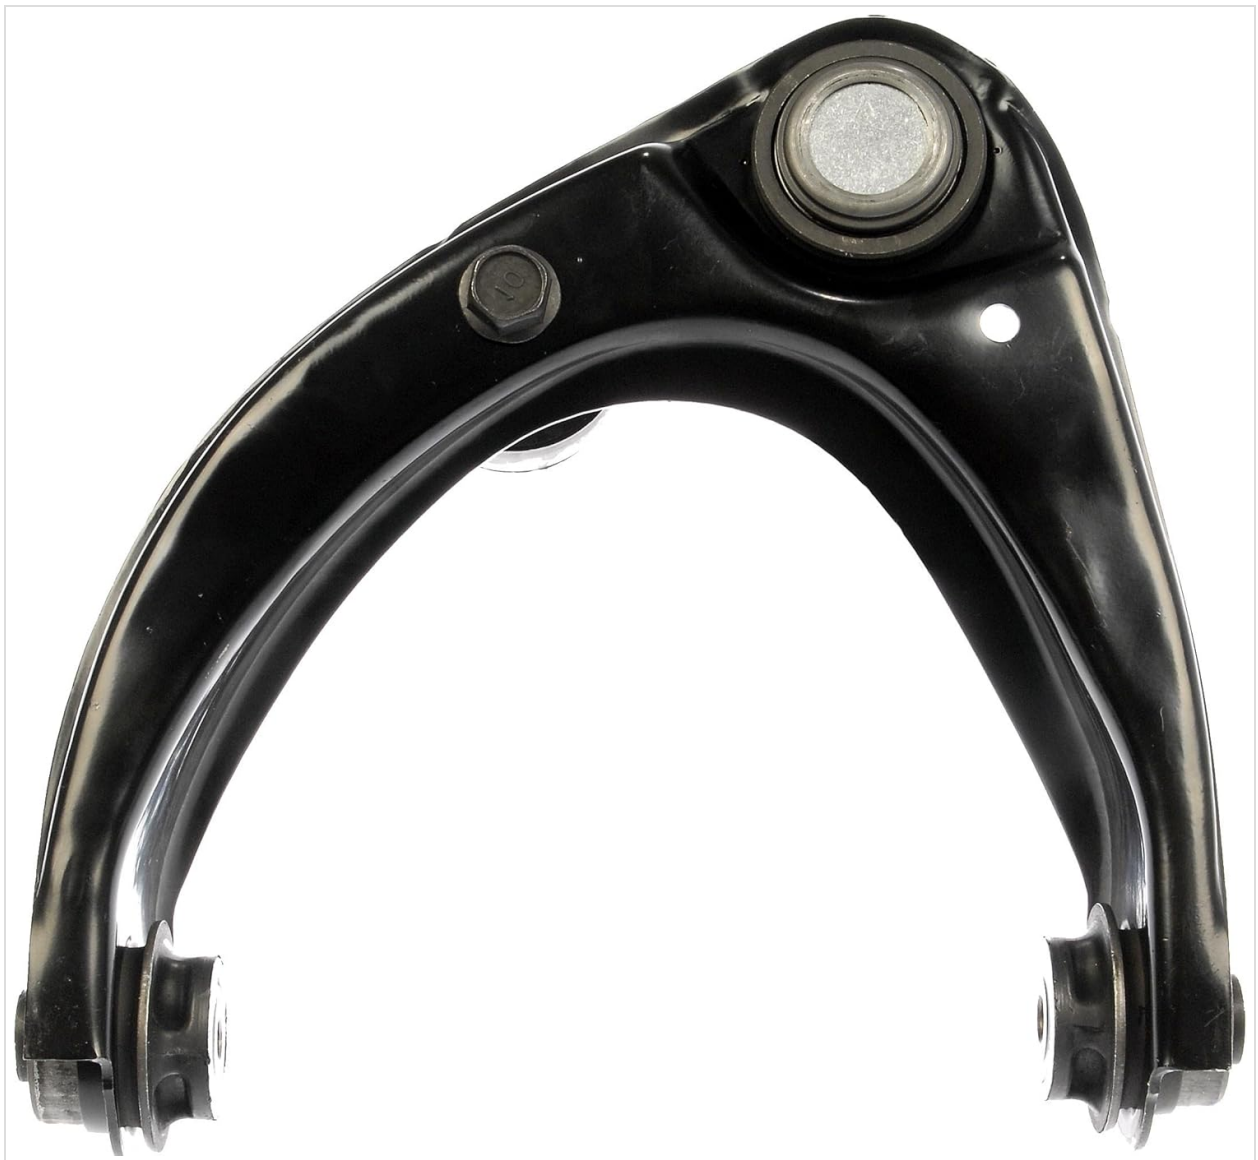
Image: The Dorman 521-794 Control Arm, illustrating the bushing locations where it attaches to the vehicle frame.

- Locate the bolts securing the control arm to the vehicle frame or subframe. There are typically two bolts.
- Remove these bolts. Note their orientation for reinstallation.

- Position the new Dorman 521-794 control arm into place.
- Insert the mounting bolts through the bushings and into the frame. Hand-tighten them initially.
- Connect the new ball joint stud to the steering knuckle. Install the new castle nut and cotter pin. Torque the castle nut to the manufacturer's specification.
