Triton 06433-P 1 3/8-inch Bearing Seal Instruction Manual

Model: 06433-P

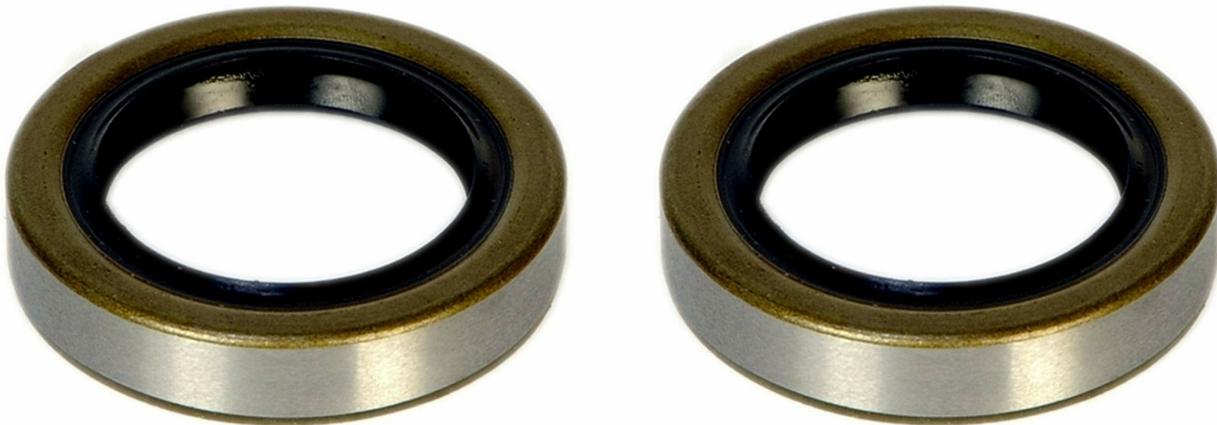
This image displays two Triton 06433-P 1 3/8-inch Bearing Seals. Each seal features a metallic outer ring with a bronze-like finish and a black rubber inner lip, designed to prevent grease leakage and protect bearings.

The Triton 06433-P 1.375-inch Bearing Seal is a critical component designed to protect wheel bearings from contaminants and retain grease, ensuring smooth operation and longevity of your axle system. This seal is supplied as a 2-pack and corresponds to Dexter Part # 010-019-00. It features a double-lip design suitable for both standard grease and E-Z Lube applications. This manual provides essential information for proper handling, installation, and maintenance of your bearing seals.

Attribute	Detail
Brand	Triton
Model Number	06433-P
Part Number (Dexter Equivalent)	010-019-00
Inner Diameter (I.D.)	1.719 inches
Outer Diameter (O.D.)	2.565 inches
Compatible Axle Weight	3,500 lb. axles
Compatible Bearings	L44649 Outer Bearing & L68149 Inner Bearing
Seal Type	Double Lip Seal
Material	Rubber
Compatible Lubricant	Grease
